INCIDENT REVIEW – OTAHUHU SUBSTATION LOSS OF SUPPLY 12TH JUNE 2006

- Interim Report
- 23 June 2006

Sinclair Knight Merz
Level 12, Mayfair House
54 The Terrace
PO Box 10-283
Wellington New Zealand
Tel: +64 4 473 4265
Fax: +64 4 473 3369
Web: www.skmconsulting.com

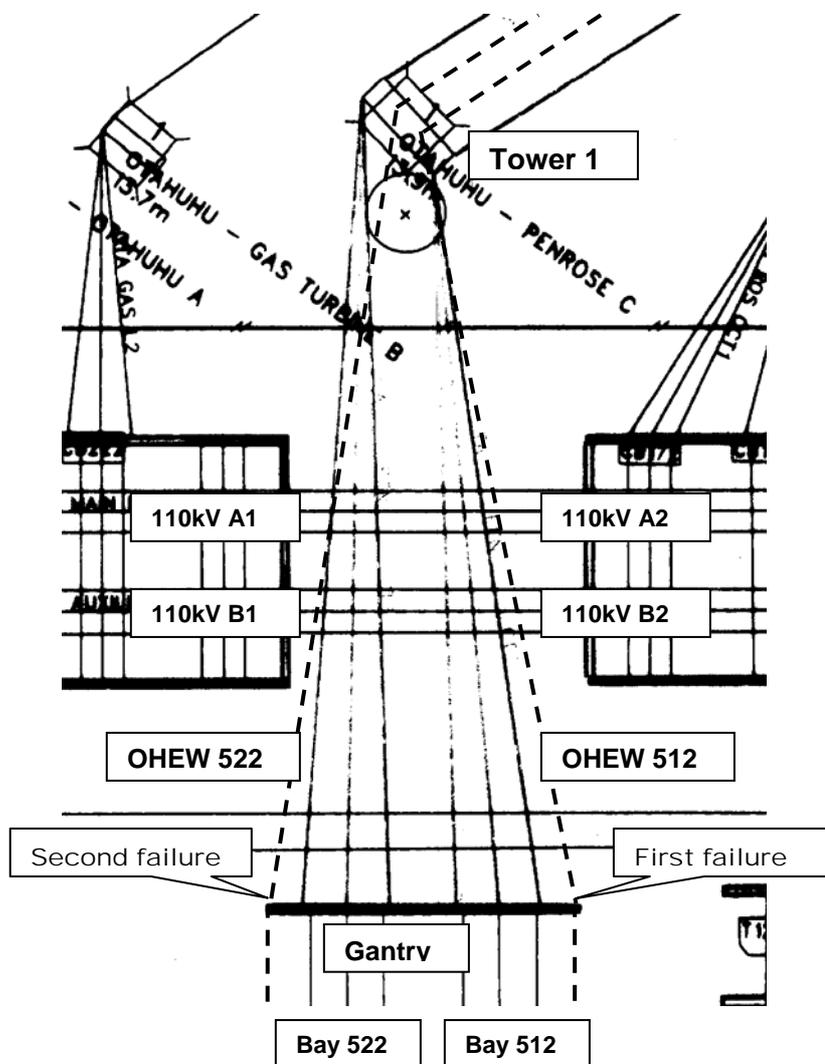
- **Figure 1 Section of Otahuhu Switchyard**

Figure 1 shows the section of Otahuhu switchyard where the events of 12th June occurred.

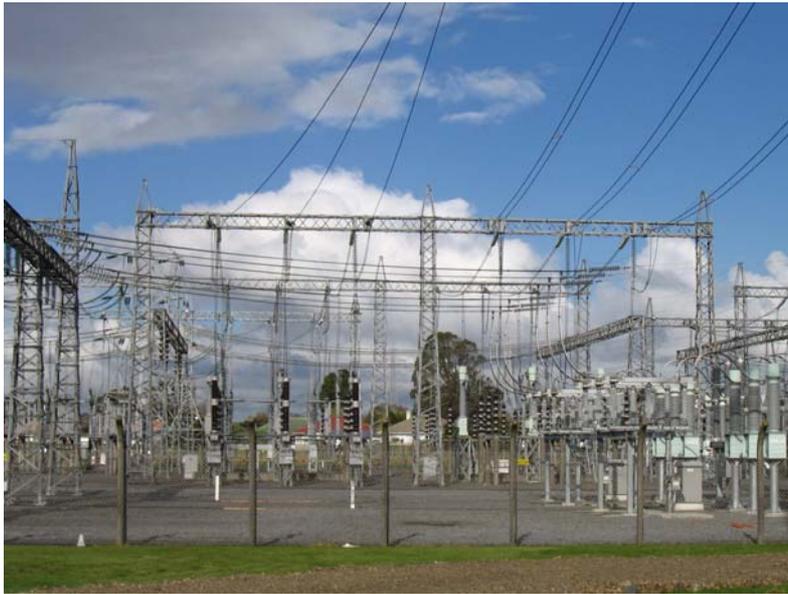
Photograph 01 – Gantry structure for the Otahuhu – Penrose 5 and Otahuhu – Otahuhu CCGT Tie Line 3 220 kV circuits.

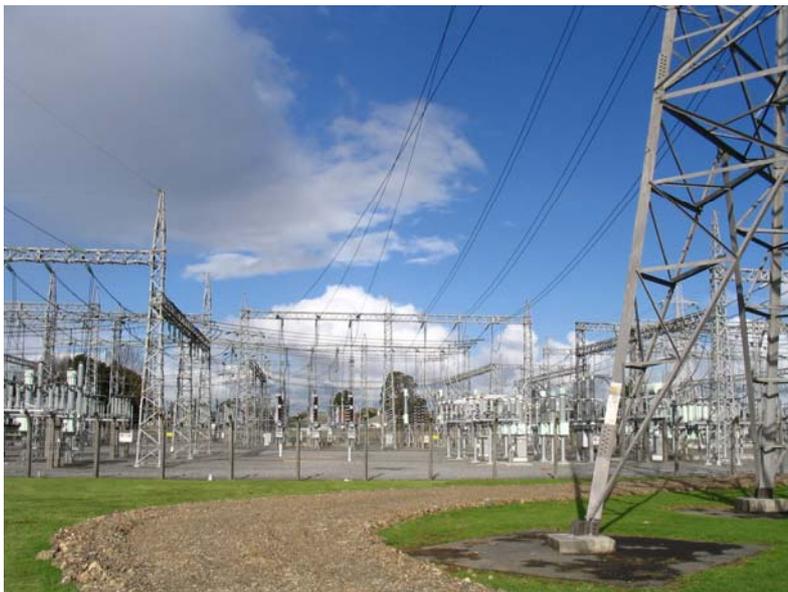
Photograph 02 – Gantry structure with Tower 1 on the right hand.

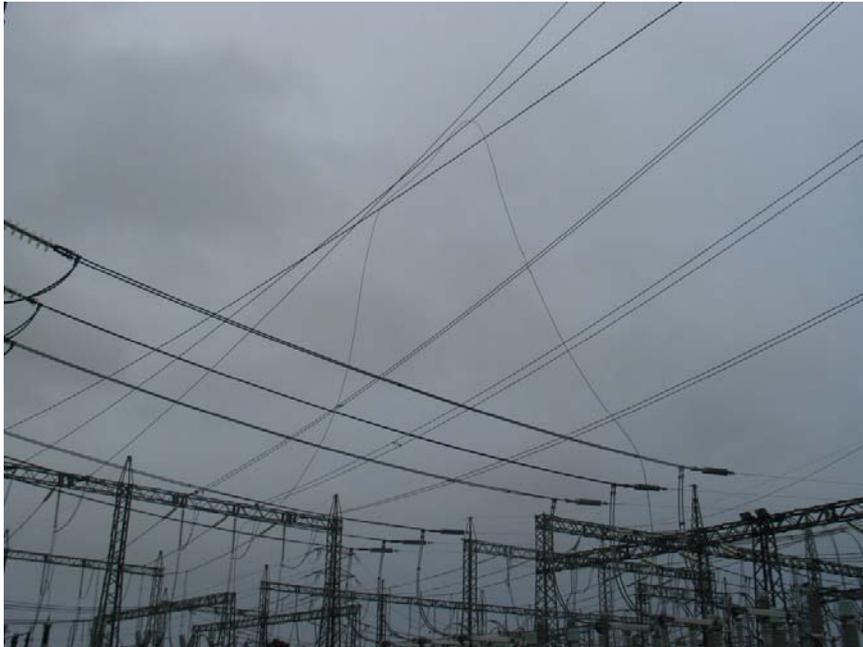
This failure led to OHEW 512 falling onto the Otahuhu – Penrose 5 220 kV circuit and the A2 and B2 110 kV bus sections causing an outage on the Otahuhu – Penrose 5 220 kV circuit and the loss of half of the 110 kV bus capacity. Photographs 03 and 04 found in Appendix E show OHEW 512 across the 220 kV circuit and the two 110 kV bus sections.

Photograph 03 – OHEW 512 across the Otahuhu – Penrose 5 220kV circuit and the A2 and B2 110 kV bus sections.

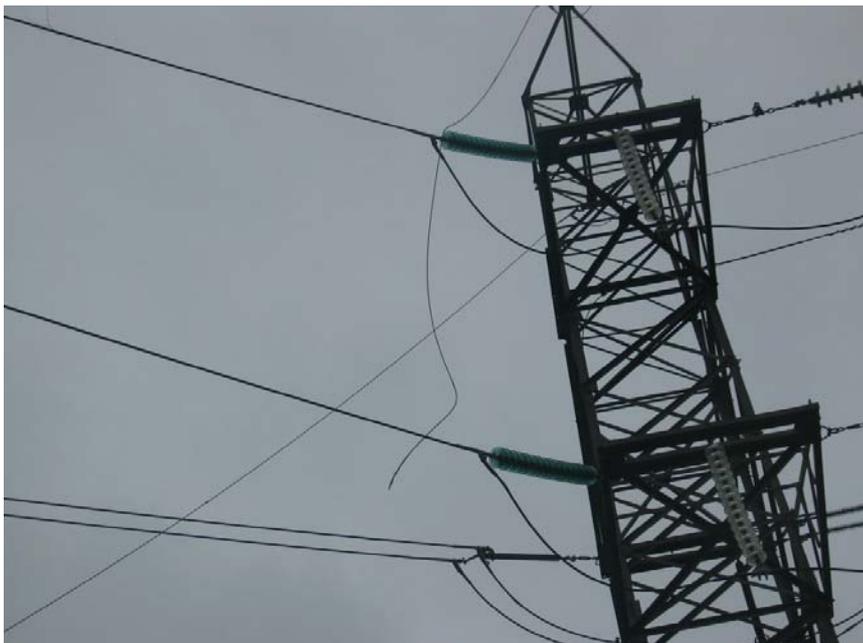
Photograph 04 – Section of OHEW 512 still attached to Tower 1.

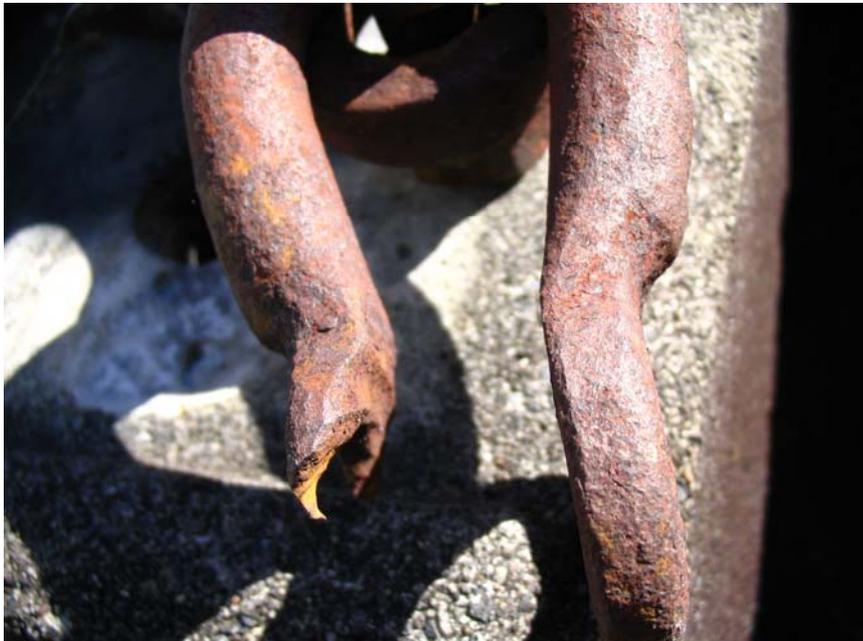
The first component to fail was the shackle attaching OHEW 512 to the earthwire peak of the gantry of switchyard bay 512. While the high wind at the time of the event was the trigger for the failure, the failure occurred because of the poor condition of the shackle. Photographs 05 and 06 show the condition of the recovered OHEW 512 shackle.

The mechanical load on the shackle for the estimated wind conditions at the time of the event was approximately 3% of the rated strength of the shackle in good condition.

Photograph 05 – Failed shackle from OHEW 512 assembly attached to gantry.

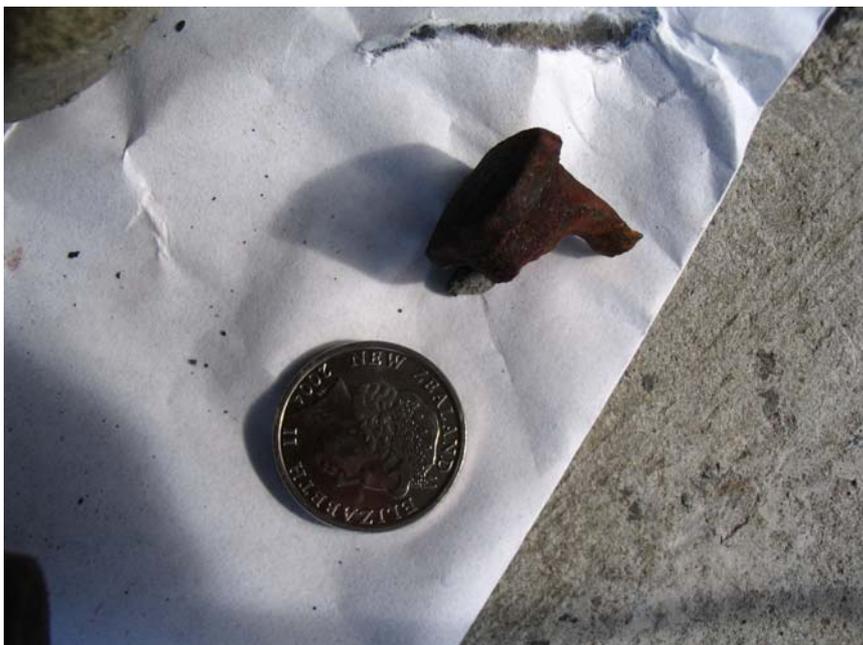
Photograph 06 – Recovered portion of part shackle pin for OHEW 512 shackle with 10c piece.

Note shackle pin wear leaving very little of the original pin diameter.

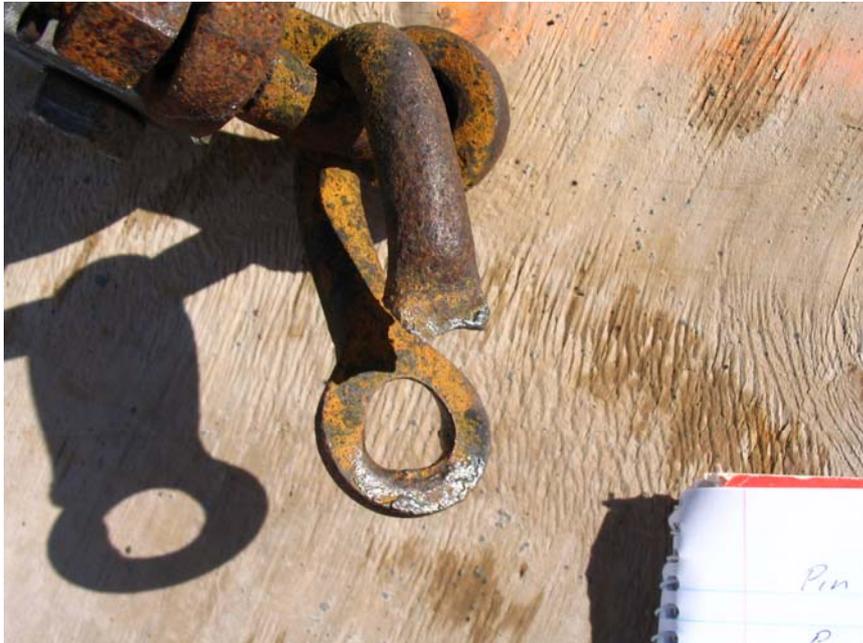
The trigger for this failure was either the high wind at the time of the event or the earth fault current flowing in OHEW 522 as a result of the first failure or a combination of both. Again, the poor condition of the shackle was the cause of the failure. Photographs 07, 08 and 09 show the condition of the recovered OHEW 522 shackle. This shackle showed evidence of arcing from fault current.

Photograph 07 – Recovered shackle for attachment of OHEW 522 to the substation gantry earthwire peak. Note burn marks from fault current.

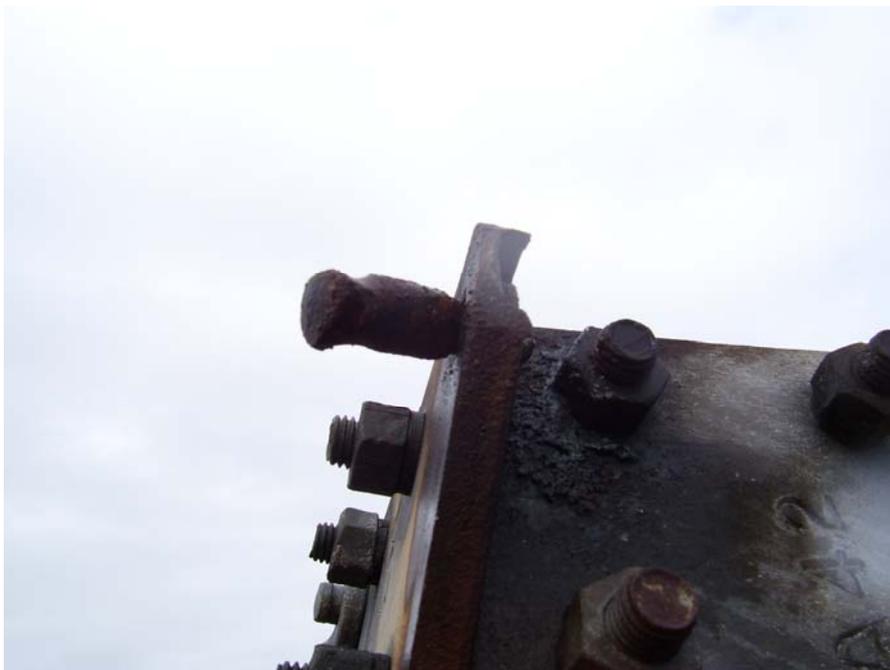
Photograph 08 – OHEW 522 gantry attachment point with shackle pin after the failure.

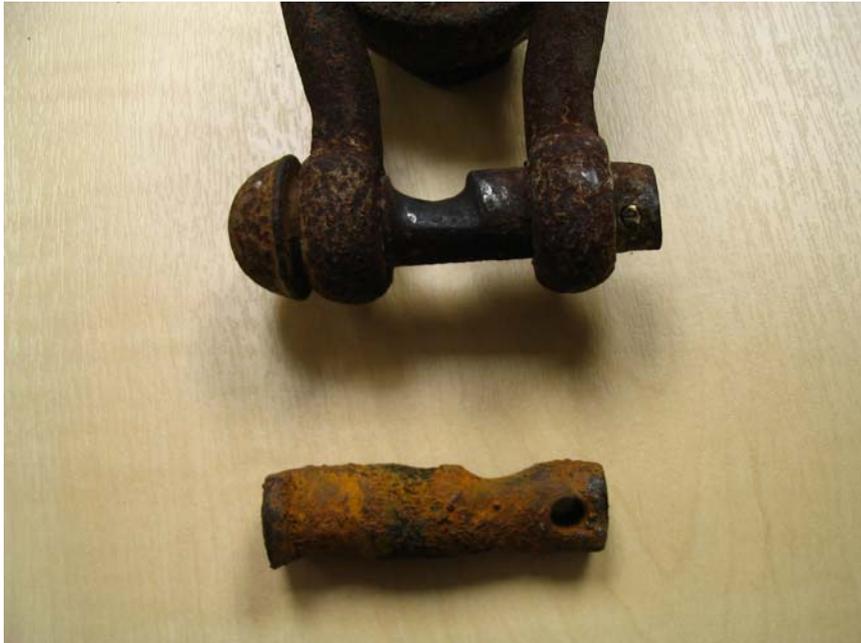
Photograph 09 – Recovered OHEW 522 shackle pin compared with the shackle pin of a recovered assembly from an adjacent gantry. Note the missing pin head of the OHEW 522 shackle pin and the extensive wear of the shackle pin from the adjacent gantry.

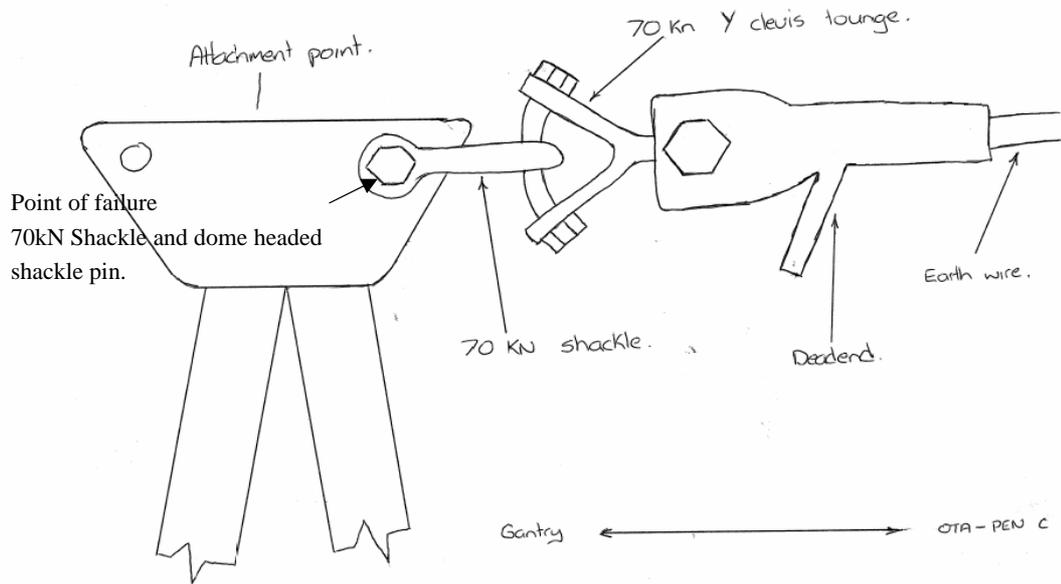
Sketch Di552060614005.PDF

The attachment point is part of the earthwire peak of the switchyard gantry.

The failure occurred at 70 kN shackle pin attachment point connection.
