**Interim Report Marine inquiry 11-204: Containership MV Rena
grounding on Astrolabe Reef 5 October 2011**

Marine inquiry 11-204
Containership MV Rena grounding on Astrolabe Reef
5 October 2011

Transport Accident Investigation Commission

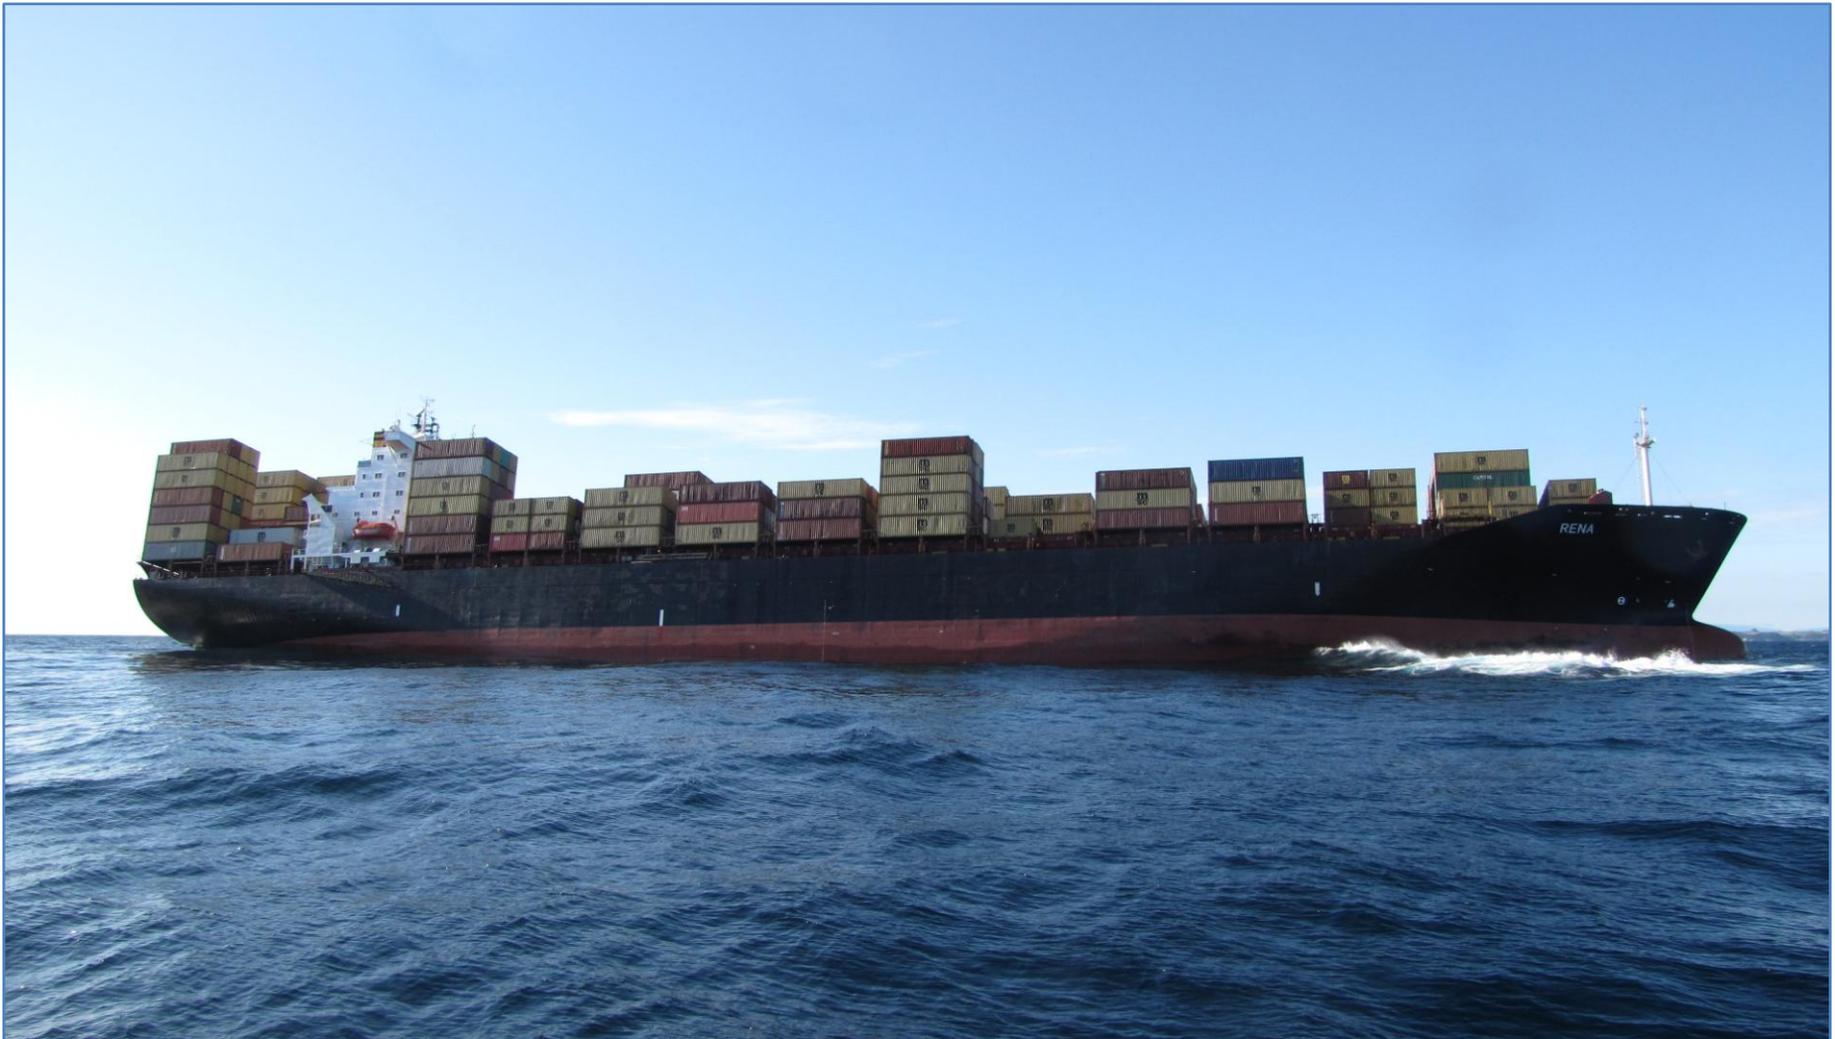
The MV *Rena* aground on Astrolabe Reef (photograph taken 6 October 2011)

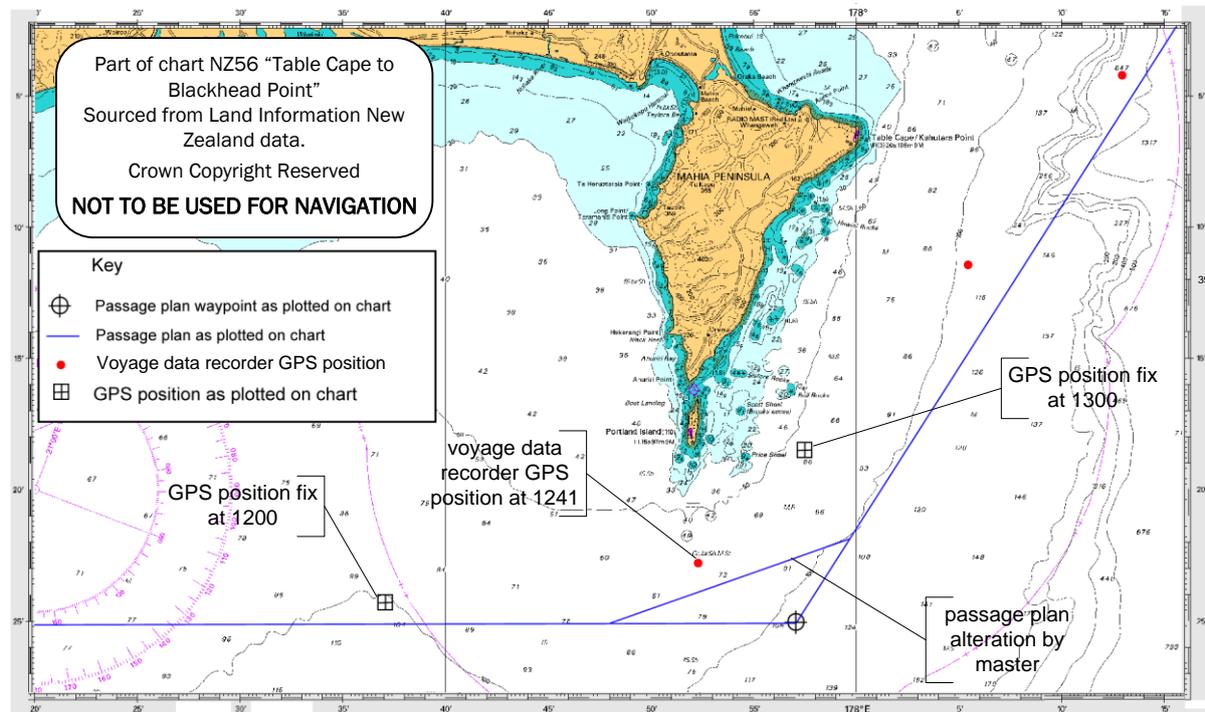
Figure 1

2.2.5. The master modified the vessel's planned passage on the chart to shorten the distance around Mahia Peninsula, as seen in Figure 1. The master handed control of the *Rena* to the third mate at 1100 as the vessel approached Mahia Peninsula. The passage plan that was in use during the voyage required that the vessel's position be plotted hourly, which was typically done using co-ordinates from the GPS. At times during the voyage the position was plotted more frequently than hourly.

Part of chart NZ56 showing passage plan, plotted positions and GPS positions obtained from the voyage data recorder on passage around Mahia Peninsula

2.2.7. The *Rena* rounded Mahia Peninsula at about 1300 and proceeded up the coast. The plotted positions were inshore of the course lines. A position plotted on the next chart used in the passage (NZ55) included a position at just over 5 nautical miles inshore of the planned passage.

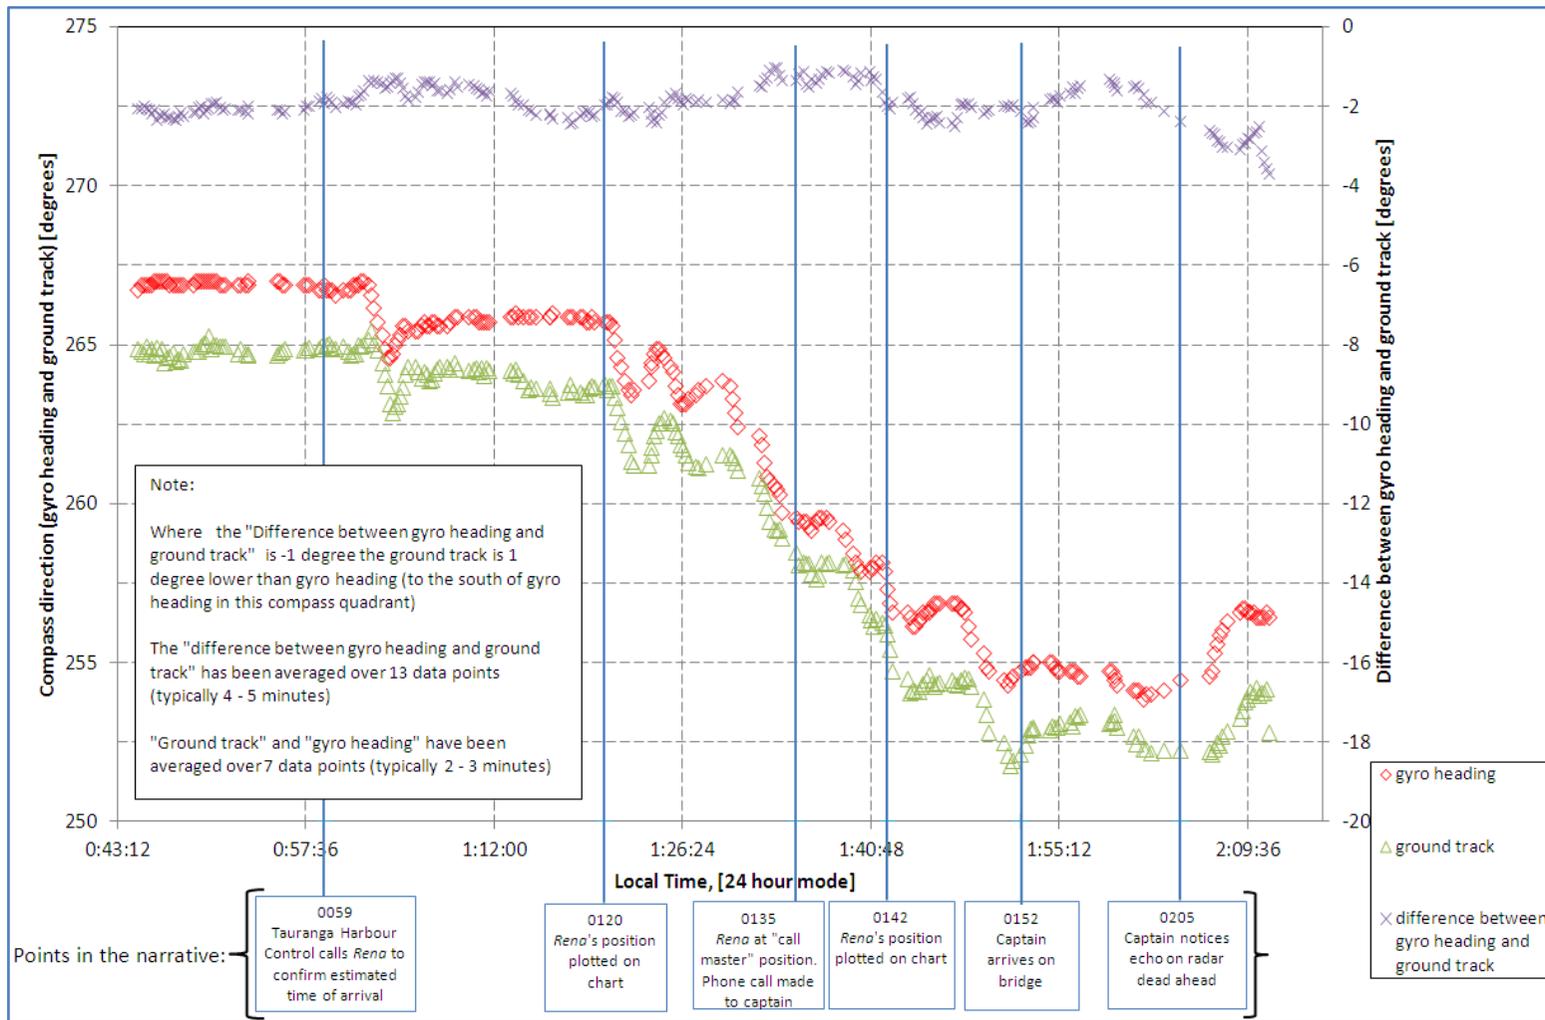
- 2.2.13. Figure 2 shows the *Rena*'s gyro heading and ground track and the difference between the 2. This data was taken from the automatic identification system and includes any error from that system. For clarity the data scatter was "smoothed" by taking an average over several data points. The bottom axis shows the time of day beginning at 0043 on 5 October 2011 and ending at around 0215 the same day. The vessel's gyro heading and ground track are read from the left-hand axis, which shows the gyro heading as recorded by the automatic identification system. The difference between the gyro heading and the ground track of the vessel is read from the right-hand axis. Some points in the narrative have been superimposed on the data for reference.

- 2.2.14. At about 0101 the course was altered to the south by about one degree as seen in Figure 2. Between 0120 and 0150 the gyro heading and ground track altered a further 10 degrees to the south, resulting in a gyro heading of about 255 degrees at about 0150.

Figure 2
Automatic identification system data showing vessel gyro heading and ground track and the difference between the 2. Some points of the narrative have been overlaid on the plot (automatic identification system data provided by Marico Marine NZ Limited)

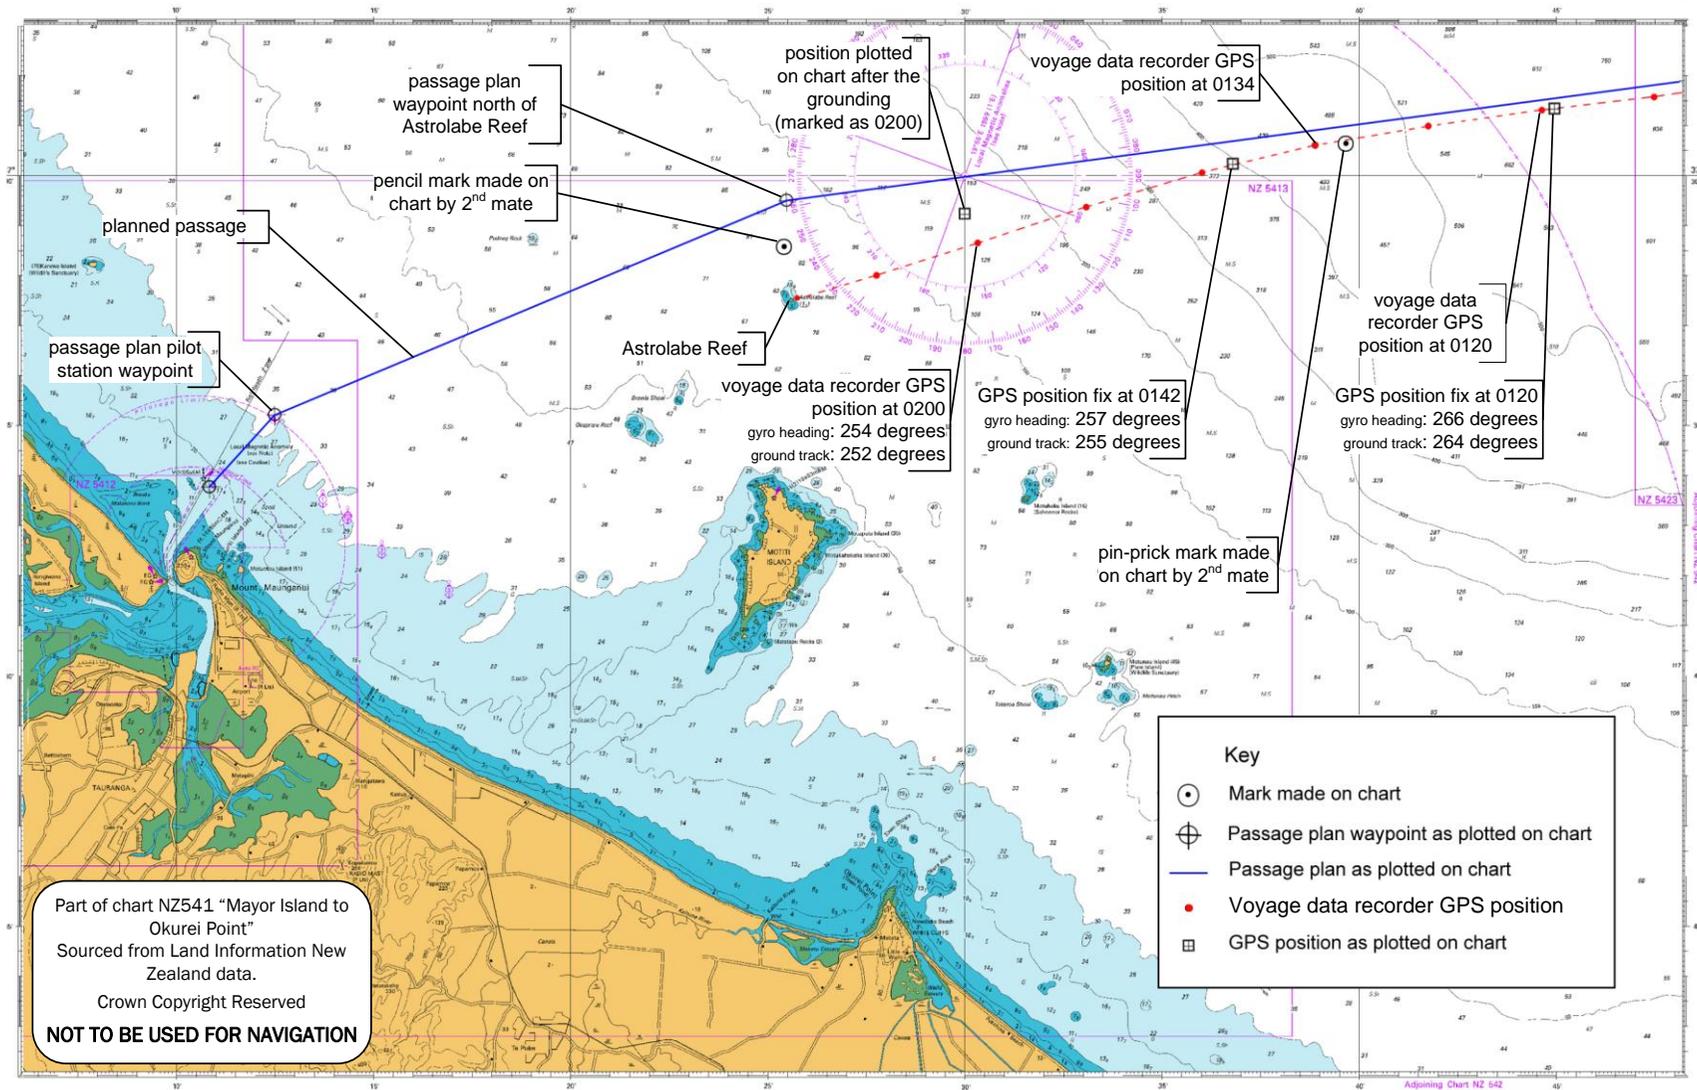
Figure 3
Part of chart NZ541 showing passage plan, plotted positions and voyage data recorder GPS positions on approach to Tauranga

- 2.2.17. The second mate's plan was to navigate closer to Astrolabe Reef. He said he placed a mark on the chart about one nautical mile north of Astrolabe Reef (shown in Figure 3), which was the point to which he intended to navigate the *Rena* before making the final course adjustment to the pilot station. The master has stated that the mark made on the chart one nautical mile north of Astrolabe Reef was put there after the grounding. The contradicting statements from the master and the second mate will be the subject of further consideration within the Commission's final report.

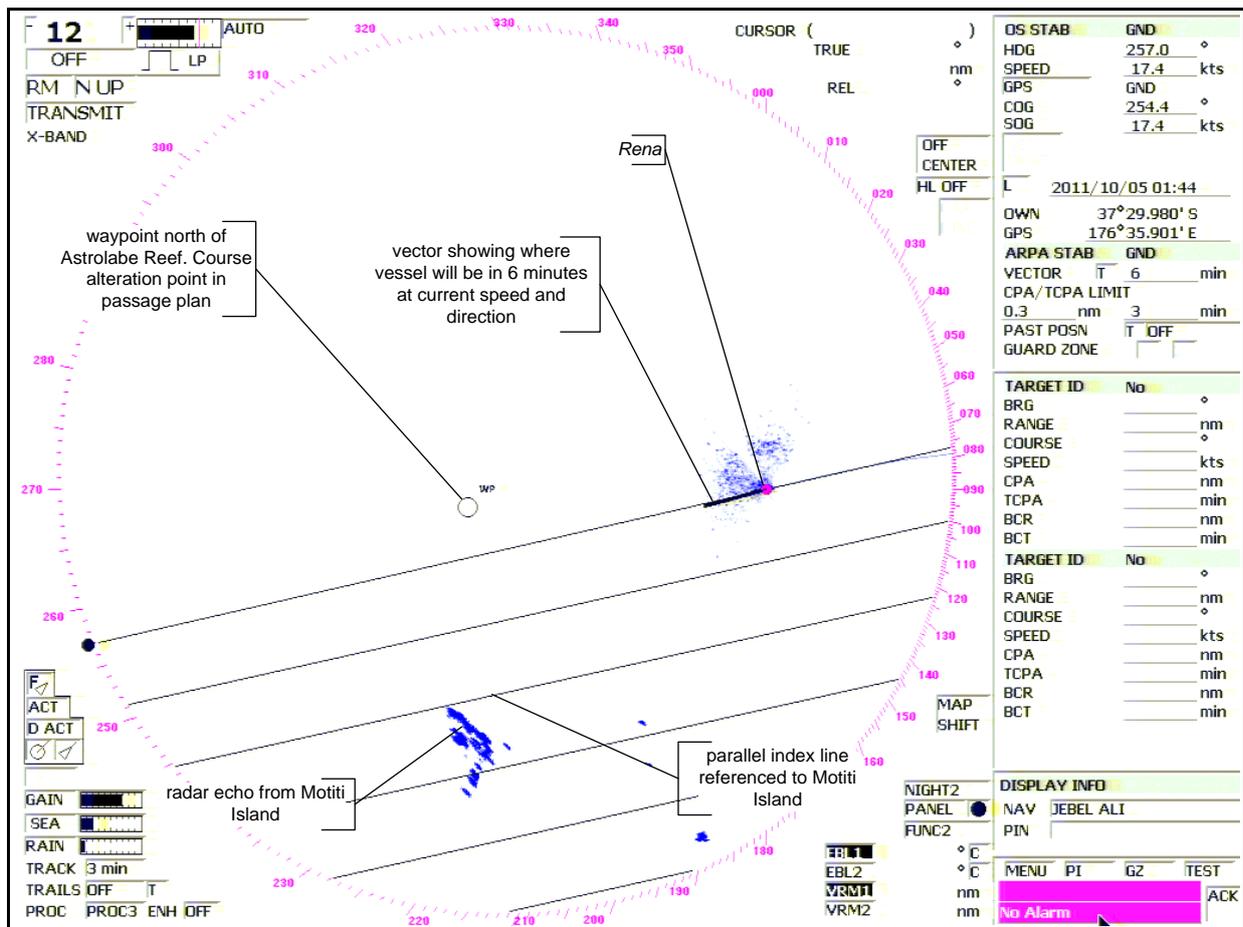
- 2.2.21. The voyage data recorder captured a screenshot of the *Rena*'s radar at about 15-second intervals. Figure 4 shows a radar screenshot captured at the time when the parallel index (referencing Motiti Island) was set up. The screenshot has been annotated with labels to identify the vessel, its course vector, Motiti Island, parallel index lines and the passage plan course alteration waypoint north of Astrolabe Reef.

Figure 4
Annotated screenshot of the *Rena*'s radar (colour reversed for clarity)
