**Royal Commission on the Pike River Coal Mine Tragedy**

# Volume 1

+ Overview

Date of Publication: October 2012

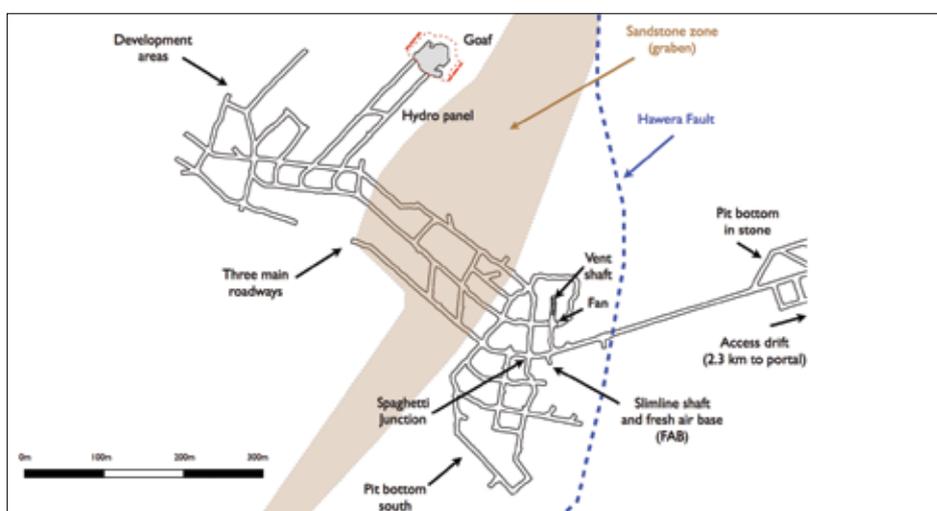
Figure 1: The mine plan as at November 2010<sup>2</sup>

There were two mine infrastructure areas (pit bottom in stone and pit bottom south), three main roadways, the hydro-mining panel and further development areas to the north-west. Spaghetti Junction was the meeting point of the drift and pit bottom, with two surface-to-mine shafts nearby – the main ventilation shaft, and the slimline shaft, at the bottom of which was a so-called fresh air base (FAB). Pike River was a small mine, still at an early stage of development.

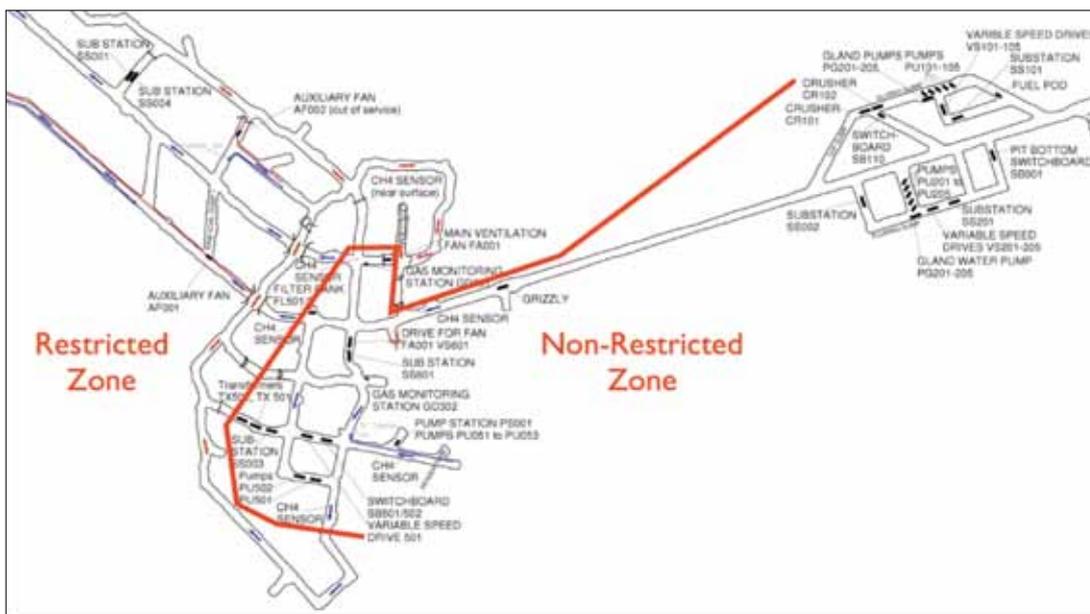
Figure 2: Boundary between the restricted and non-restricted zones<sup>6</sup>

Regulations require a gassy mine to have a restricted zone where all electrical equipment must be incapable of sparking an explosion. The dividing line at Pike River is shown below.

The non-restricted zone, as drawn, allowed unprotected electrical equipment to be located on the right-hand side of the line in most of pit bottom south. The zone was fixed without a risk assessment, after electrical equipment was

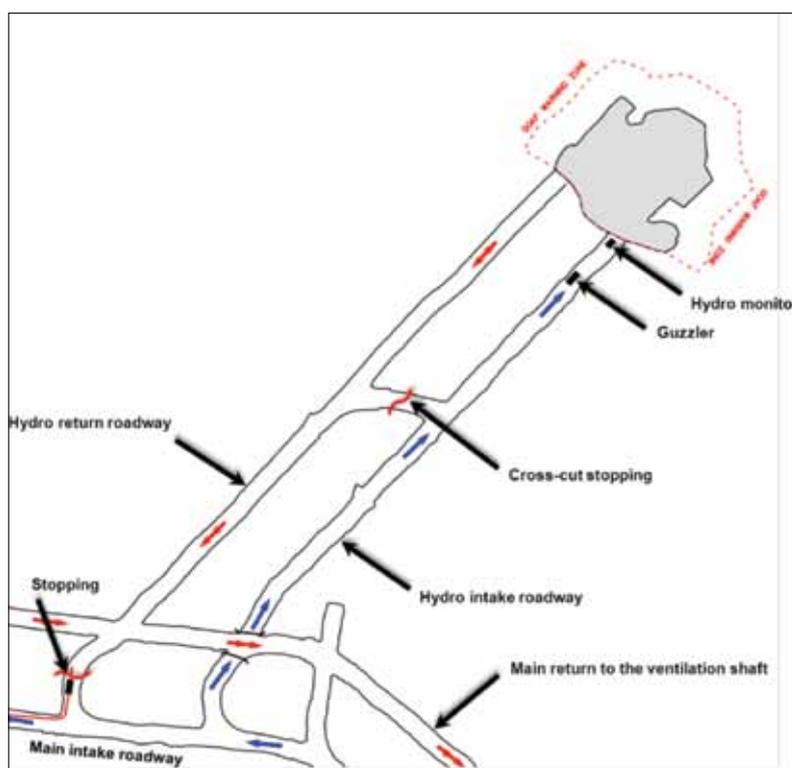
Figure 3: Diagrammatic outline of hydro panel<sup>7</sup>

Hydro mining started at Pike River in September 2010. This is an uncommon and specialised mining technique that uses a water jet to cut the coal face and requires expert design of the mining panel and equipment. Operators must be trained to follow a set cutting sequence and to direct the water jet to avoid the undue disturbance and release of methane. The hydro panel was developed as shown in this plan.

The water jet was mounted on the monitor, with an operator stationed at the guzzler. The goaf was unsupported and roof falls were expected. The intake of fresh air is represented by the blue arrows and the outflow of return air by the red arrows.
