# Canterbury Earthquakes Royal Commission

FINAL REPORT

VOLUME 4  
EARTHQUAKE-PRONE BUILDINGS

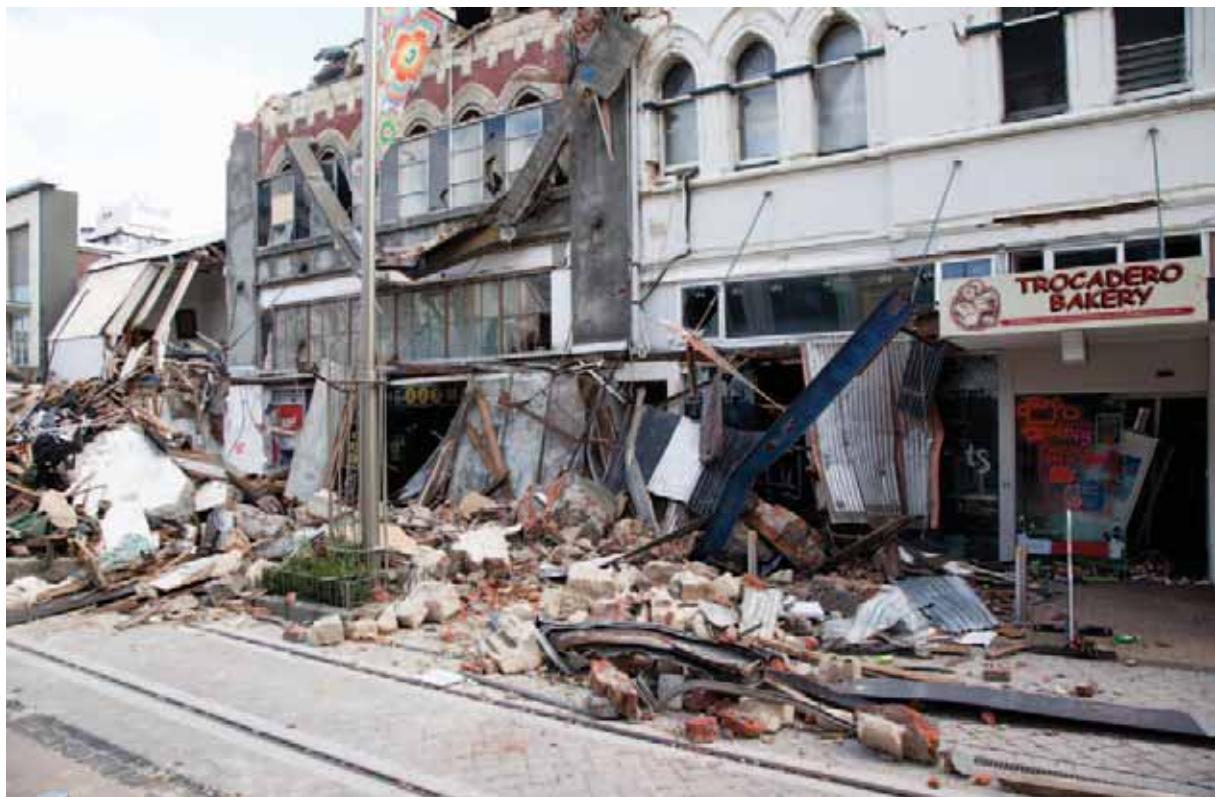
Mr Peter Smith, who provided an independent report to the Royal Commission, stated that in the February earthquake large sections of the eastern wall of 91 Cashel Street fell onto 93 Cashel Street. Equally significant portions of the western wall façade failed and fell onto the building at 89 Cashel Street. A portion of the frontage fell onto Cashel Street.

Figure 6: 89, 91 and 93 Cashel Street after the February earthquake

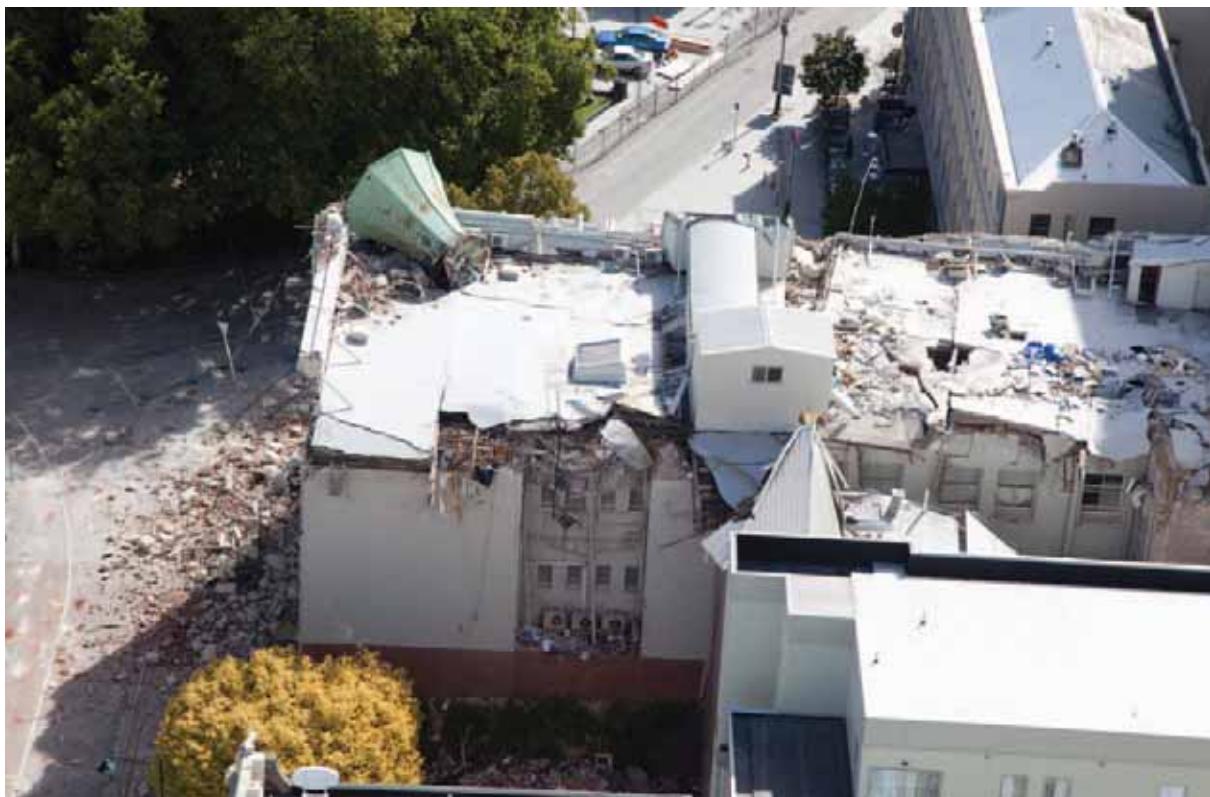
- collapse of the third (top) floor including the roof;
- collapse of most of the parapets;
- collapse of the turret; and
- cracks to the southern and western façades.

Figure 9: The roof and eastern wall of The Press building after the February earthquake

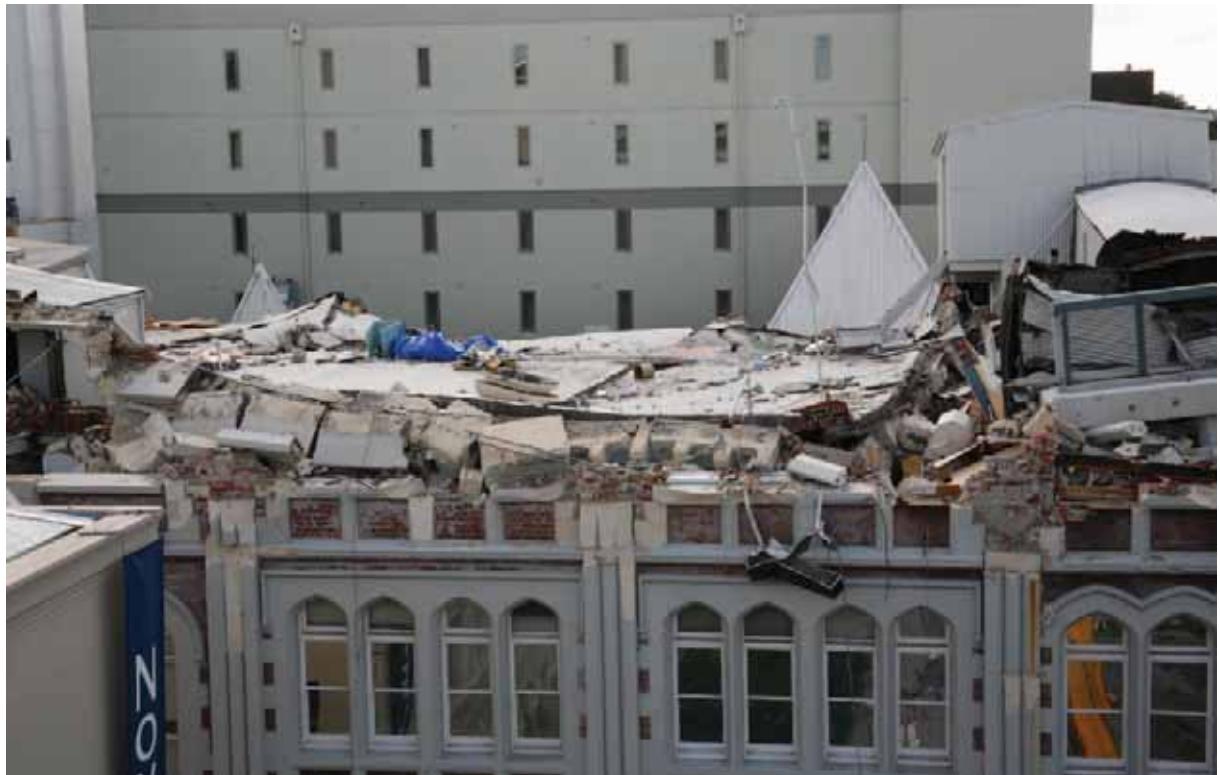
Figure 10: The western wall and roof of The Press building following the February earthquake

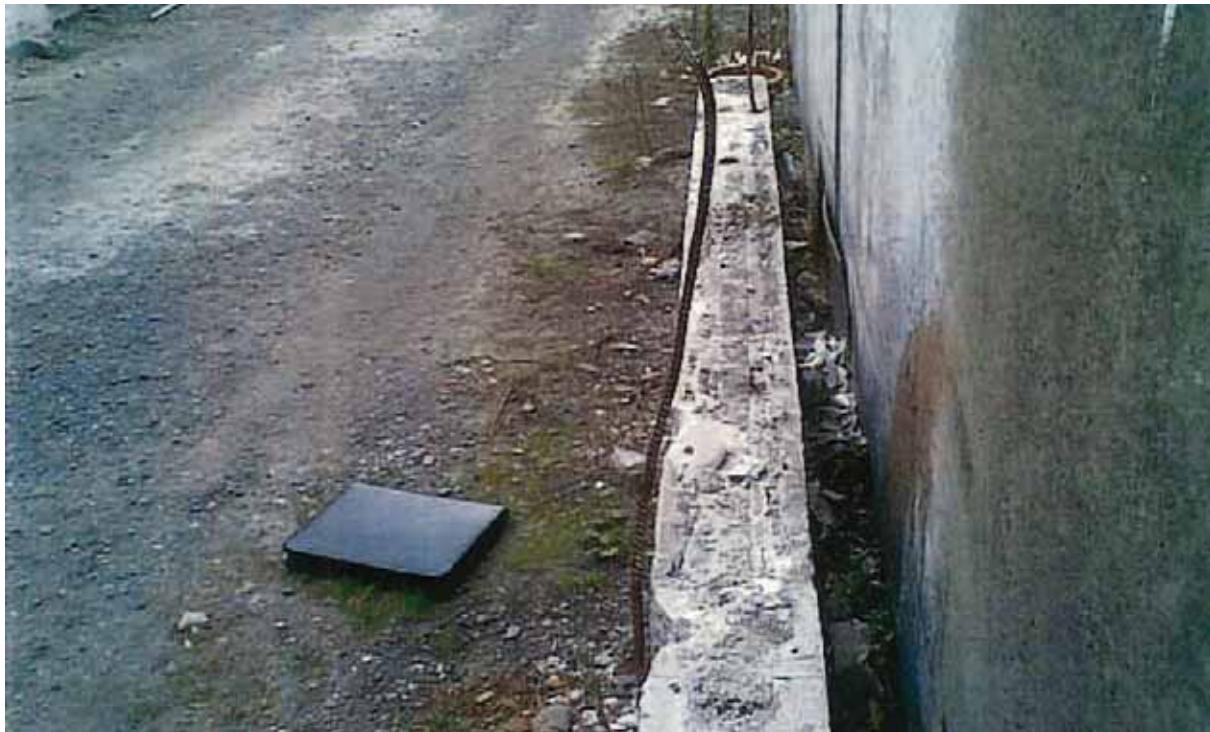
Mr Peter Smith stated in his report to the Royal Commission that the wall had two reinforcement rods (both approximately 20mm in width), one at each end. The owner has since advised the Royal Commission that there were four vertical reinforcing rods in the wall. Whatever the position was, it is apparent that the wall was inadequately reinforced to resist the effects of the February earthquake.

Figure 12: The base of the wall after the collapse and removal of the wall

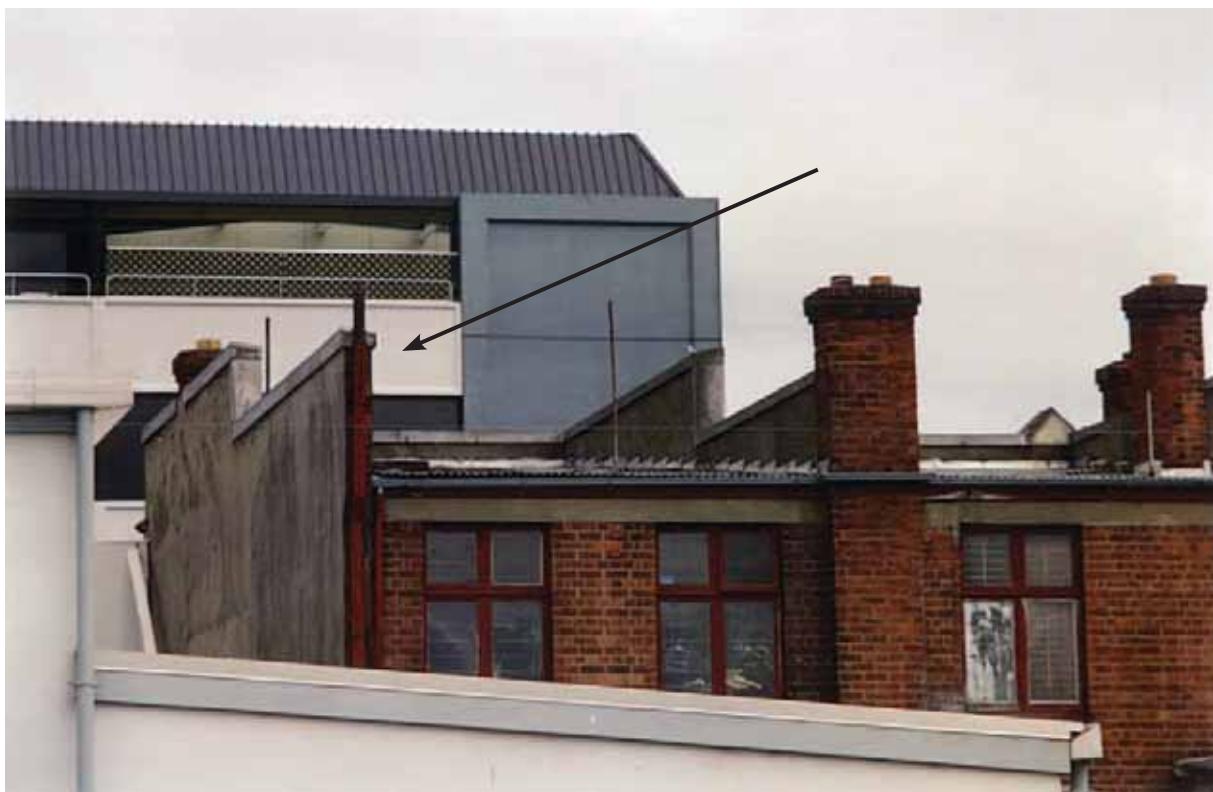
Figure 14: The rear of 382 and 384 Colombo Street, showing the wall and parapet of 382 (arrowed)

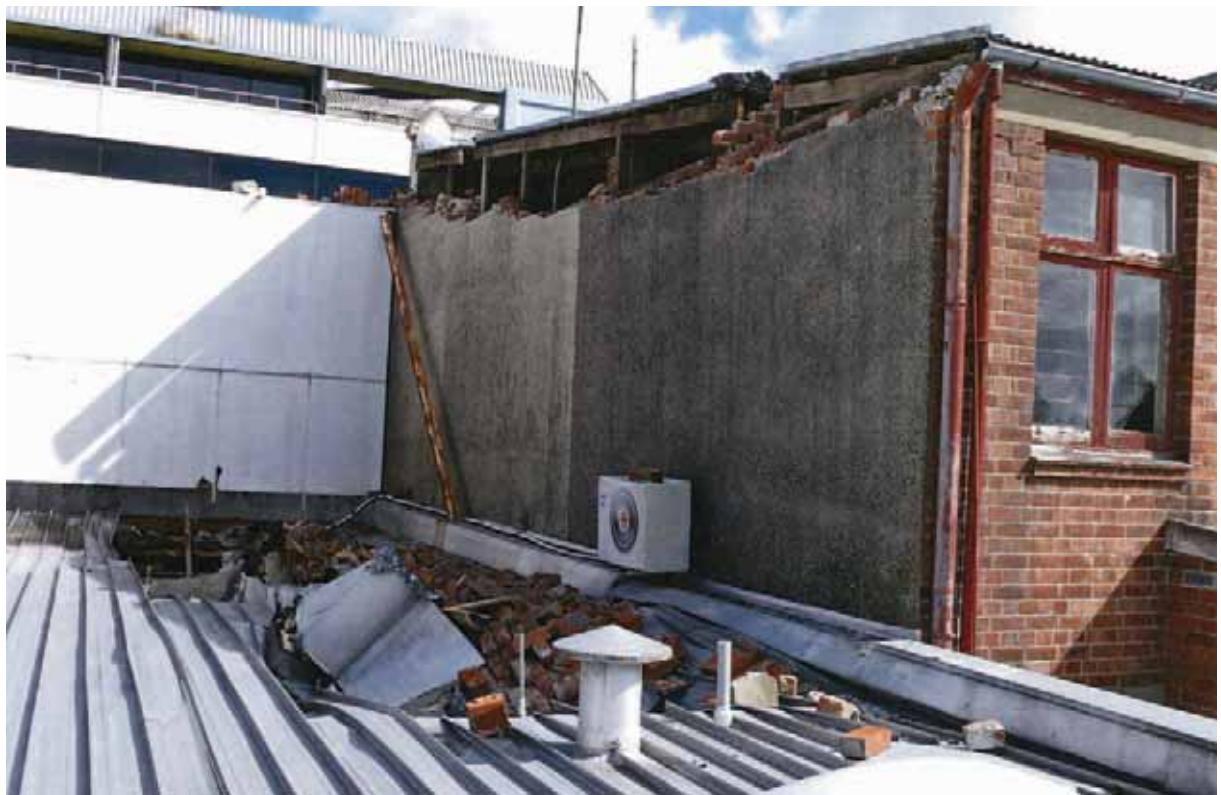
Mr Peter Smith said in his evidence to the Royal Commission that in the February earthquake, the south wall parapet failed along the roofline, following what appeared to be the ceiling lining, as if the ceiling had provided some restraint to that wall and stopped a total façade failure. He noted that the crack referred to by Mr Avnell in the parapet was about 600mm above the roofline.

Figure 15: The southern parapet wall of 382 Colombo Street, which collapsed onto the roof of the Tasty Tucker Bakery

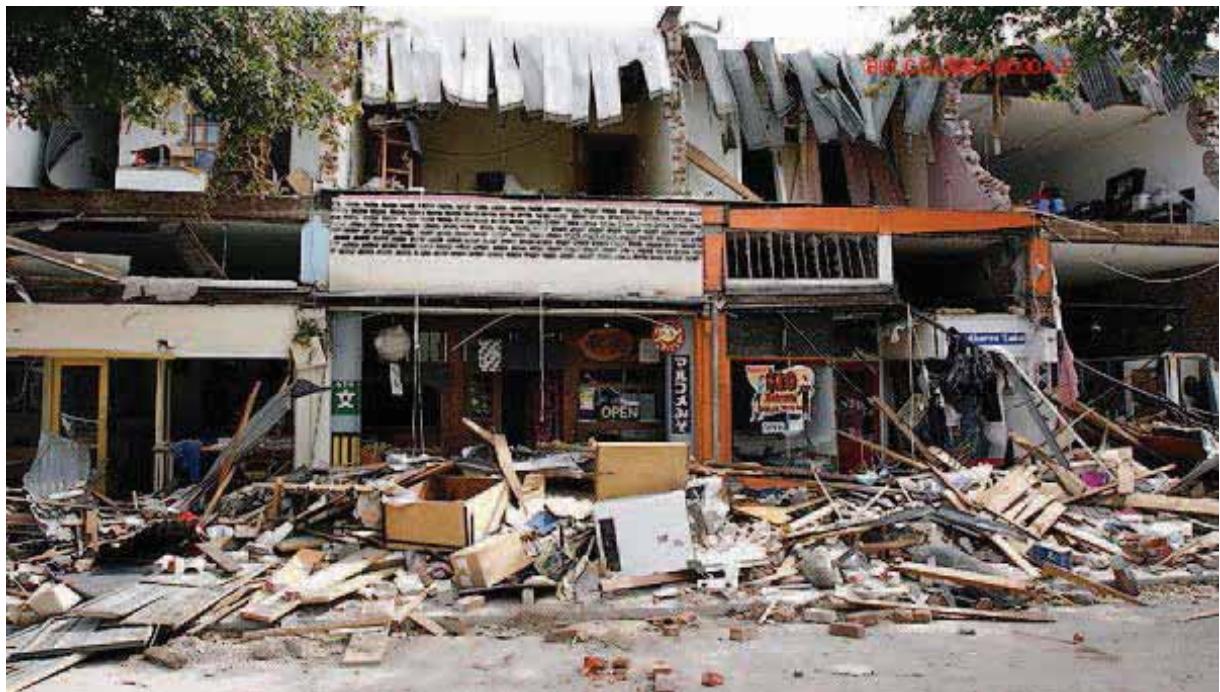
Mr Peter Smith, who prepared an independent report for the Royal Commission, concluded that both buildings failed in the February earthquake by an outward rotation of their first-floor façades, including the parapets, which collapsed onto Colombo Street.

Figure 19: 595 (to the left) and 595A (adjacent to it) Colombo Street after the February earthquake

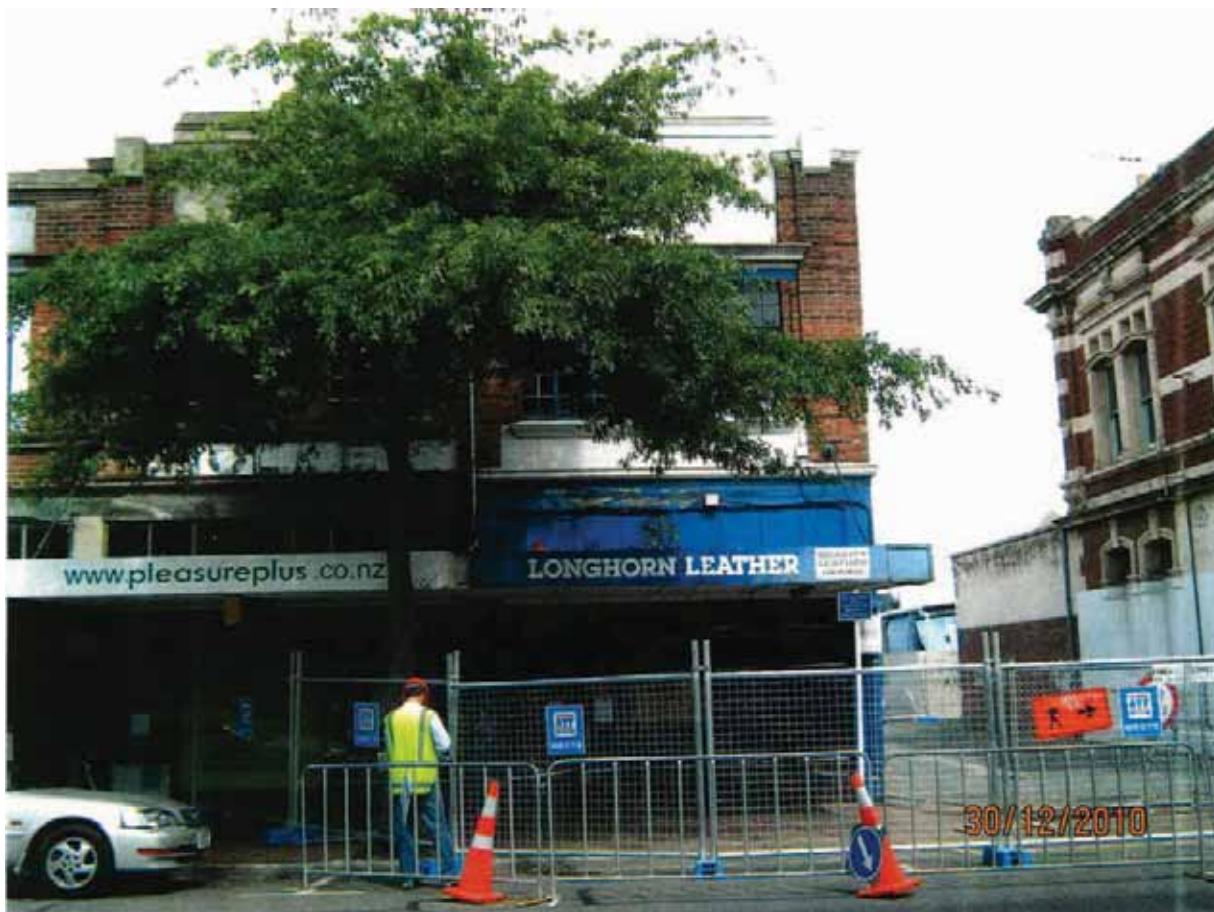
Figure 20: 601 (Pleasure Plus) and 601A (Longhorn Leather) Colombo Street following the September earthquake

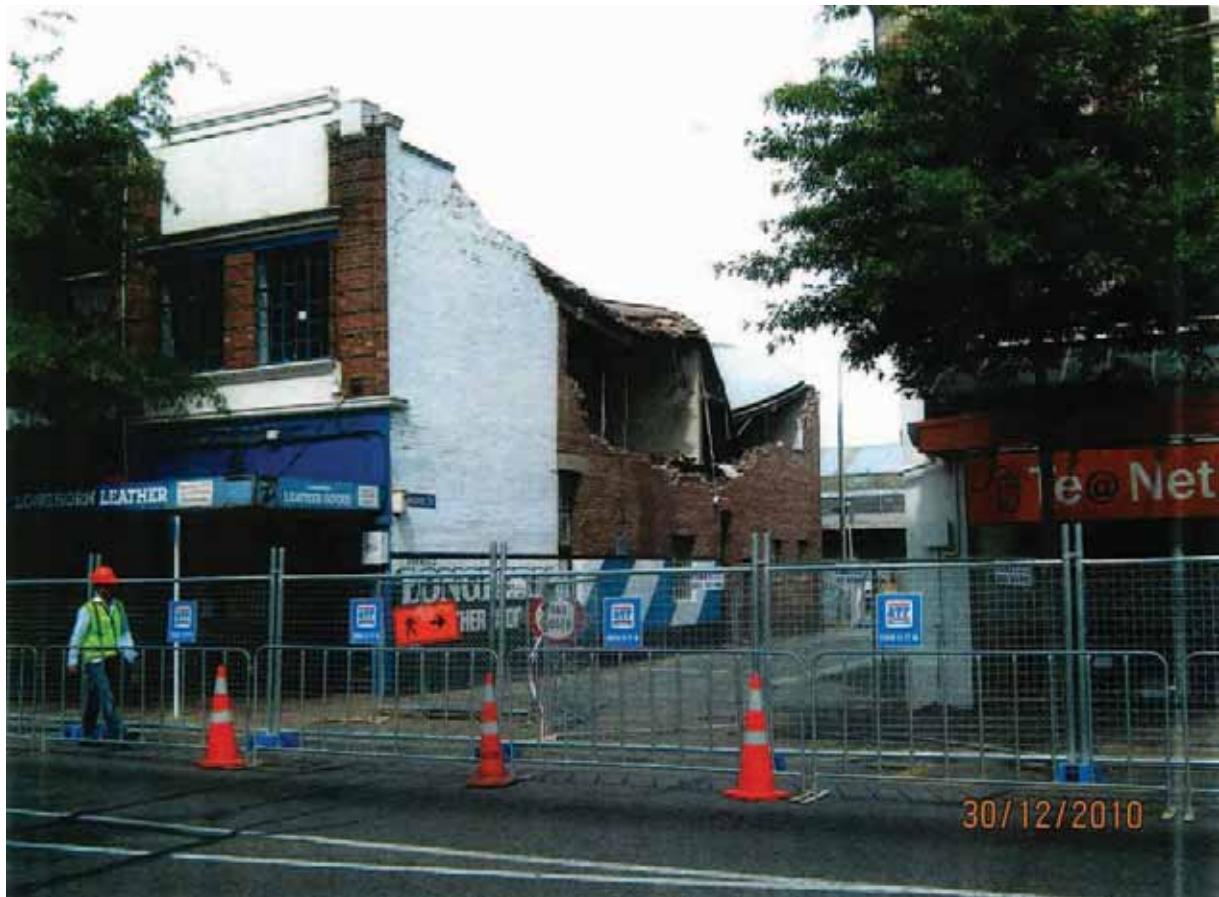
The building was assigned a red placard by the CCC following the September earthquake, owing to the partial collapse of the Mollett Street façade. Cordon were placed blocking off Mollett Street and the footpath adjacent to 601A Colombo Street. It appears that those cordon remained in place until 22 February 2011.

Figure 21: The damaged Mollett Street frontage of 601A Colombo Street after the September earthquake

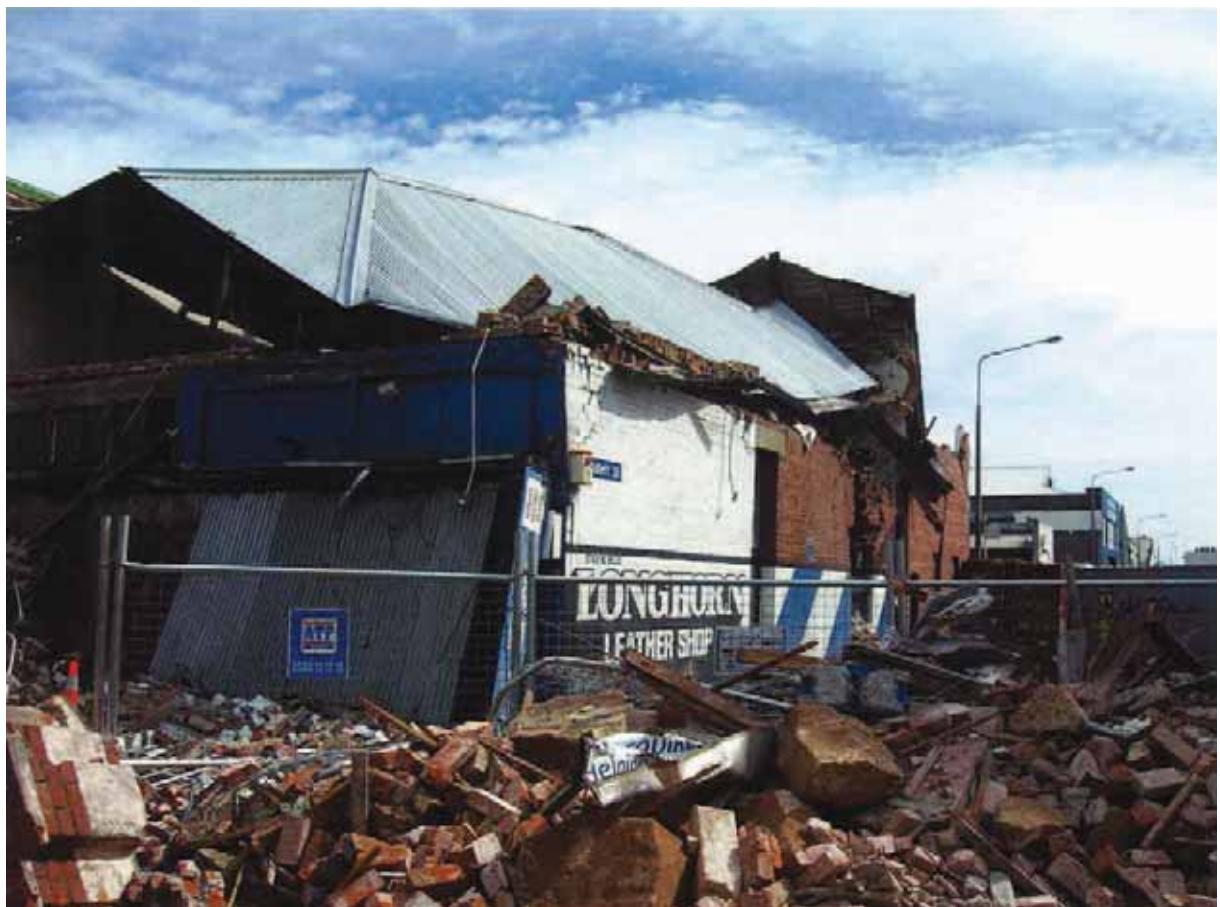
Mr Peter Smith said in his report to the Royal Commission that in the February earthquake the failure of the Colombo Street façade and the remainder of the Mollett Street façade was an outward rotation of the façade about the first-floor support.

Figure 22: The building at 601 and 601A Colombo Street after the February earthquake

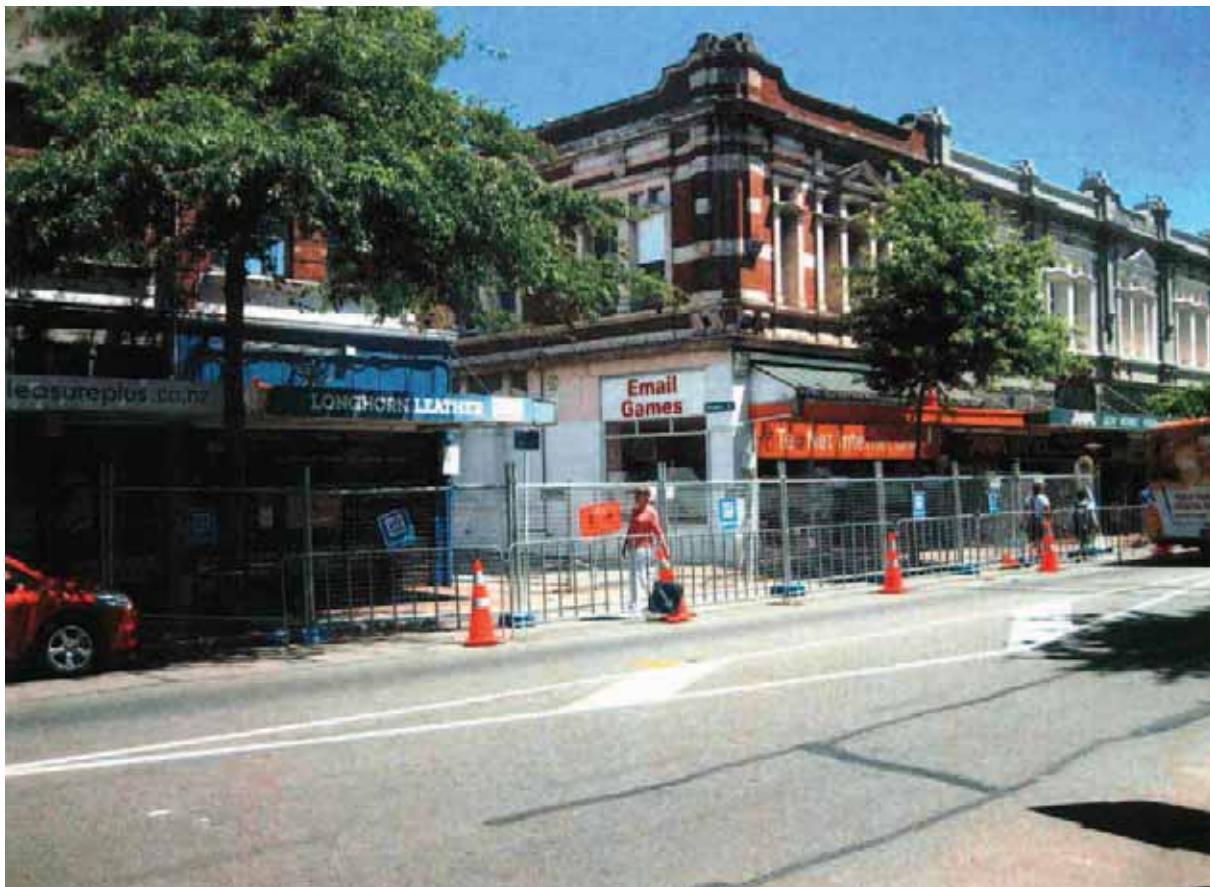
The building was severely damaged in the September earthquake, in particular the south wall adjacent to Mollett Street. As a result, following a CCC Level 1 Rapid Assessment on 5 September 2010, a yellow placard was placed on the building. A Level 2 Rapid Assessment was recommended.

Figure 24: 603 Colombo Street following the September earthquake. The Te@ Net Internet Café occupied the ground floor of the building

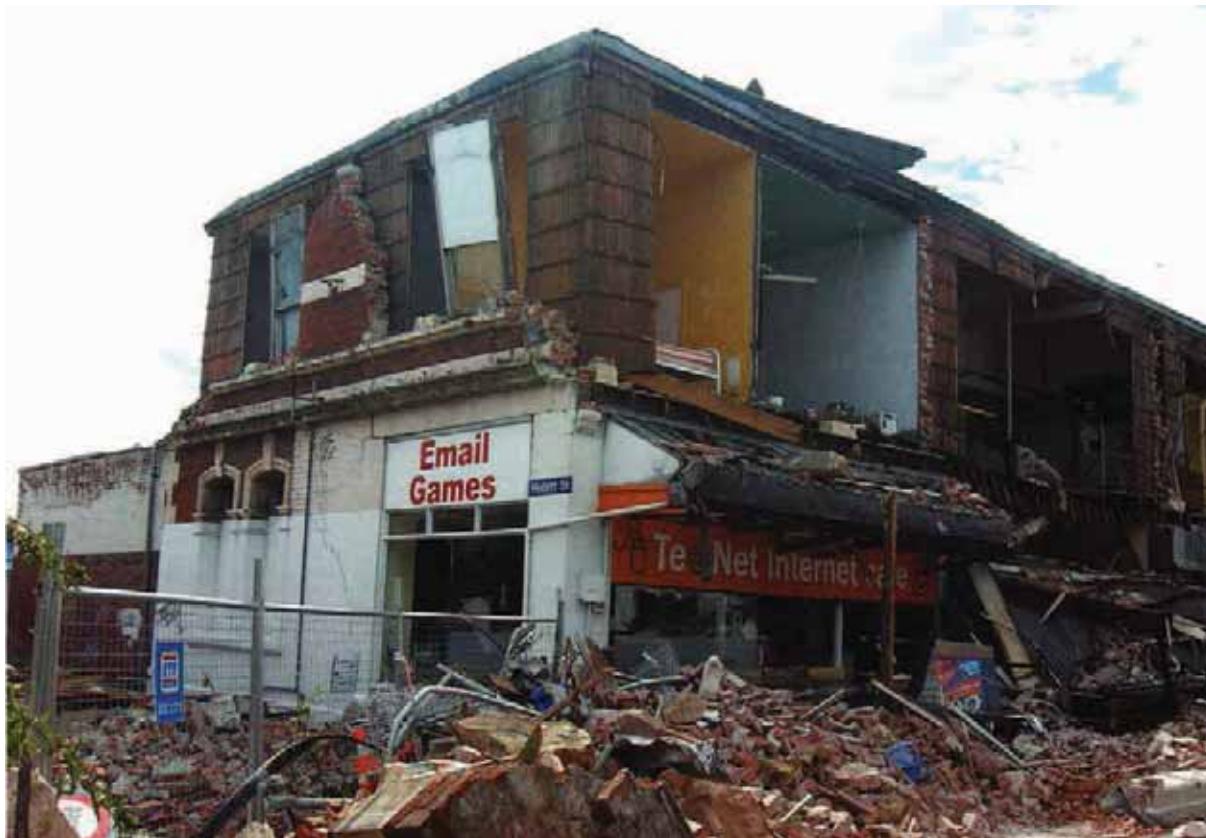
Mr Smith said that the February earthquake “demonstrated beyond question the danger of these façades and the need to cordon off in front of buildings where the building does not have integrity to restrain that façade to a reasonable strength level”.

Figure 27: 603 Colombo Street following the February earthquake

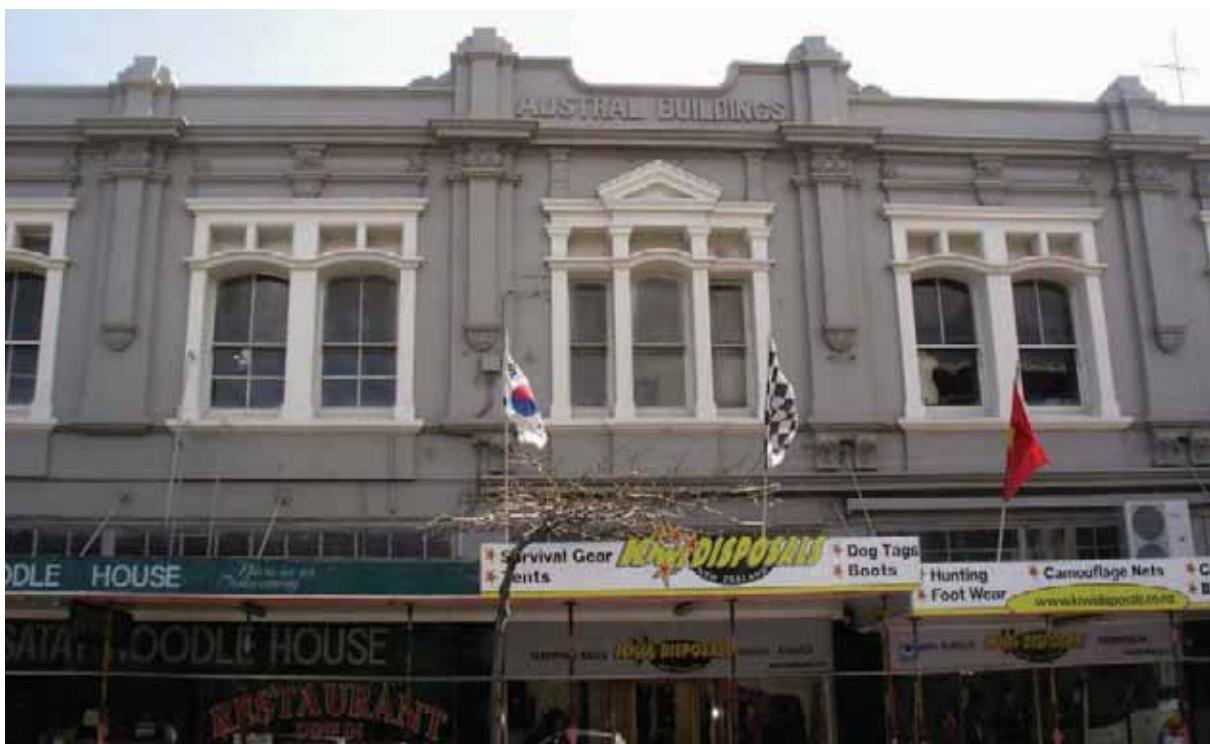
Figure 31: The building viewed from the opposite footpath on Colombo Street. Propping can be seen under the awning

Mr David Eaton, a co-director of Buchanan & Fletcher, carried out an inspection on 14 September 2010. He noted cracking in the east-west walls and recommended propping of the front edge of the veranda along the Colombo Street frontage. This work was carried out by Bushnell Builders Ltd.

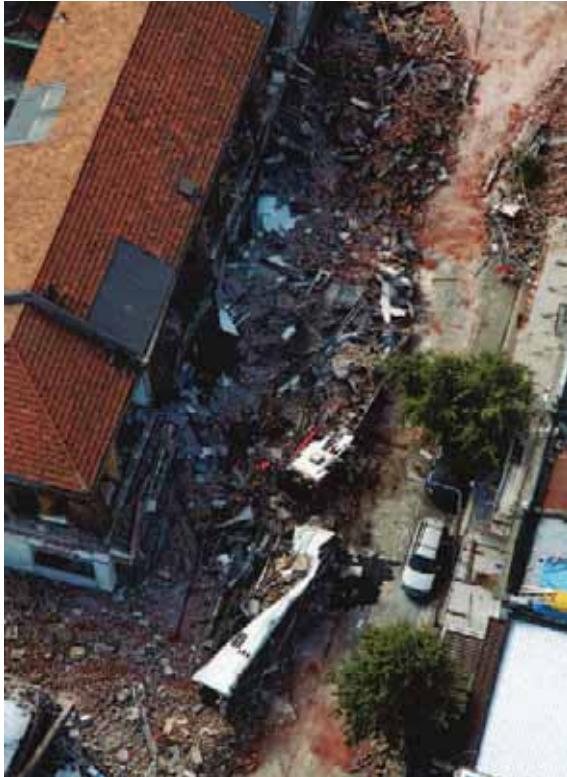
Mr Smith said in his report to the Royal Commission that “The first floor façade of the buildings failed by an outward rotation of the façade about the first floor support beams in severe shaking during the 22 February 2011 earthquake”.

Figure 32: An aerial view of the south end of the building, showing the two damaged buses on Colombo Street after the February earthquake

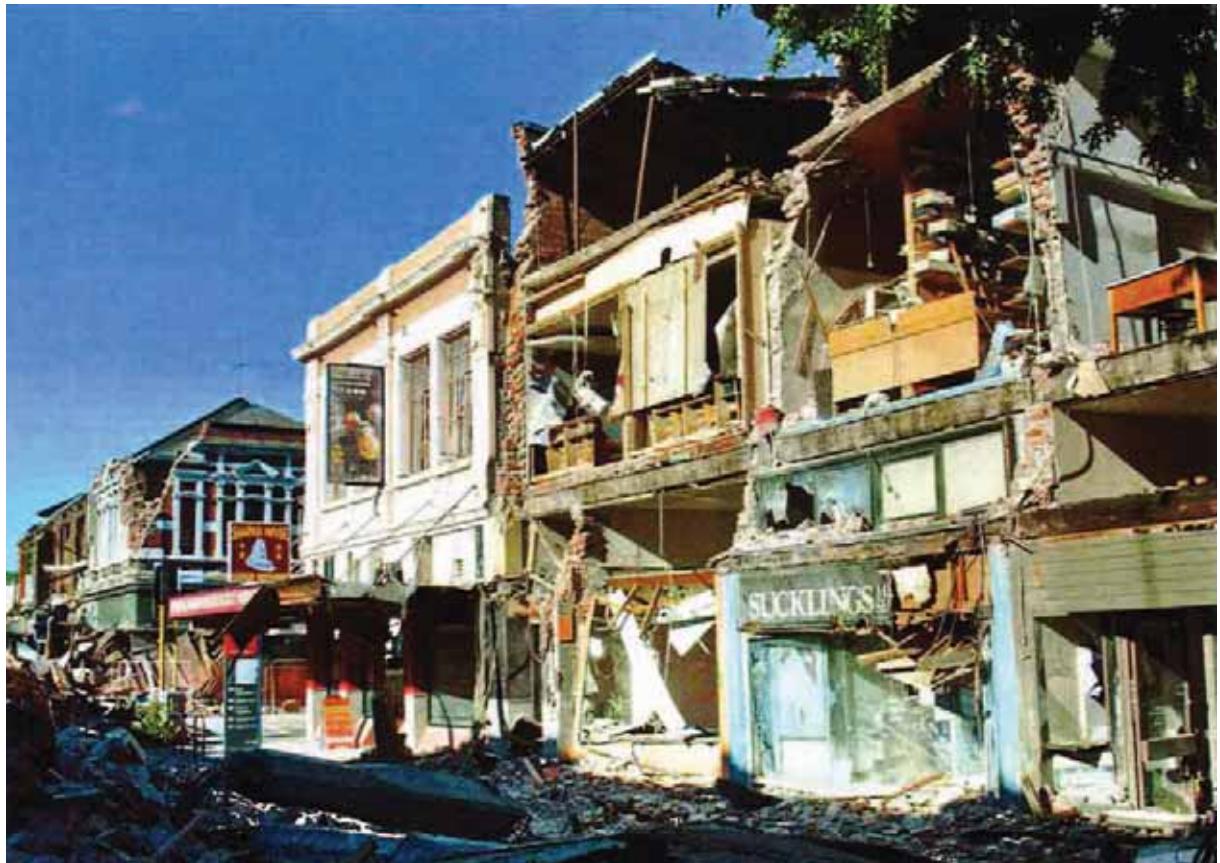
Mr Smith noted that the façades of the buildings at 617–621 Colombo Street did not fail, presumably as a result of the strengthening work undertaken; and he compared this to the failure of the end buildings of a series of interconnected URM buildings of similar height (at 593, 601A and 603 Colombo Street), which had not previously been strengthened. He said that this demonstrated the potential benefit of strengthening even to such a low level as 20% of the current Code. However, the failure of the façades at 623 and 625 Colombo Street (and also 627 and 629) highlighted the fact that such minimal strengthening of URM building façades is unlikely to be effective in a severe earthquake.

Figure 37: Damage to 617–625 Colombo Street after the February earthquake (looking south along Colombo Street)

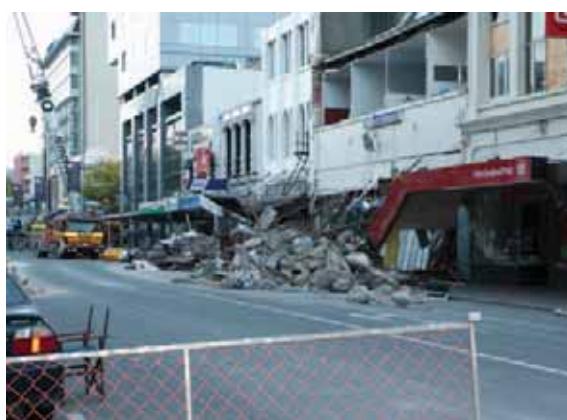
The building was extensively damaged in the February earthquake, including collapse of the façade onto the street. Mr Peter Smith stated in his report to the Royal Commission that “from the photographs it would appear that the front façade above first-floor window-sill level rotated outwards from the support at the window-sill level, collapsing onto the footpath as a result of the severe shaking experienced during the earthquake”.

Figure 39: 738 Colombo Street after the February earthquake

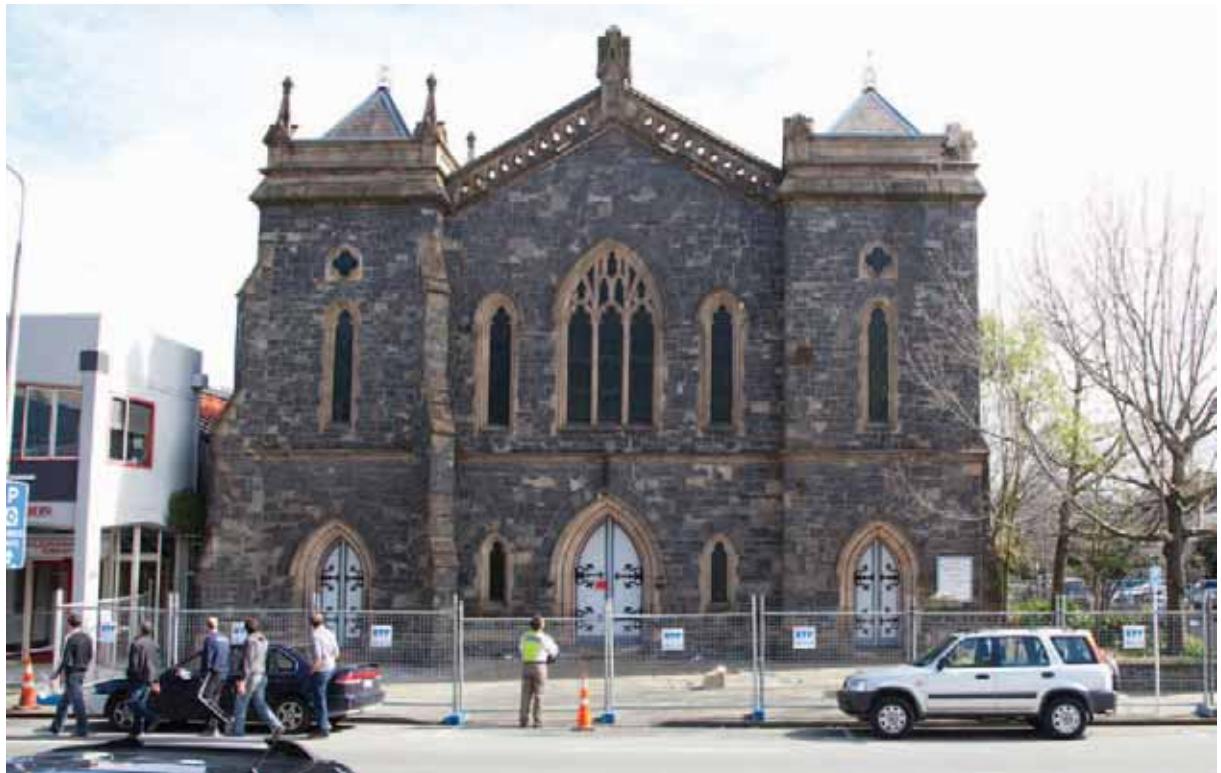
Figure 42: The eastern façade of the Durham Street Church after the September earthquake

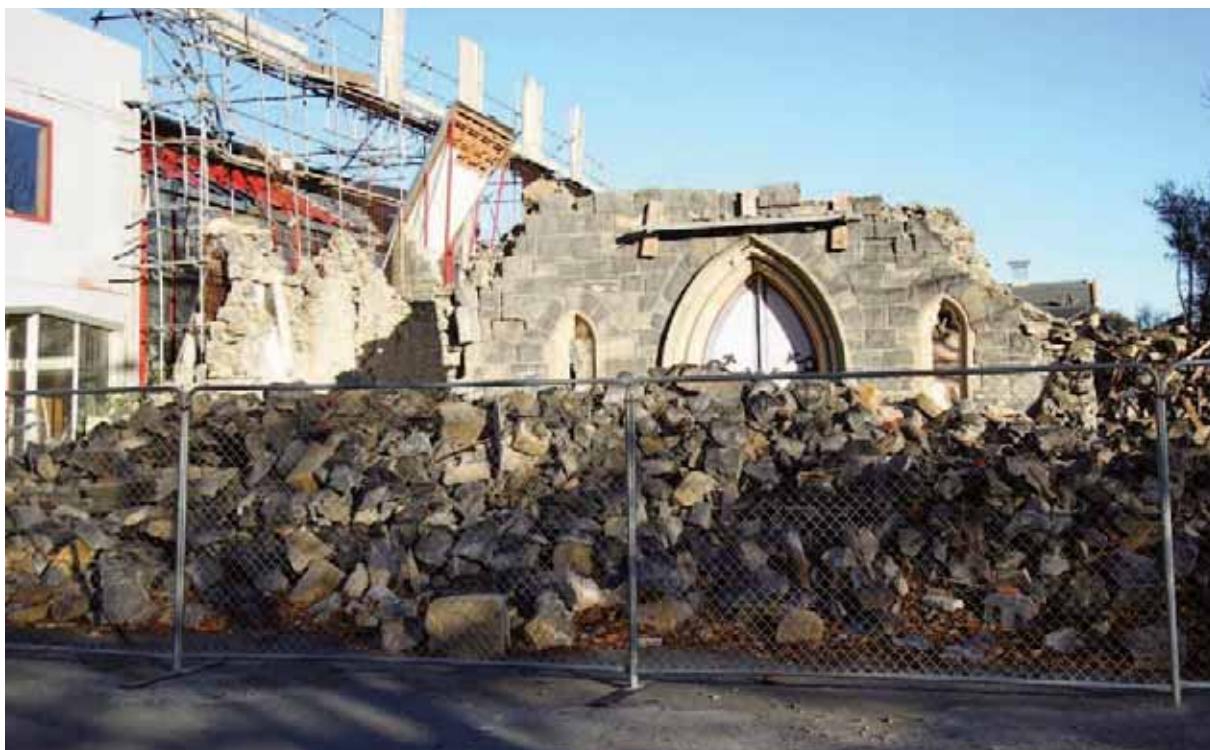
Figure 46: The eastern side of the Durham Street Methodist Church after the February earthquake

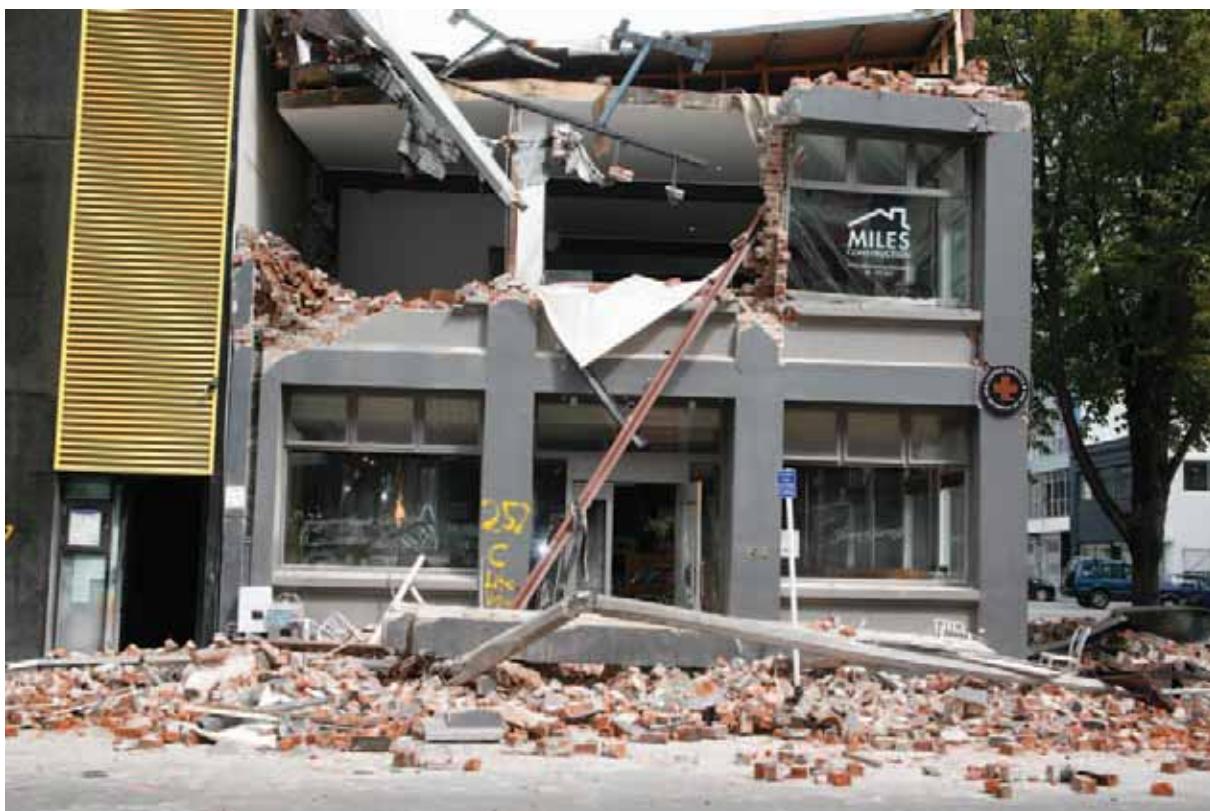
Figure 51: The northern frontage of 194 Hereford Street after the February earthquake

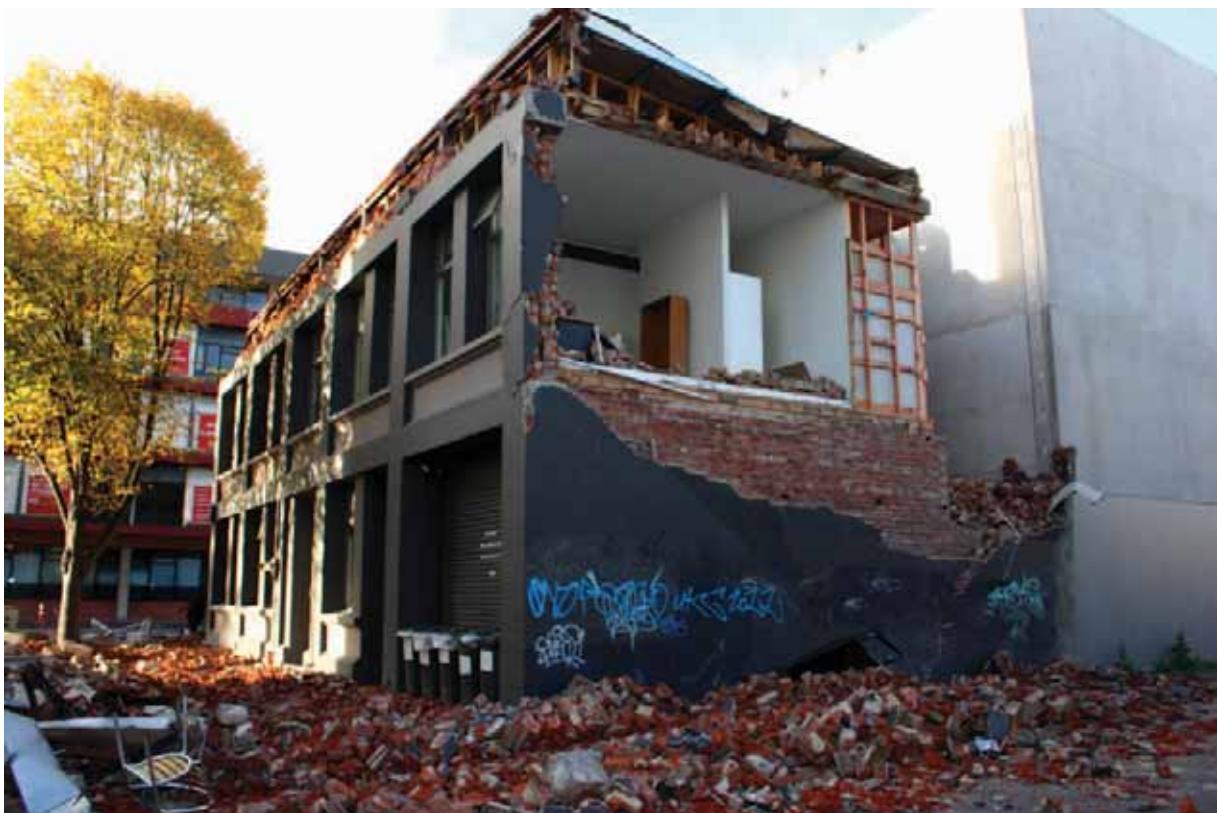
Figure 52: The western and southern walls of 194 Hereford Street after the February earthquake

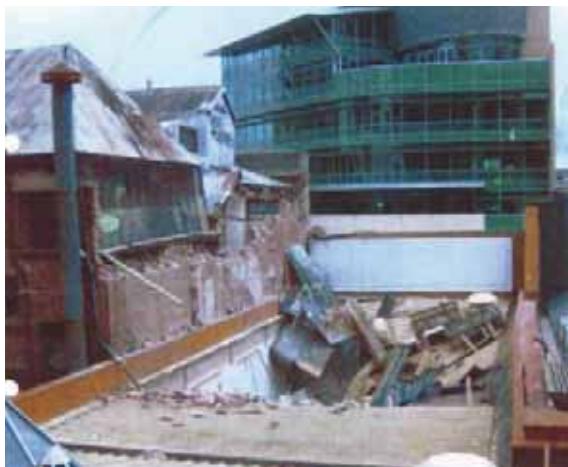
Figure 55: The roof of the Link Centre after the February earthquake, with 246 High Street on the left

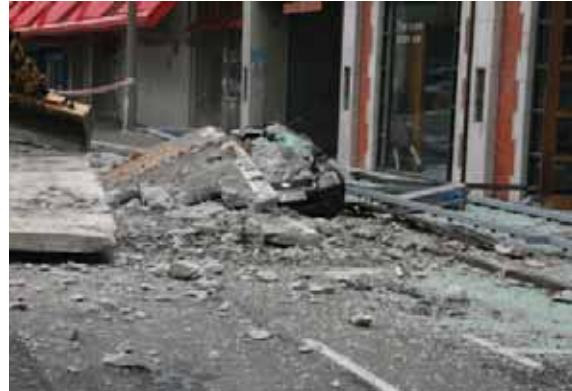
Figure 59: A spandrel panel on Ms Arnold's car (left), and the site after removal of the spandrel panel

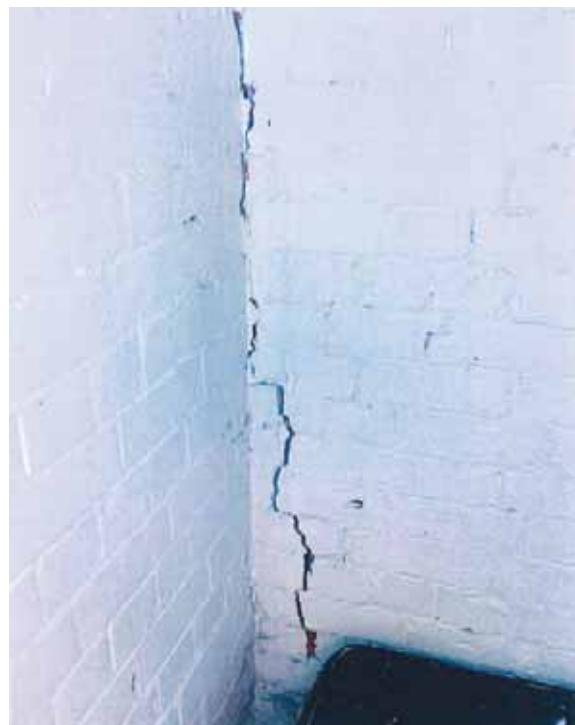
Figure 62: Cracking of the interior wall of the south-eastern corner on level two of the building

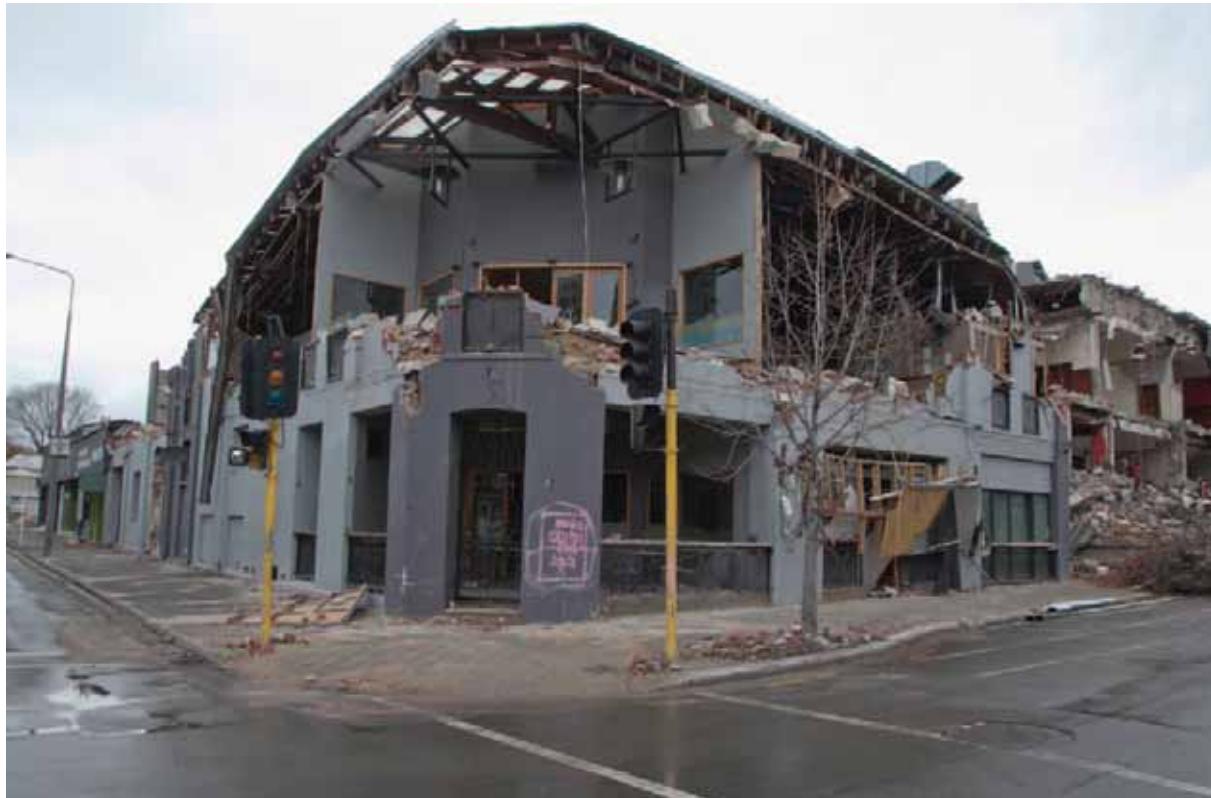
Figure 65: The north-western corner of 200–204 Manchester Street after the February earthquake

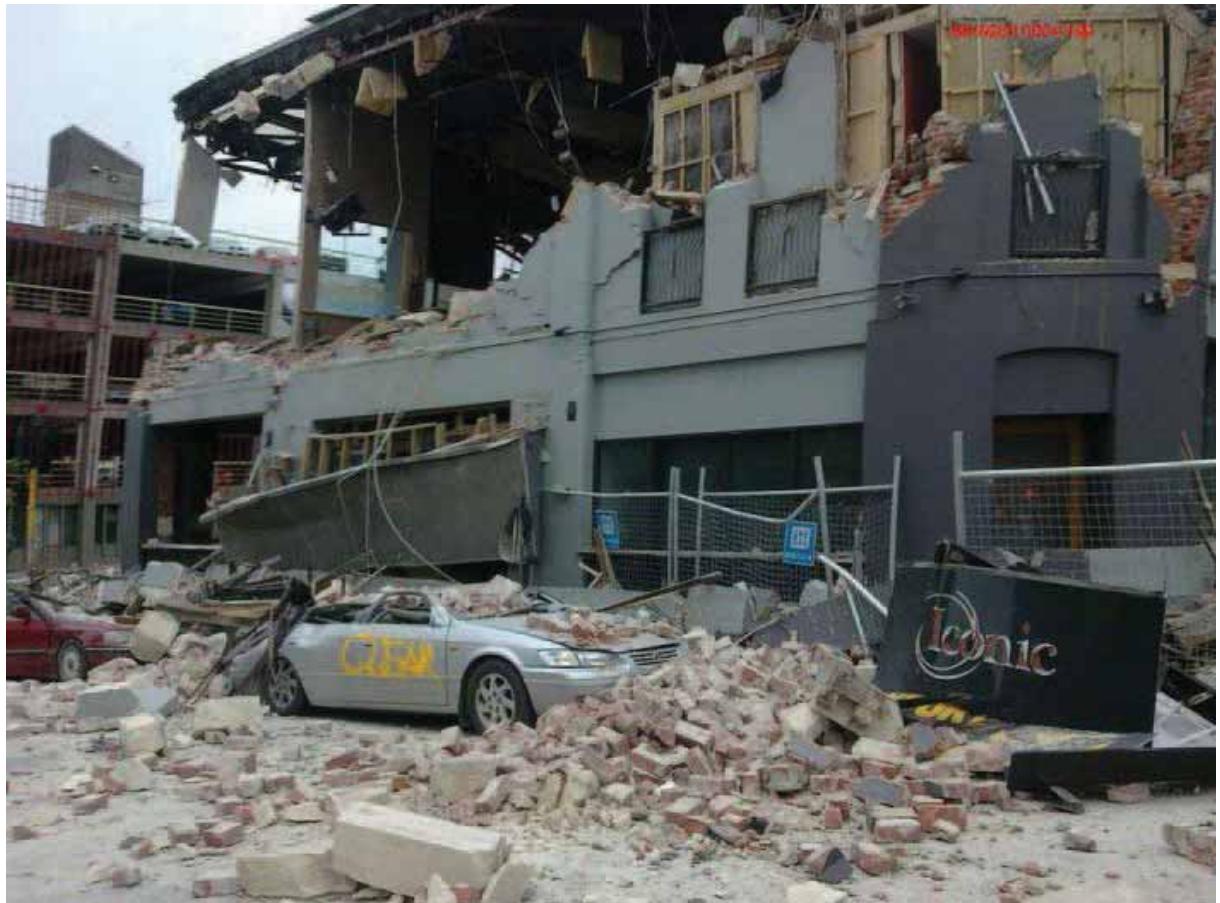
Figure 66: The western wall of 200–204 Manchester Street after the February earthquake
