# Canterbury Earthquakes Royal Commission

FINAL REPORT

VOLUME 4  
EARTHQUAKE-PRONE BUILDINGS

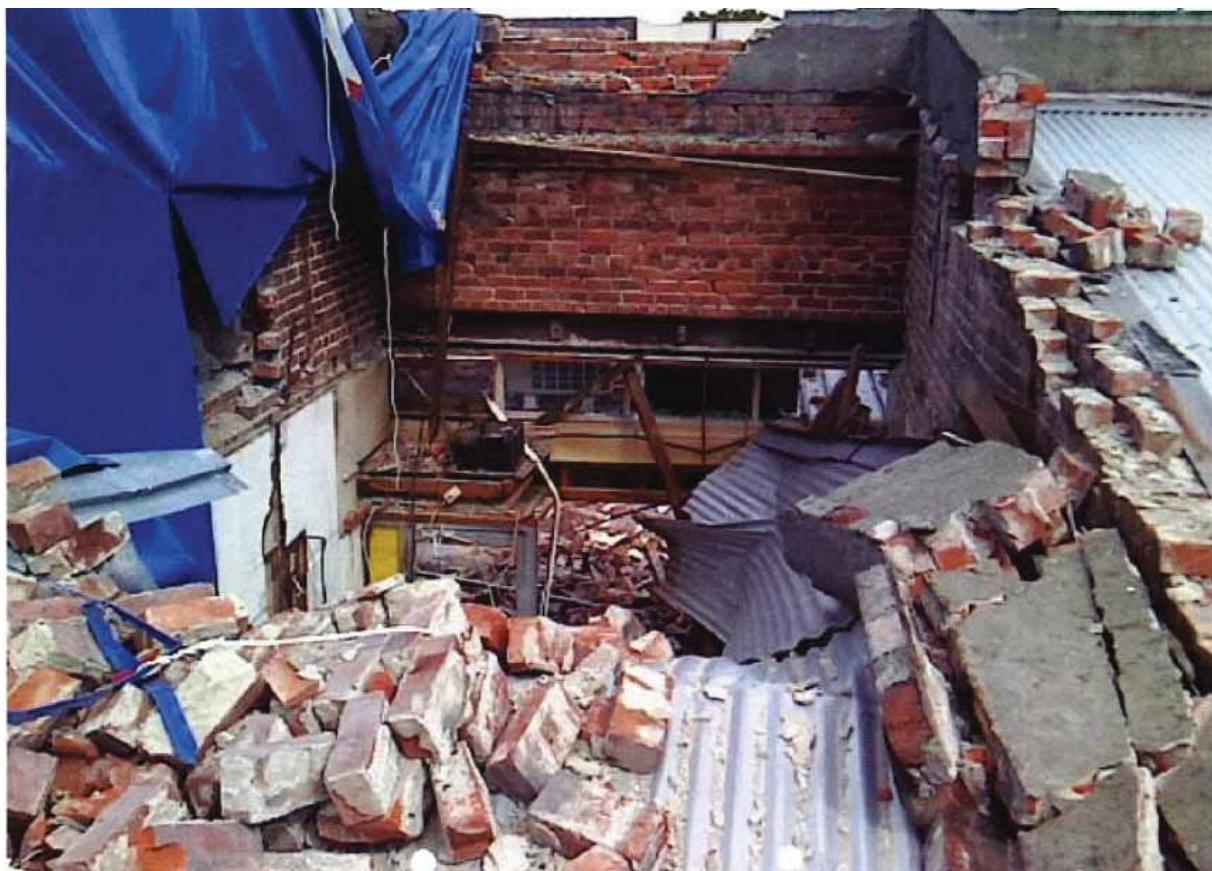
Figure 75: Collapse of the western wall of the building into 389A Worcester Street

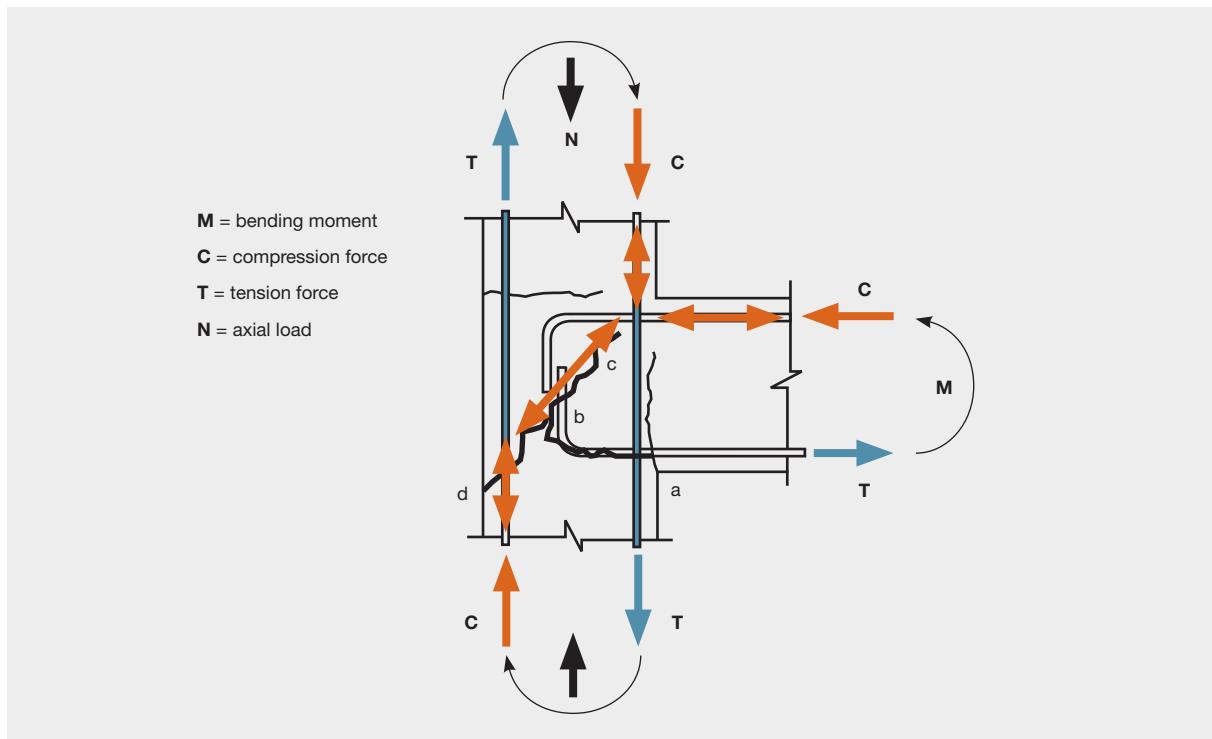
Figure 89: Inadequately detailed beam-column connection
