FINAL REPORT

VOLUME 5

SUMMARY AND RECOMMENDATIONS IN VOLUMES 5-7
CHRISTCHURCH, THE CITY AND
APPROACH TO THIS INQUIRY

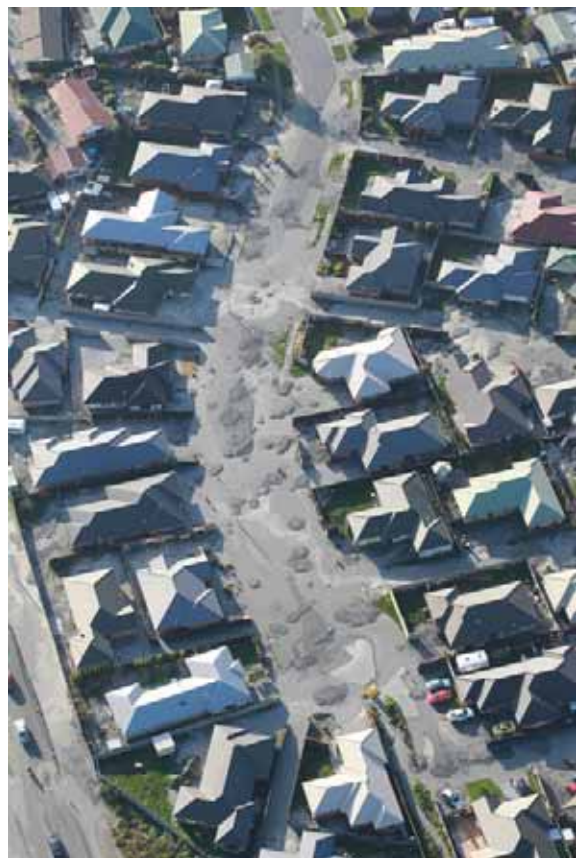
Figure 6: The eastern suburbs suffered repeatedly from liquefaction. This aerial photo shows a street in Bexley after the June 2011 aftershock (source: Fairfax Media/The Press)

In the larger earthquakes that occurred in Canterbury there was extensive liquefaction, particularly in the eastern suburbs near the sea (Figure 6 shows the liquefaction in the eastern suburb of Bexley). Hill suburbs experienced cliff collapse and rock fall, as Figure 7 illustrates. In the Port Hills, especially Lyttelton, moving land, collapsed cliffs, and rockfall caused severe damage to retaining walls. Damage to the land under the CBD is described in section 2 of Volume 1.

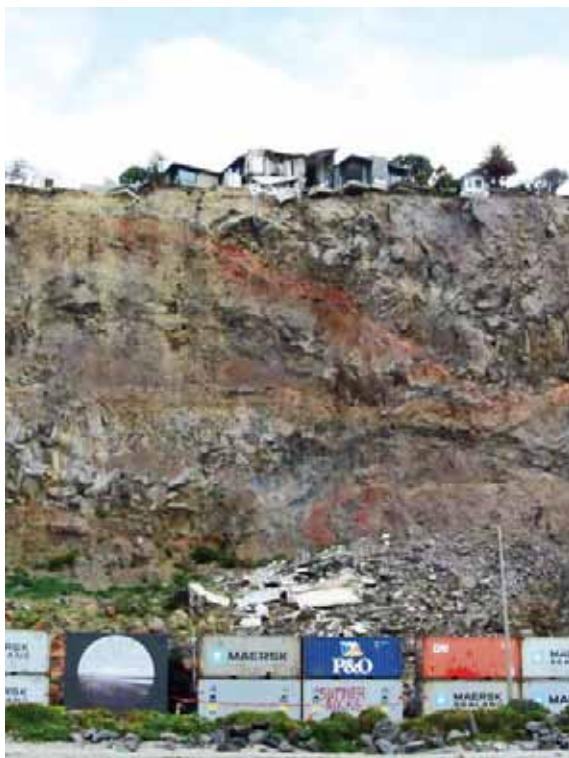
Figure 7: Collapsing rocks in the suburb of Sumner caused houses to fall down the cliff. A row of shipping containers was installed to protect the busy road below from danger (source: Flickr/newtown graffiti)

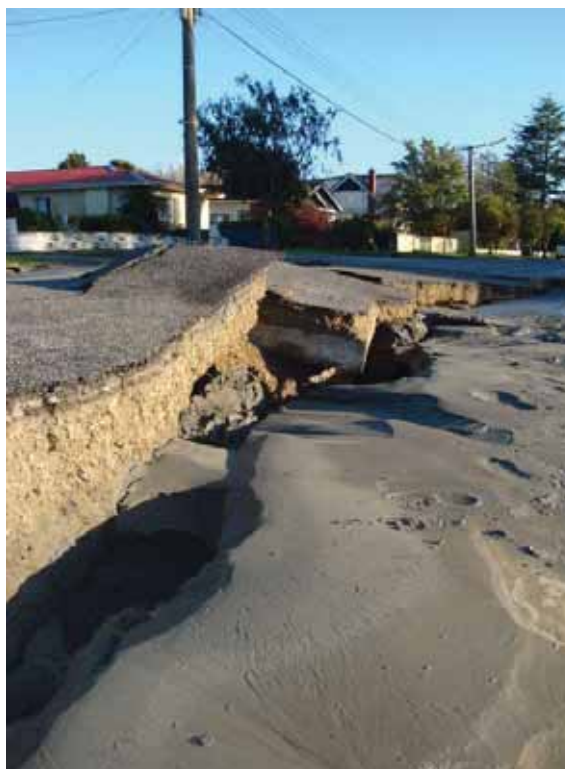
Figure 8 shows the road damage caused by the Canterbury earthquakes. An estimated 1,021 kilometres of road need to be rebuilt due to earthquake damage. This is 52 per cent of Christchurch's urban sealed roads. There will be major renewal projects to rebuild these roads and in some cases the road will need full reconstruction.

Figure 8: Road damage caused by the earthquakes (source: Michael Campbell)

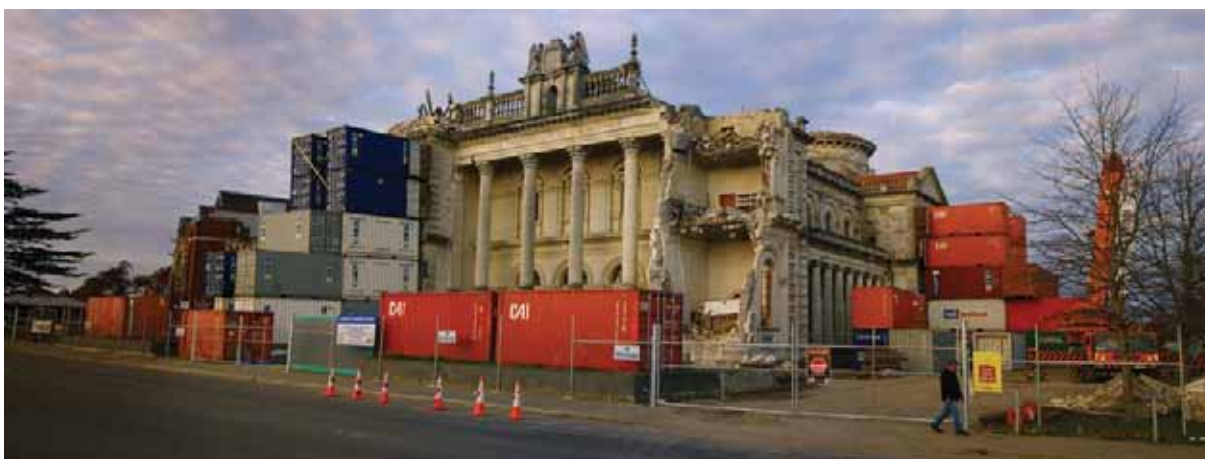
Figure 11: The Cathedral of the Blessed Sacrament, also known as the Catholic Basilica, after the Canterbury earthquakes

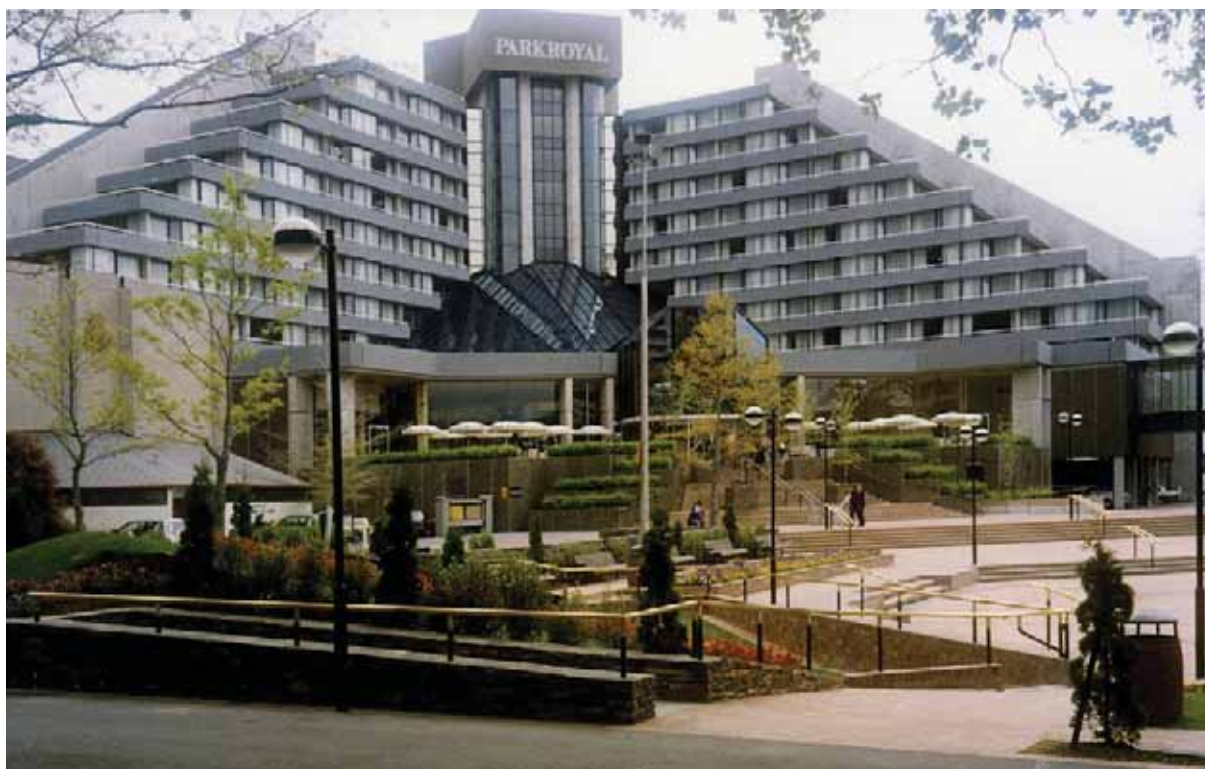
Figure 13: The Crowne Plaza Hotel, formerly the Park Royal Hotel, was damaged by the earthquakes and demolished in 2012 (source: Gudrun Gisella)
