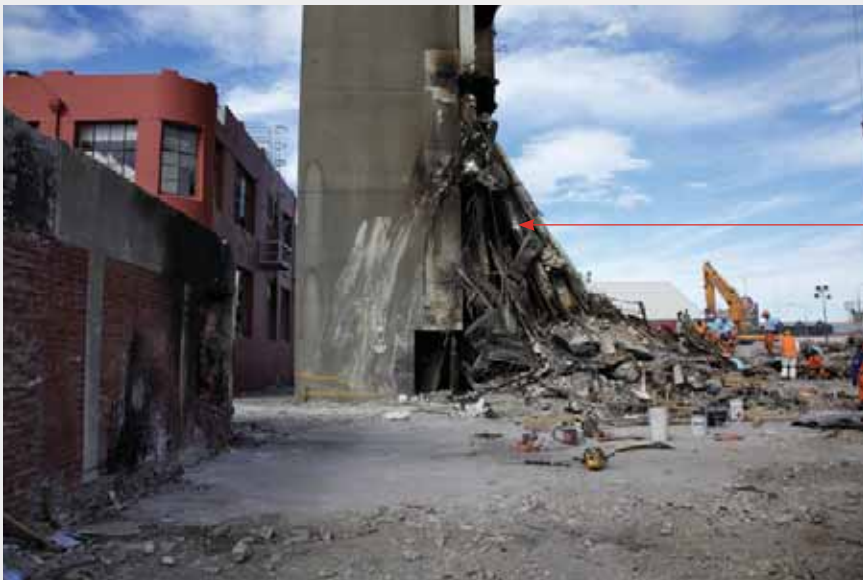
Figure 66(a): Western elevation of collapsed floor slabs leaning against north wall complex (source: Robert Heywood)

The concrete floor slabs came to rest leaning against the north wall complex as illustrated in Figure 66(a). Dr Heywood could identify all five edges of the suspended floor slabs in this Figure. This photograph was taken after most of the building debris had been removed. Mr Frost's opinion was that the upward slope

of the floor slabs towards the north wall complex was a strong indication that the floor separated from the north wall complex later rather than earlier in the collapse sequence, see Figure 66(b). He explained that if the floor slabs had separated from the north wall complex before they lost support from the central columns, he would have expected to see the floors in a horizontal orientation or even sloping down towards the north wall complex.

Floor slabs leaning against north wall complex

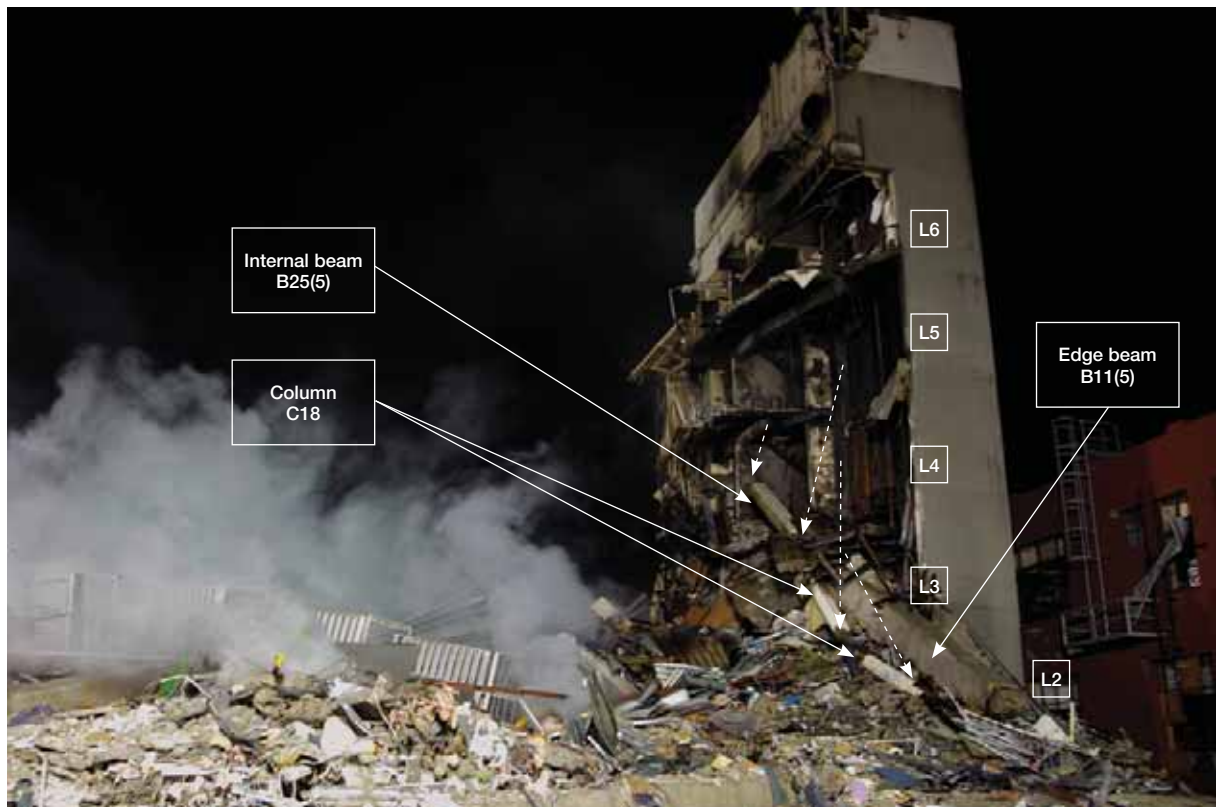
(b) Floor detachment from east side of north wall complex (source: Robert Heywood)

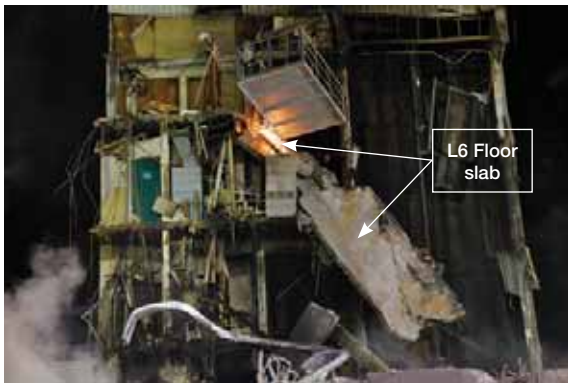
Dr Heywood also gave evidence about the detachment of the floors from the north wall complex. The detachment was complete on levels 4, 5 and 6 (Figure 67(b)), although some internal and edge beams were still attached to the north wall complex. Dr Heywood stated that in the vicinity of the amenities (the western portion of the north wall complex) the floor slab was severed 1–2m south of line 4, leaving the floor slab cantilevering from the north wall complex (see Figure 67(a)). The 664 mesh was observed to have failed in tension on the level 6 failure surface. The downward angle of the exposed mesh and the spalling of the underside of the slab are consistent with some downward movement during failure. The failure line at level 6 extended across the front of the stairs and lift wells before turning north at the eastern edge of the north wall complex. This section of the slab was subsequently removed because of safety concerns (see Figure 67(a)). On levels 4 and 5 the failure line extended across in front of the stairwell before turning into the lift well.

(a) Detachment of floors at levels 4, 5 and 6

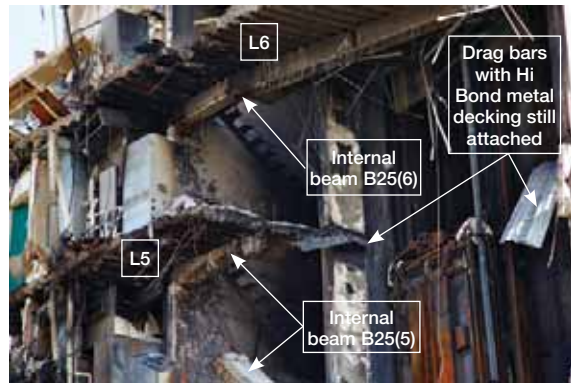
Dr Heywood saw drag bars installed on levels 4, 5 and 6 on both sides of the lift well walls in the north wall complex. He said that these drag bars did not prevent the slab from detaching from the north wall complex (see Figures 66(b) and 67(b)), however the drag bars still remained attached to the lift well. In some places a piece of Hi-Bond metal decking remained attached to the drag bars. The drag bars were bent downwards, which is consistent with them supporting the weight of the floor slabs during the collapse rather than the floor slabs detaching from the drag bars before the collapse. Earthquake forces would have applied principally horizontal forces to the drag bars before the collapse. Dr Heywood explained that if the earthquake forces caused separation of the floor slabs from the drag bars, he would have expected to see the drag bars virtually horizontal.

(b) Level 5 and 6 floor slab, drag bar and beam connection

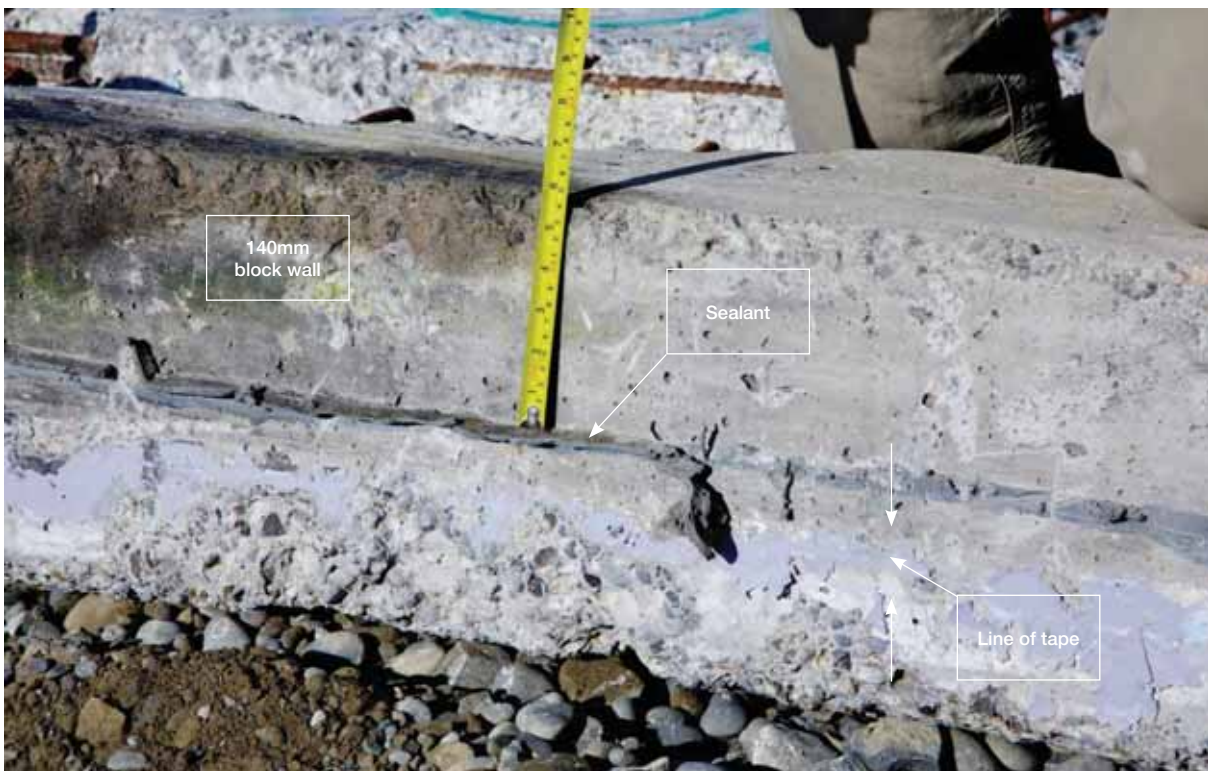
A block wall was constructed on the first three levels of the western side of the building. The wall provided resistance to fire from the adjacent building and was not designed to contribute to the lateral load resistance of the CTV building. Dr Heywood observed sealant on the side of some rectangular columns in a position consistent with the 140mm block work (Figure 68). There was no sign of ties or reinforcement connecting the rectangular column and the block work. This evidence suggests that the wall was constructed as detailed in the structural drawings.

Figure 68: Sealant on a remnant of the western wall (source: Robert Heywood)

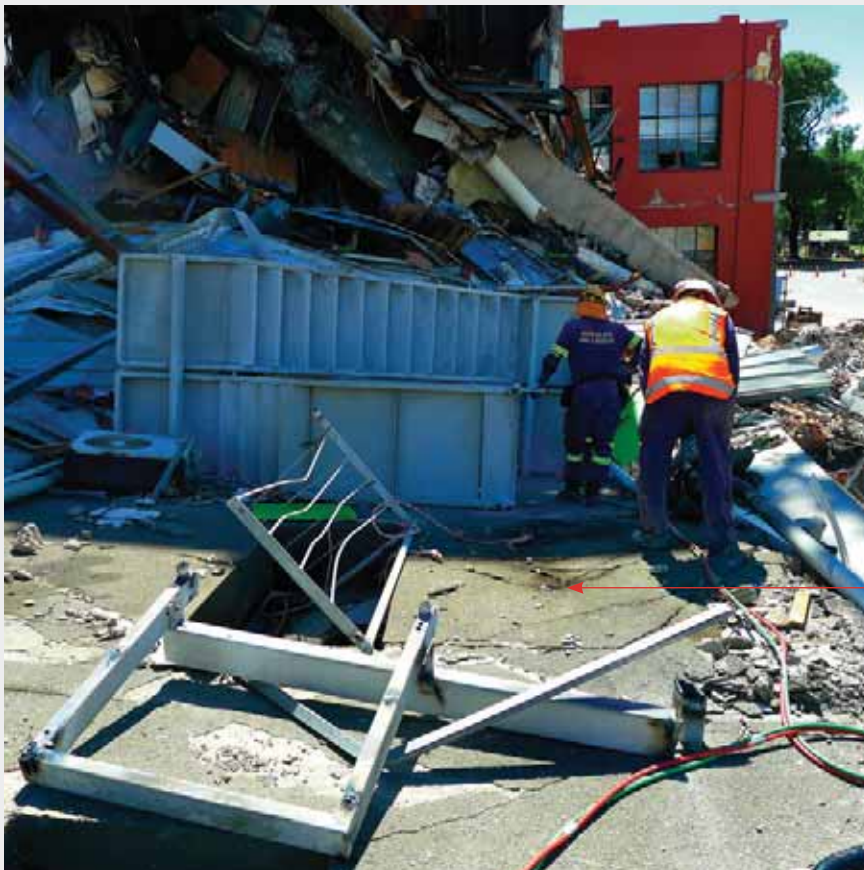
Mr Frost observed some horizontal cracking and spalling near the base of the south shear wall. He described this cracking as consistent with weak axis bending (bending to the north). These cracks were widest at the outer face (see Figure 69(b)) and barely visible on the inside face. Mr Frost saw no evidence of vertical movement of this wall relative to the adjacent ground slab.

Mr Frost had expected to see a significant amount of diagonal cracking in the coupling beams located above the doorway openings in the south shear wall. However, he saw no sign of such cracking. He concluded that the south shear wall had experienced little or no horizontal loading. Dr Heywood drew attention to Figure 69(a), which is a photograph taken on top of the south shear wall around level 3. He noted that the cracking in the south shear wall appeared to be more severe on the eastern side.

South shear wall showing cracking on eastern side

Figure 69(a): Upper levels of south shear wall shown in the foreground lying flat in a photograph taken on top of building debris (source: Graham Frost)

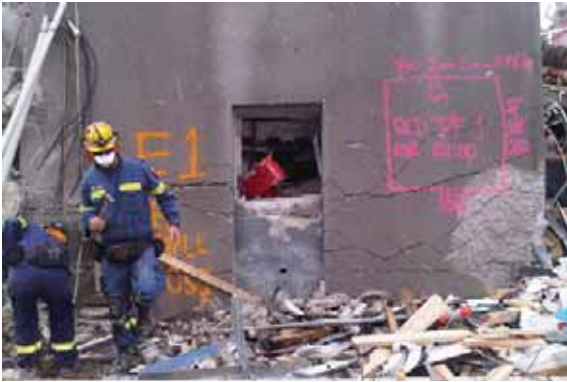
(b) Level 1 of the south shear wall (source: Graham Frost)

Figure 69(c) is a view taken through the broken window, which can be seen in Figure 69(b). Dr Heywood identified the severed edges of the level 2 and 3 floor slabs through this window. Figure 69(d) is a view of the edges of the floor slabs visible to the east of the south shear wall. Dr Heywood identified all five suspended floor slabs in this area. The connections between each of the suspended floor slabs and the south shear wall were severed and the edges of the floor came to rest relatively close to the base of the south shear wall. This indicated floor detachment before the south shear wall collapsed.

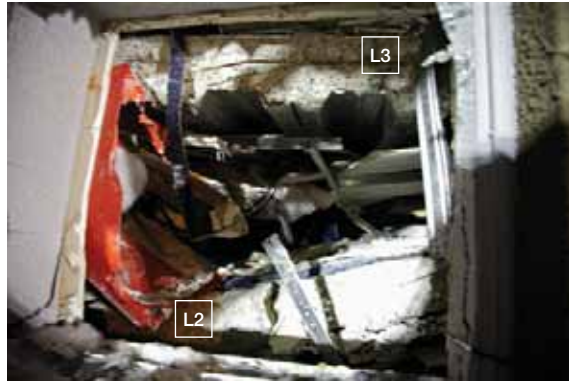
(c) Floor slab through level 1 door window (source: Robert Heywood)

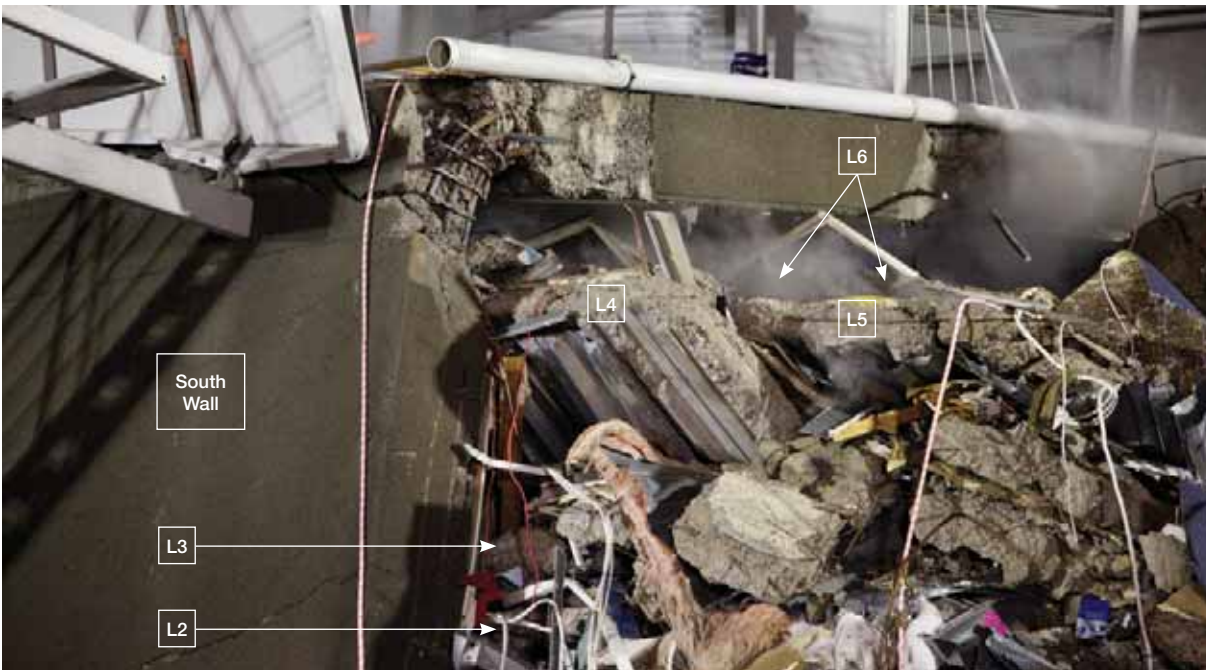
(d) Eastern side of collapsed south shear wall with floor slabs below (source: Robert Heywood)

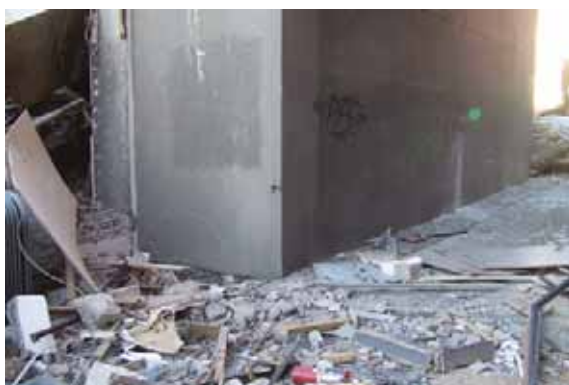
Dr Heywood observed portions of the north wall complex in good condition (see Figure 70(a)), except where damage had resulted from the edge beams pulling away from the walls. A closer inspection of the northern face revealed two horizontal cracks in the rendered concrete within a metre of ground level (Figure 70(b)). Dr Heywood suggested this cracking could have been either pre-existing or caused by bending towards the south. He thought that the north wall complex performed well during the earthquake.

(a) Eastern elevation of wall complex (source: Graham Frost)

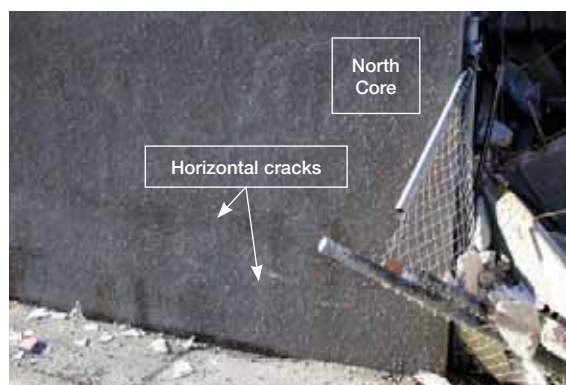
(b) Cracking in northern face, western end (source: Robert Heywood)
