**Quantitative
Assessment Report
Buller X-Ray
Building**

Buller X-Ray Building

Date: 29 January 2013
Reference: WCAN1.02 / 155GG
Status: FINAL1

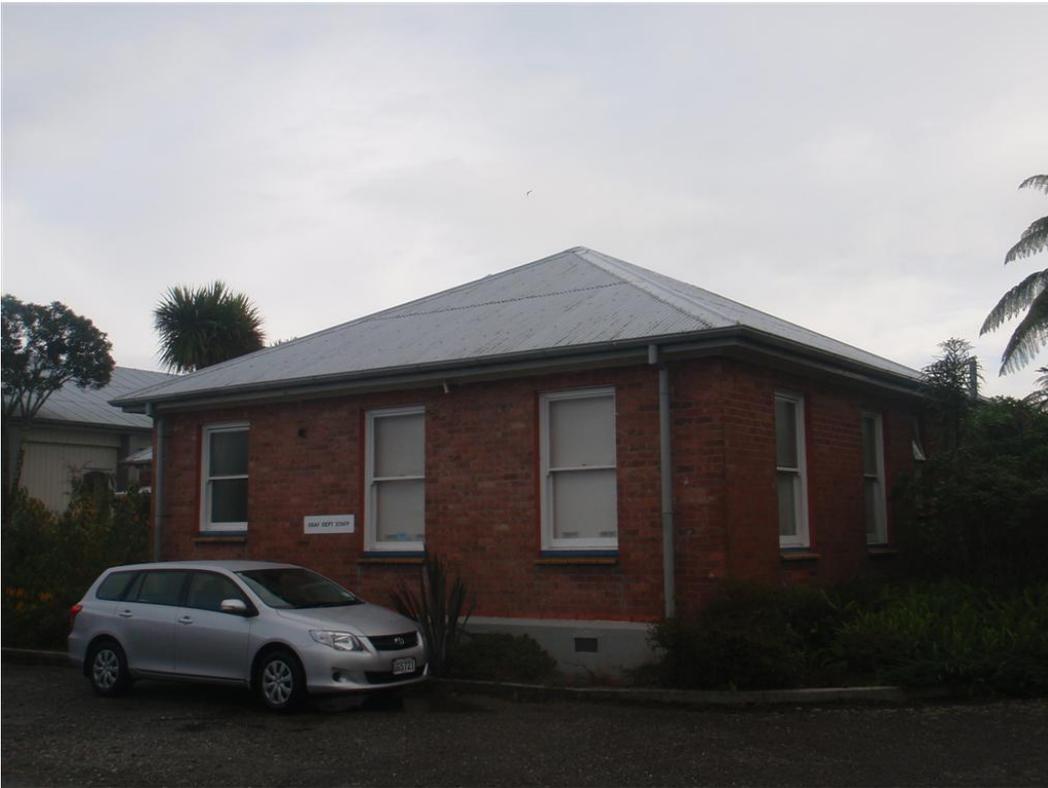
Photo 1: South elevation.

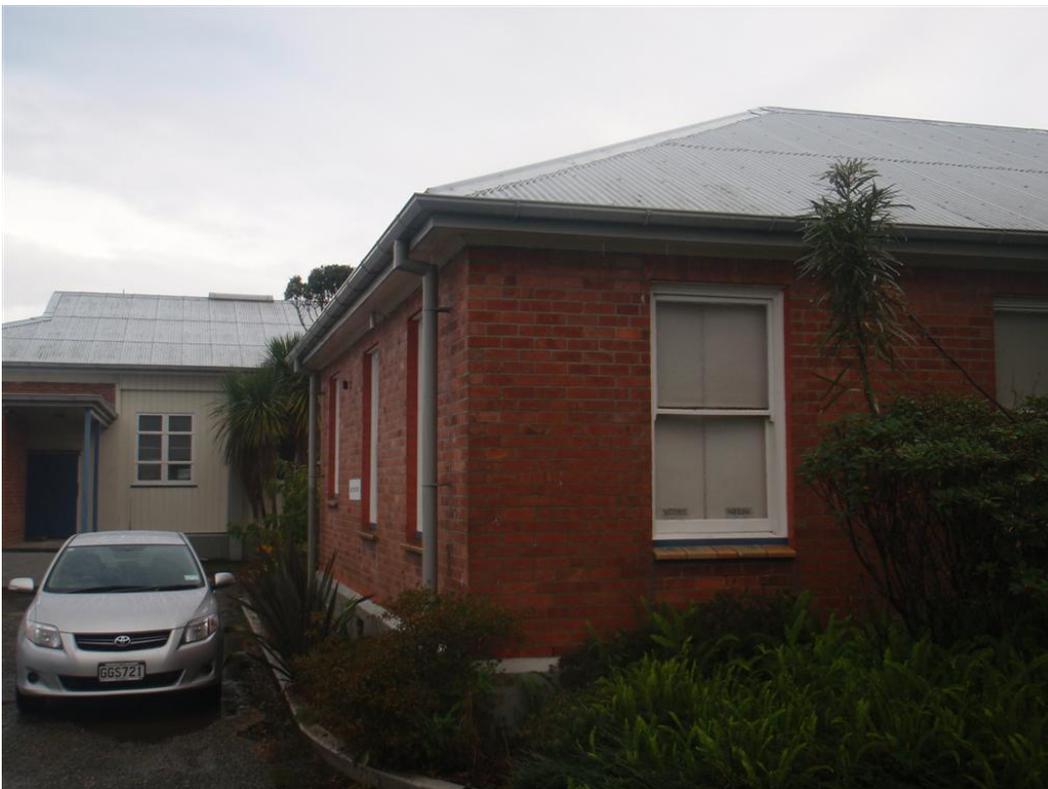
Photo 2: South east corner of building.

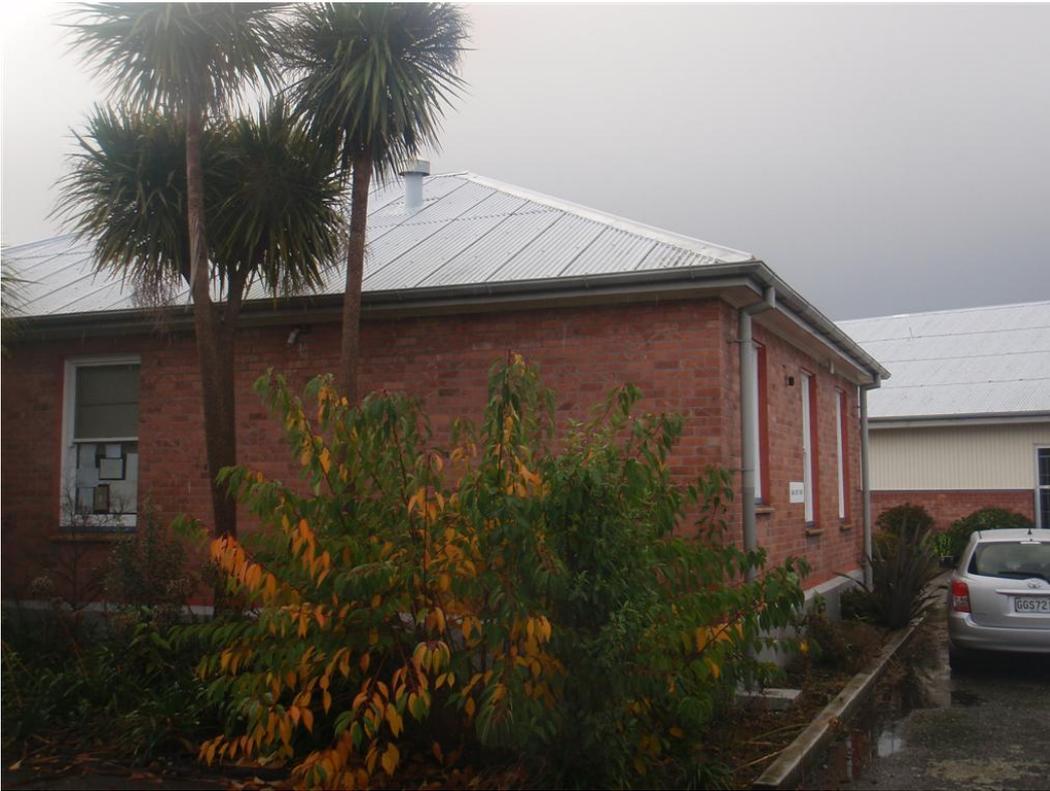
Photo 3: South west corner of building.

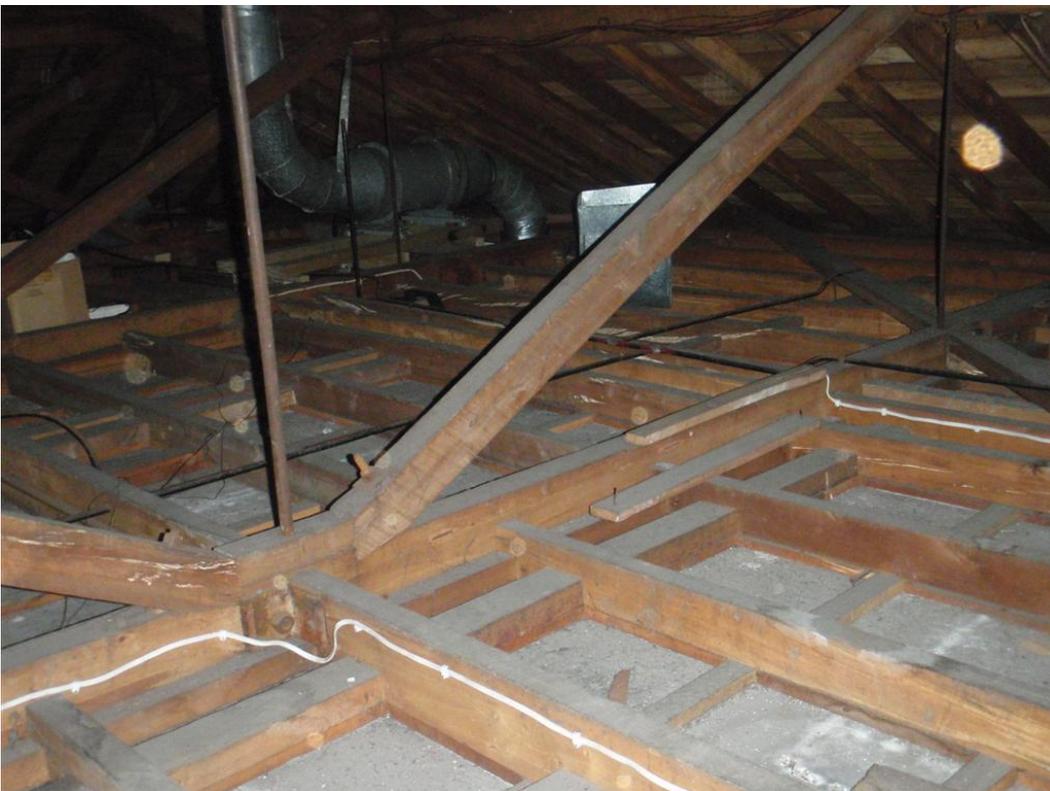
Photo 4: Roof structure.

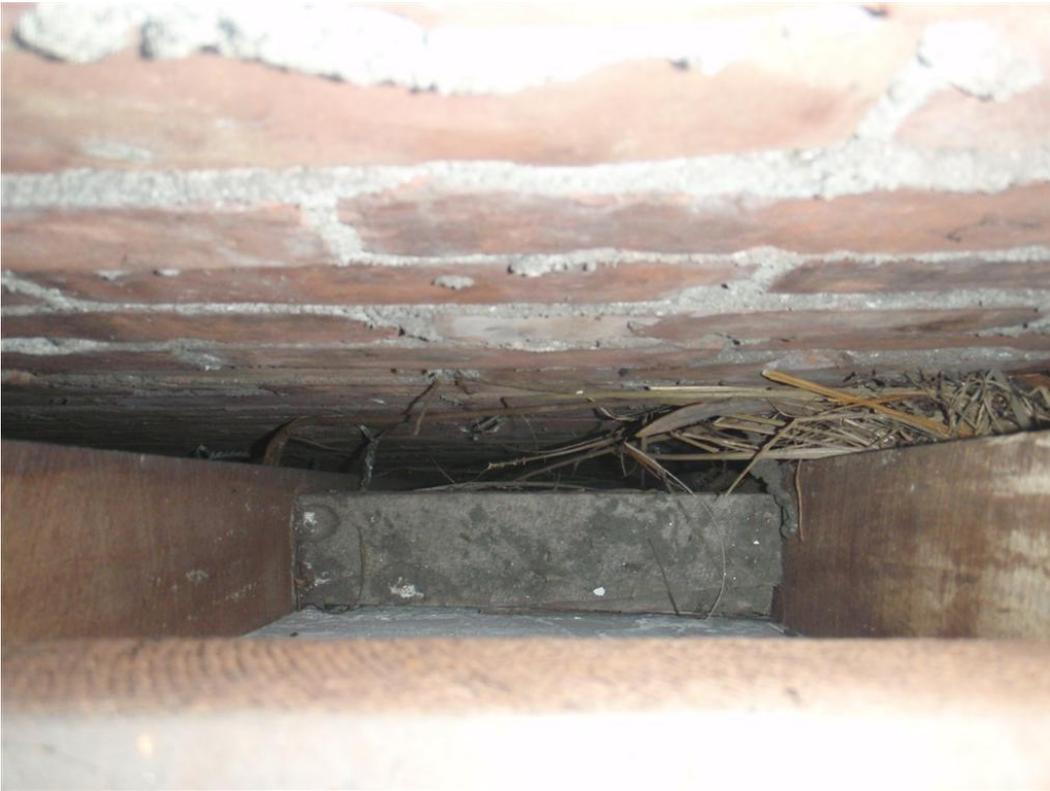
- » The building generally appears to be in a reasonable condition.
- » Timbers are generally connected with nominal nailing, consistent with early New Zealand construction practices.
- » There appears to be nominal tie wires between the external veneer cladding and the timber framed walls.

Photo 5: External timber framed wall and brick veneer cladding.

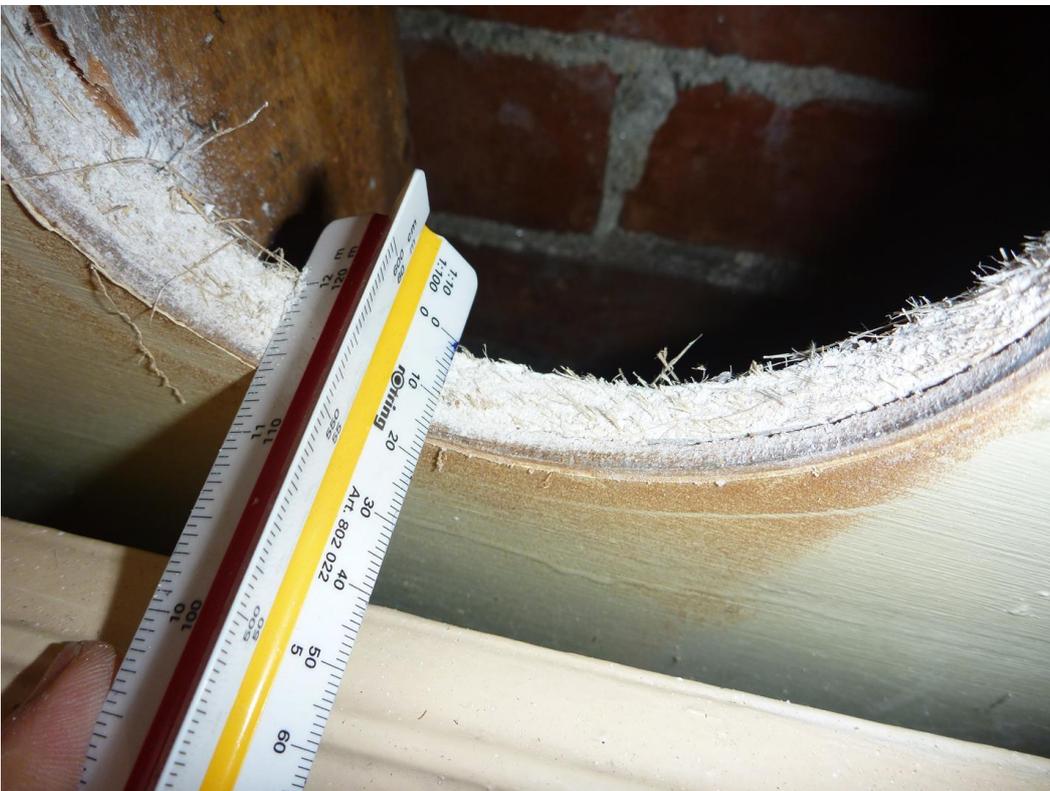
Photo 6: Plasterboard lining.

- » Strengthen selected timber framed walls through removal of existing internal linings, installation of fixings at the base of the wall, and relining with Gib Braceline (or similar).

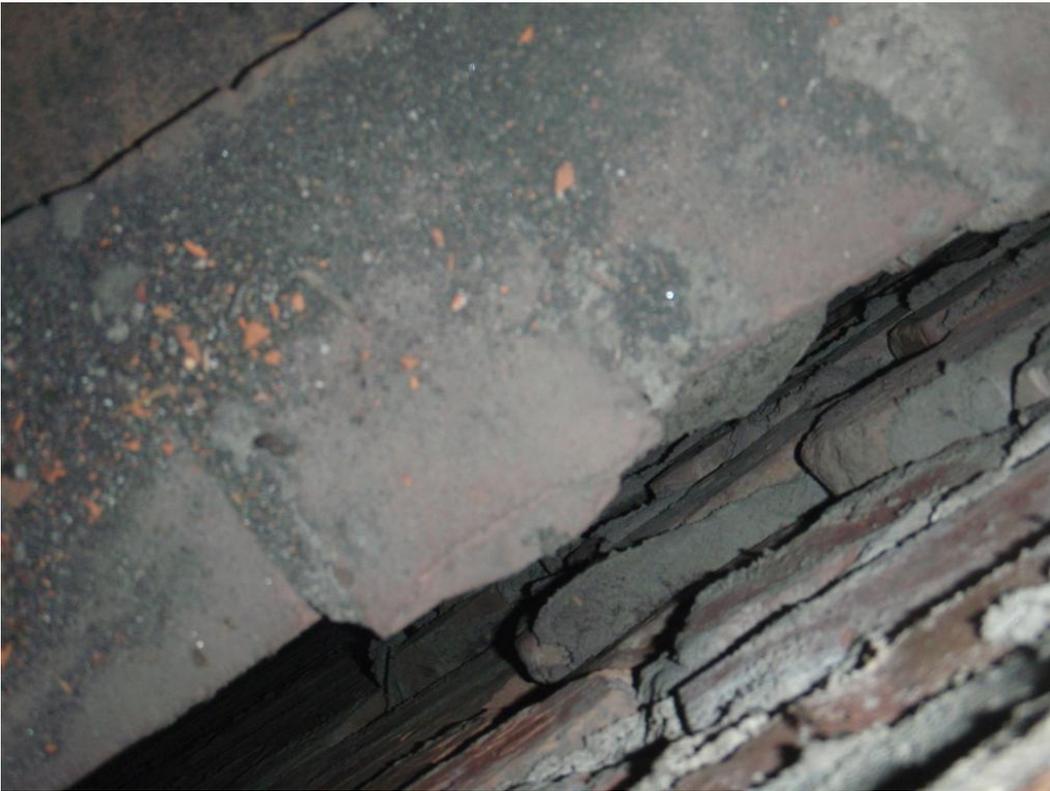
Structural Element/System	Failure mode or description of limiting criteria based on capacity of critical element	Critical Structural Weakness	% NBS based on calculated capacity
URM walls	Out of plane failure of double leaf URM walls.	No	20% ($\mu = 1$)
Timber floor diaphragm	Deformation capacity of floor diaphragm exceeded	No	20% ($\mu = 3$)
Plasterboard lined timber framed walls	In plane racking failure of timber framed, plasterboard walls.	No	22% ($\mu = 2$)
Reinforced concrete foundation walls	In plane shear. This assumes no contribution from rocking of reinforced concrete piles.	No	$\geq 100\%$ NBS ($\mu = 2$)

Photo 7: Internal double leaf URM walls.

Structural Element/System	Possible strengthening techniques
Internal URM walls	<ul style="list-style-type: none"> • Remove and reinstate with timber framed walls, or • Tie the two leafs of brickwork together with Helifix (or similar) ties.
Timber floor diaphragm	<ul style="list-style-type: none"> • Improve connections bearer to pile, joist to bearer, bearer to reinforced concrete foundation wall, joist to reinforced concrete foundation wall. • Install anchor piles at select locations.
Plasterboard lined timber framed walls	<ul style="list-style-type: none"> • Remove internal linings on selected walls and install new hold down fixings. • Reinstall internal linings with Gib Braceline or similar to improve performance of wall.

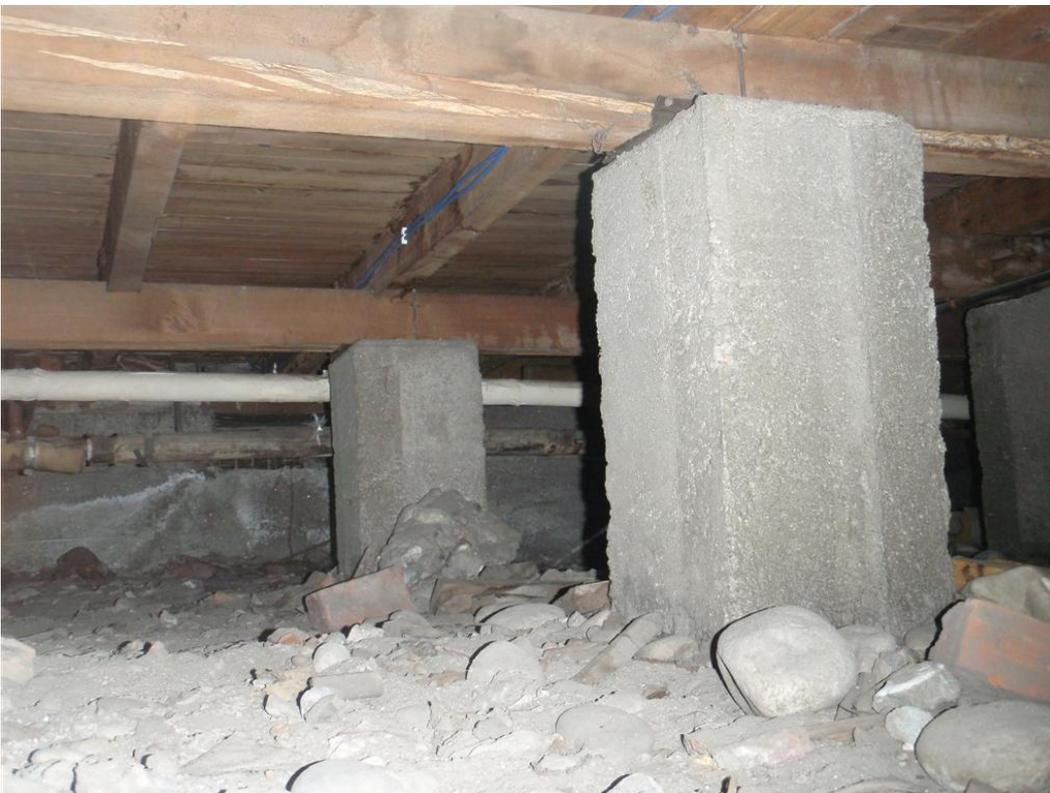
Photo 8: Typical concrete piles and timber subfloor.

- » Strengthen subfloor through installation of
 - additional fixings between the timber floor and perimeter concrete wall.
 - additional fixings between timber subfloor elements (joists, bearers etc).

- subfloor bracing.
