Inquiry 12-001: Hot-air balloon collision with power lines
and in-flight fire, near Carterton,
7 January 2012

Final Report

Aviation inquiry 12-001
Hot-air balloon collision with power lines and
in-flight fire, near Carterton,
7 January 2012

Approved for publication: October 2013

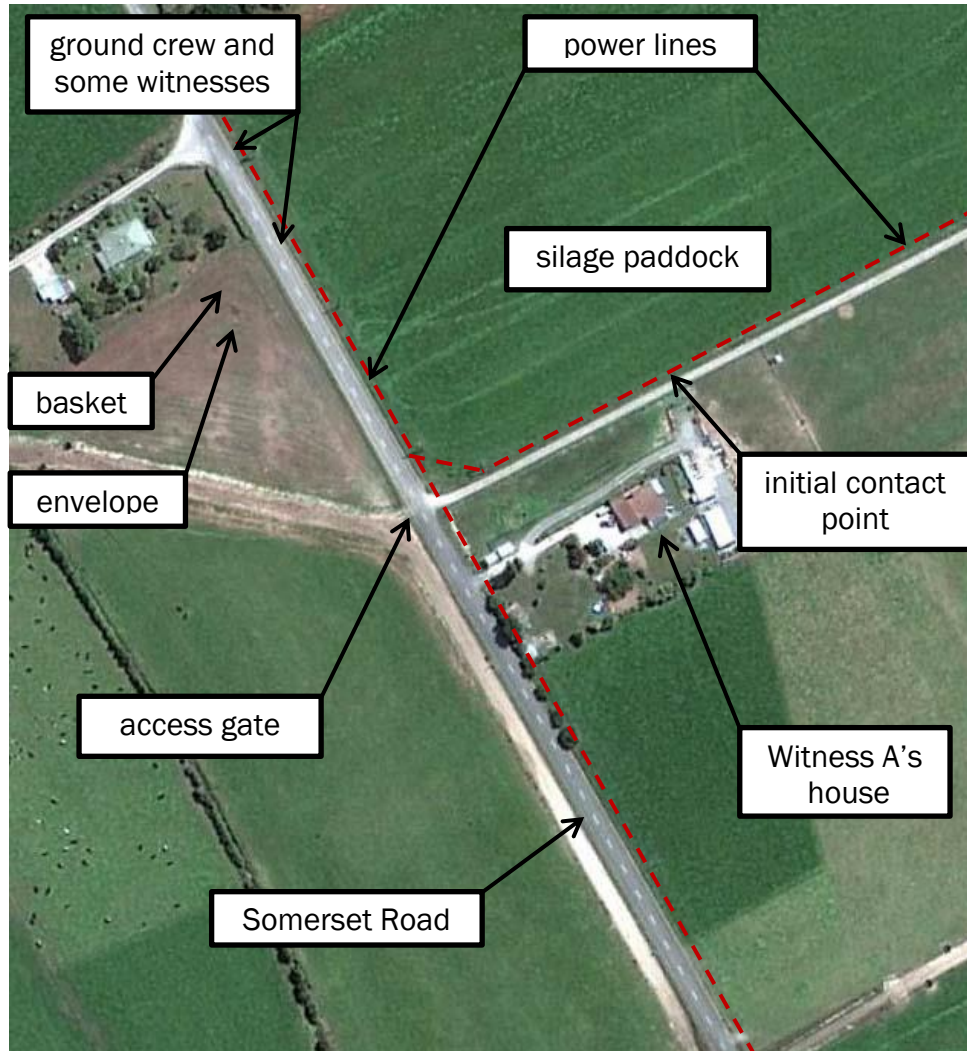
Figure 2
Accident site

- 3.2.3. A preliminary examination of the 33 kV power line was completed before any repair work was started. The wire closest to the silage paddock (the blue phase wire) was found broken and lying across the remaining 2 wires. This was the wire that had been caught across the top of the basket. It displayed significant damage. The centre wire (the yellow phase wire) was still suspended from the poles and displayed some damage. This was the wire seen caught near the bottom of the balloon basket. The wire closest to the small paddock (the red phase wire) was still suspended from the poles and showed little damage.

- 3.2.4. The balloon wreckage was found concentrated in a paddock situated on the other side of Somerset Road, 150 m west of where the balloon first contacted the power line. The envelope had separated from the basket where the flying cables from the basket attached to the base tape at the mouth of the envelope, or at the opposite end where they attached to the basket. The basket had struck the ground almost level. The metal framing of the basket, the burner frame and burners had collapsed downwards with the impact and slightly away from the pilot's end. Two fuel cylinders had been thrown clear of the wreckage and lay near the envelope several metres away. The wreckage had continued to burn on the ground until extinguished by emergency services, with most of the wooden wicker and cane construction material destroyed. Debris was scattered between the point of contact with the power line and the wreckage.

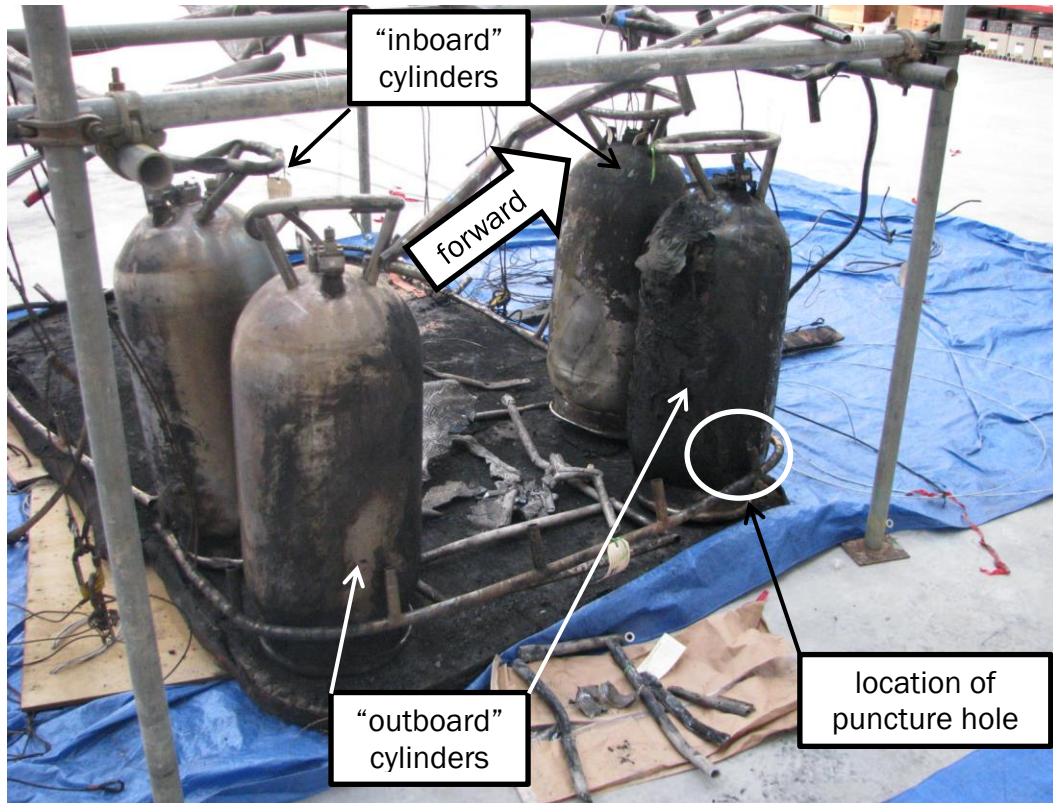
Figure 3
Basket reconstruction

- 3.2.11. The basket’s stainless steel framing was severely distorted. Evidence of electrical arcing was found around the top of the basket piping frame and on the wire around the bottom of the basket frame around the pilot’s compartment that also housed the LPG cylinders. All but one of the support suspension cables running around the basket were intact. That one cable had indications of electrical arcing.

- 3.2.12. The fire specialist noted that the 4 fuel cylinders all “showed signs of extreme heat which had melted the aluminium fittings. None of the cylinders showed signs of expansion due to internal pressure. This would indicate that the gas most probably vented through their pressure relief valves”. One of the cylinders had a small hole near the base that looked as if it had been caused by electrical arcing. This was determined to be the origin of the fire.

- 3.2.14. All the fuel hoses and fittings to connect the cylinders to the burners were accounted for. The lever-style tap fittings for each of the cylinders were dismantled to confirm the positions of the taps. The taps of the 2 inboard LPG cylinders closest to the centre of the basket were determined to be in the OFF or CLOSED position. The cylinder that had the small puncture hole in it was also CLOSED. The tap of the fourth cylinder was determined to be OPEN. There were 2 cross-feed valves, one between the 2 burners and the second between the 2 outboard cylinders. Both were found to be CLOSED.

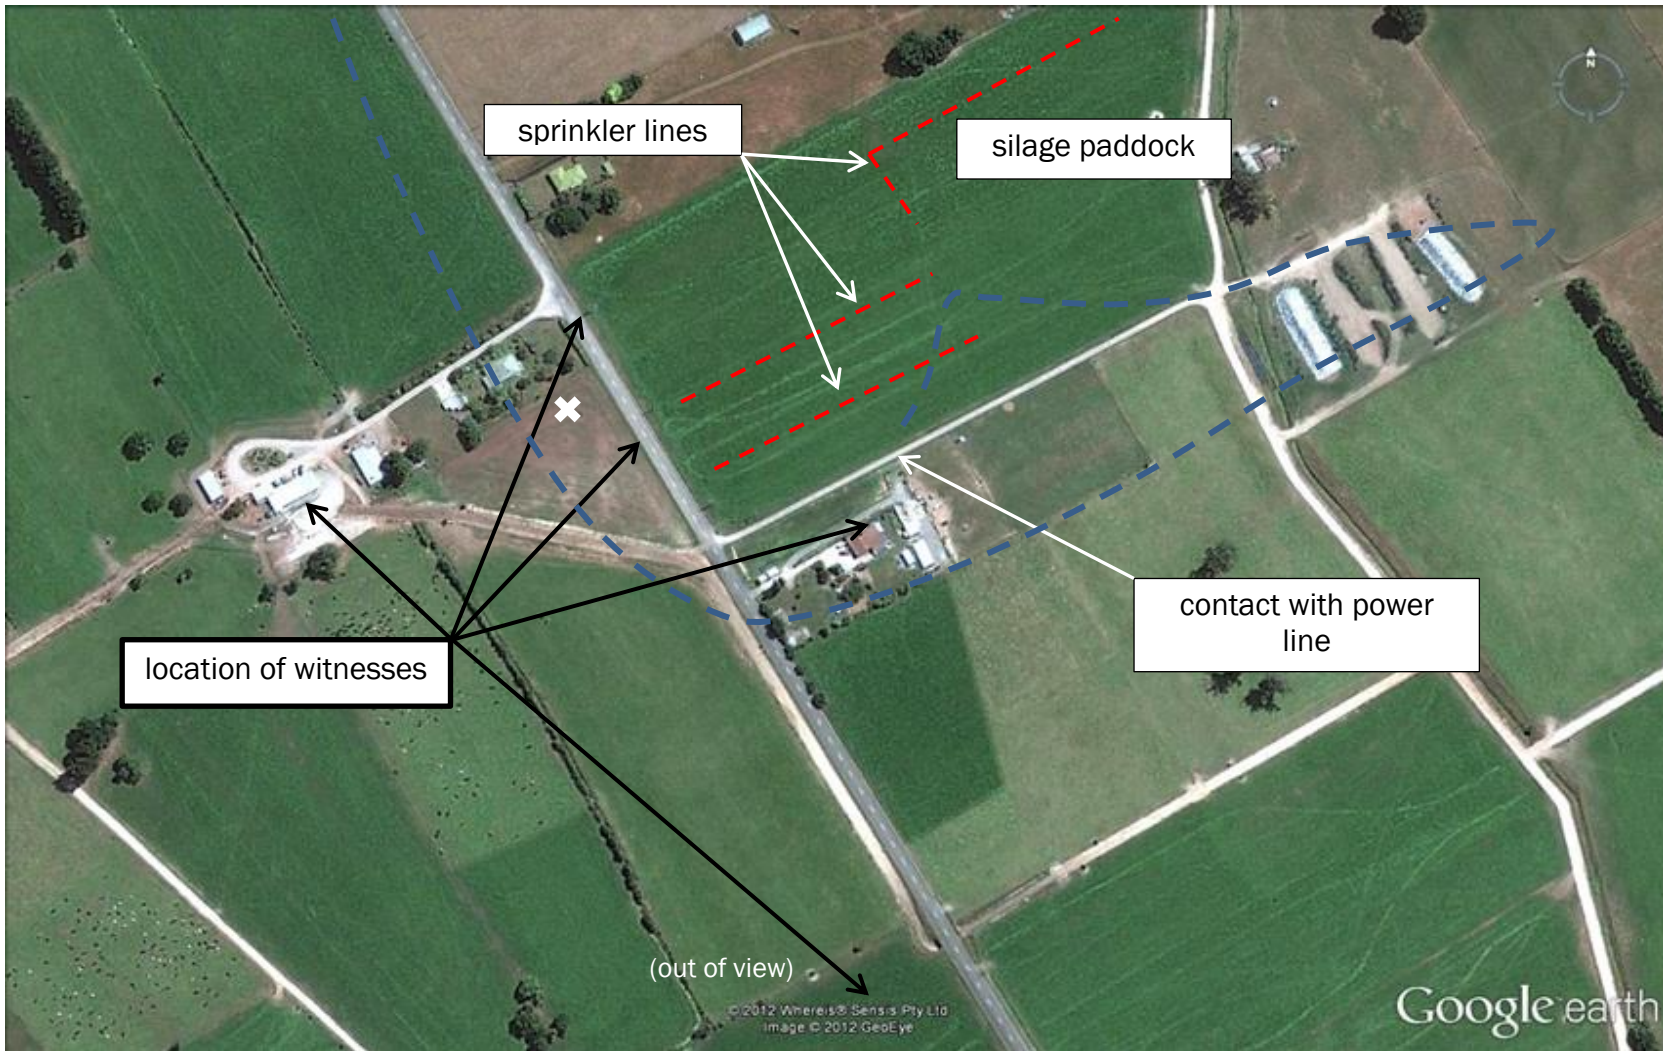
Figure 6
Approximate final portion of flight
(Image courtesy of Google Earth)

balloon entered the silage paddock, the runners¹⁶ on the landing side of the basket faced east towards the power line it later struck. This placed the pilot at the front end of the basket closest to the power line running along Somerset Road.

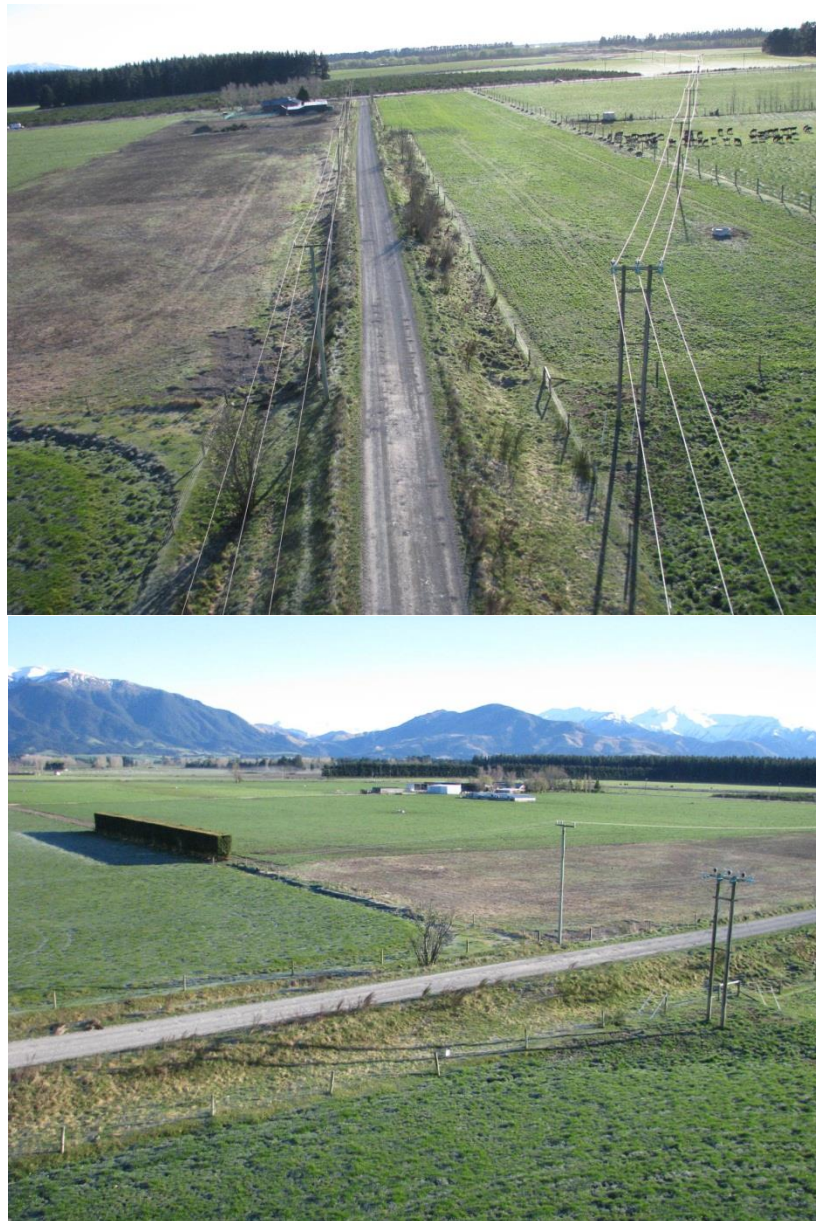
Figure 7
Power lines

- 4.2.8. Wires can be difficult to detect, especially single and small-diameter wires. The dulling of wires from exposure to the elements, certain lighting conditions and the presence of material such as lichen can act to camouflage wires. Figure 7 shows examples of a power line viewed from 2 different angles and demonstrates the potential difficulty in seeing wires. The poles, however, remain clearly visible.

- 4.2.9. Balloon pilots should be aware of these factors and are taught to look for poles as an indication of the presence of wires. Once a wire is sighted, the pilot should maintain a safe height above it or, if at very low level, start a climb early enough to clear the obstacle with a good safety margin.
