Interim Report AO-2016-007: Collision with terrain, Robinson R44, ZK-HTH
Glenbervie Forest, Northland, 31 October 2016

Interim Report

Inquiry AO-2016-007
Collision with terrain
Robinson R44, ZK-HTH
Glenbervie Forest, Northland
31 October 2016

Transport Accident Investigation Commission

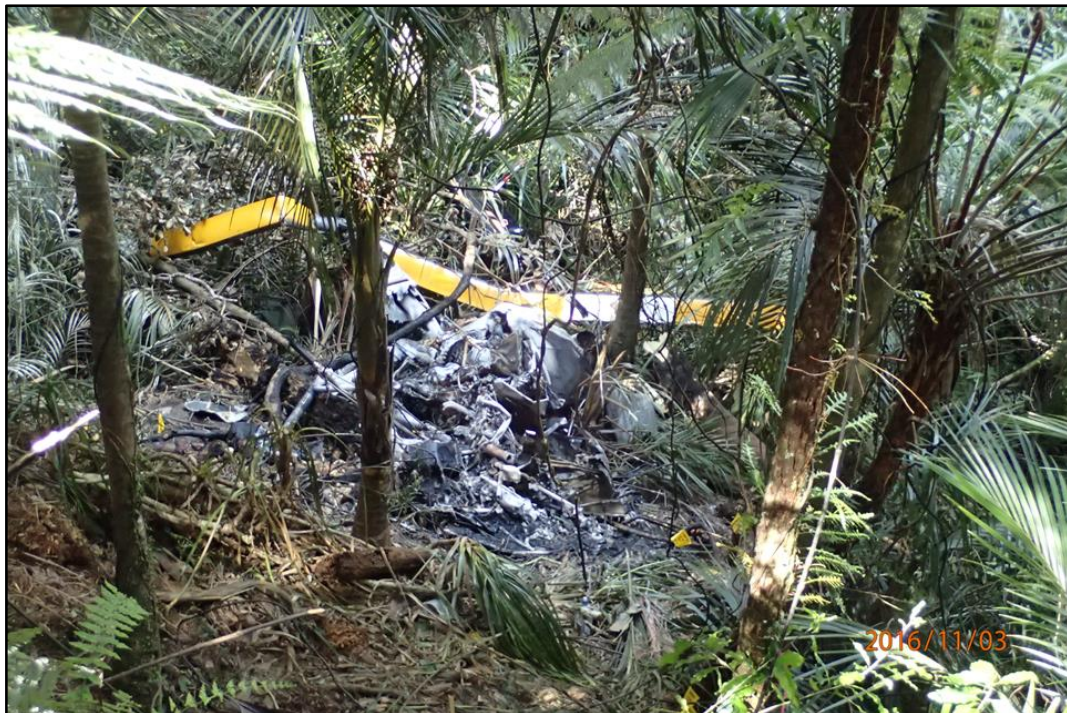
Figure 1
Accident site

- 2.2.1. The wreckage was located in a compact area with most of the helicopter contained around the point of impact with the ground (see Figure 1). Parts of the landing skids and the carbon-fibre spray booms had broken off as the helicopter fell through the trees in a northerly direction. The damage to the helicopter indicated that it had struck the ground with a high rate of descent and a low forward speed.

- 2.2.2. An intense fire had destroyed most of the fuselage forward of the tail boom, including the main rotor transmission housing and most of the fairing around the main rotor drive-shaft. The fire had melted the aluminium components in the fuselage and destroyed the fibreglass cabin structure. The fire had not spread beyond the main wreckage.

- 2.2.3. The tail, including the horizontal and vertical stabilisers and the complete tail rotor assembly, had detached as a unit from the tail boom. Heavy crushing was found on the leading edge of the horizontal stabiliser, which was consistent with the stabiliser having hit a tree.

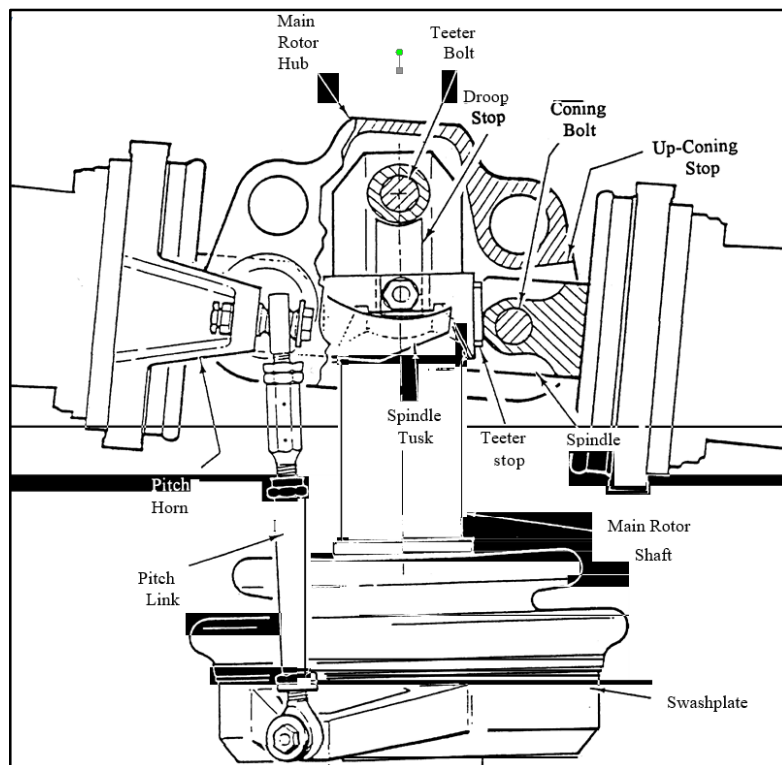
Figure 2
Robinson main rotor head
(source: Robinson)

- 2.2.4. The main rotor blades were attached to the hub and were not damaged by the fire. Outboard sections of both blades had separated and were found close to a tree, which was identified as the first tree the helicopter had struck as it entered the forest. Two pitch links² were normally connected between the upper swashplate³ and the pitch horn on the main rotor blades (refer Figure 2).

- 2.2.5. Both pitch links were found attached to the upper swashplate. However, both had disconnected from their respective main rotor blades. One had broken at the upper rod-end thread, and the other was missing its upper attachment bolt that connected it to the pitch horn on the blade.
