Inquiry AO-2014-006: Robinson R44 II, ZK-HBQ, mast-bump and
in-flight break-up, Kahurangi National Park, 7 October 2014

Final Report

Aviation Inquiry AO-2014-006
Robinson R44 II, ZK-HBQ, mast-bump and
in-flight break-up, Kahurangi National Park,
7 October 2014

Approved for publication: February 2017

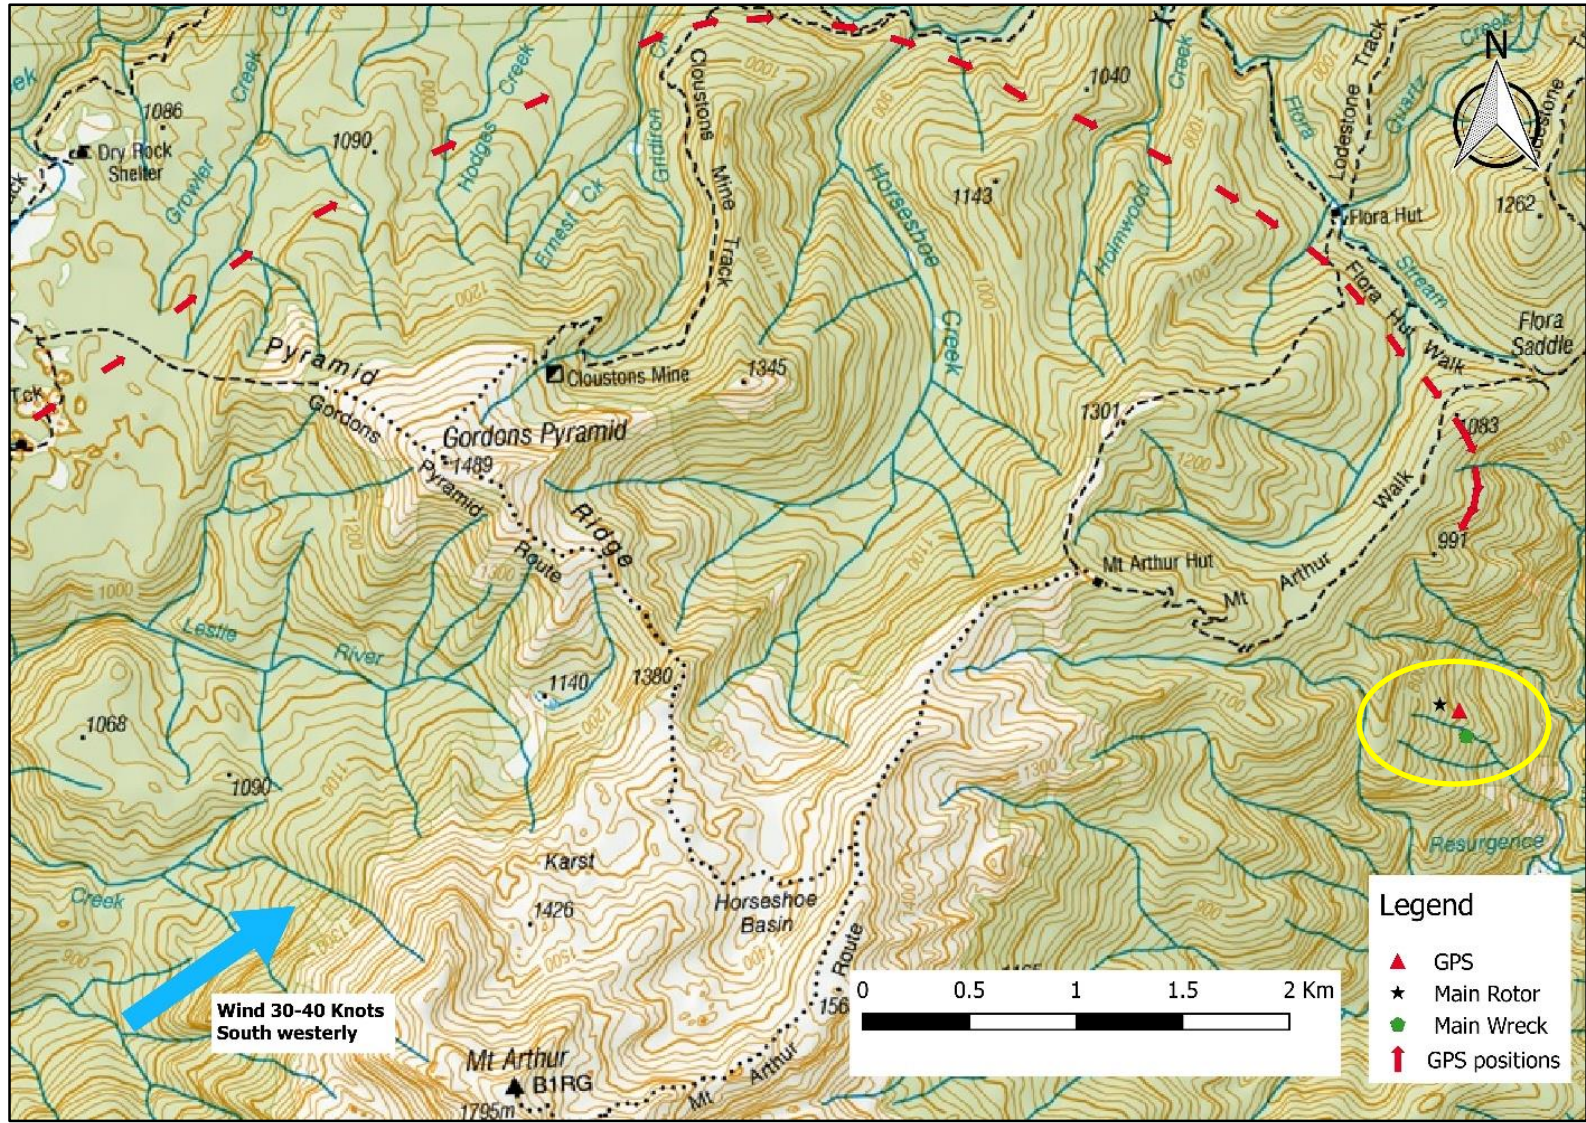
Figure 2
GPS positions and accident site

- 3.6.1. The main wreckage was found in dense bush on steep terrain approximately one kilometre south of the last position recorded on the GPS unit, at an altitude of about 2,200 feet (see Figure 2). The main wreckage, consisting of the cabin, engine, main rotor transmission and tail boom, fell through the tree canopy in a southerly direction. Despite being fitted with an

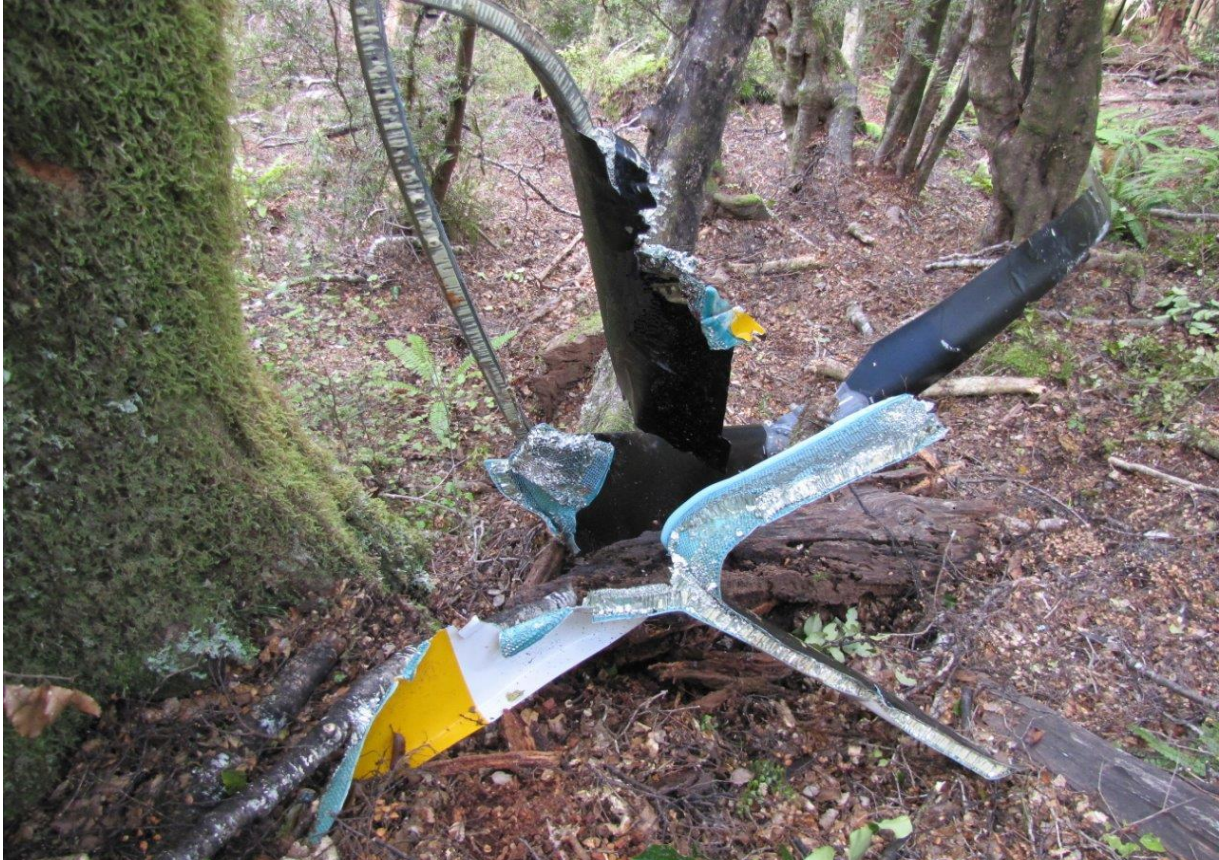
Figure 3
Main rotor as found

- 3.6.3. The main rotor was found approximately 100 metres from the main wreckage and to the west of the other items (see Figure 3). A three-foot outboard section of one blade was missing. The main rotor driveshaft had sheared just below the teeter stops²¹, which had been crushed by the blade spindles²² (see Figure 4). One of the pitch change horns had broken off, and both pitch change links had failed at the upper rod end threads. There was arc-shaped scoring damage to the main rotor hub outboard surfaces, and the remaining pitch change horn displayed impact damage.

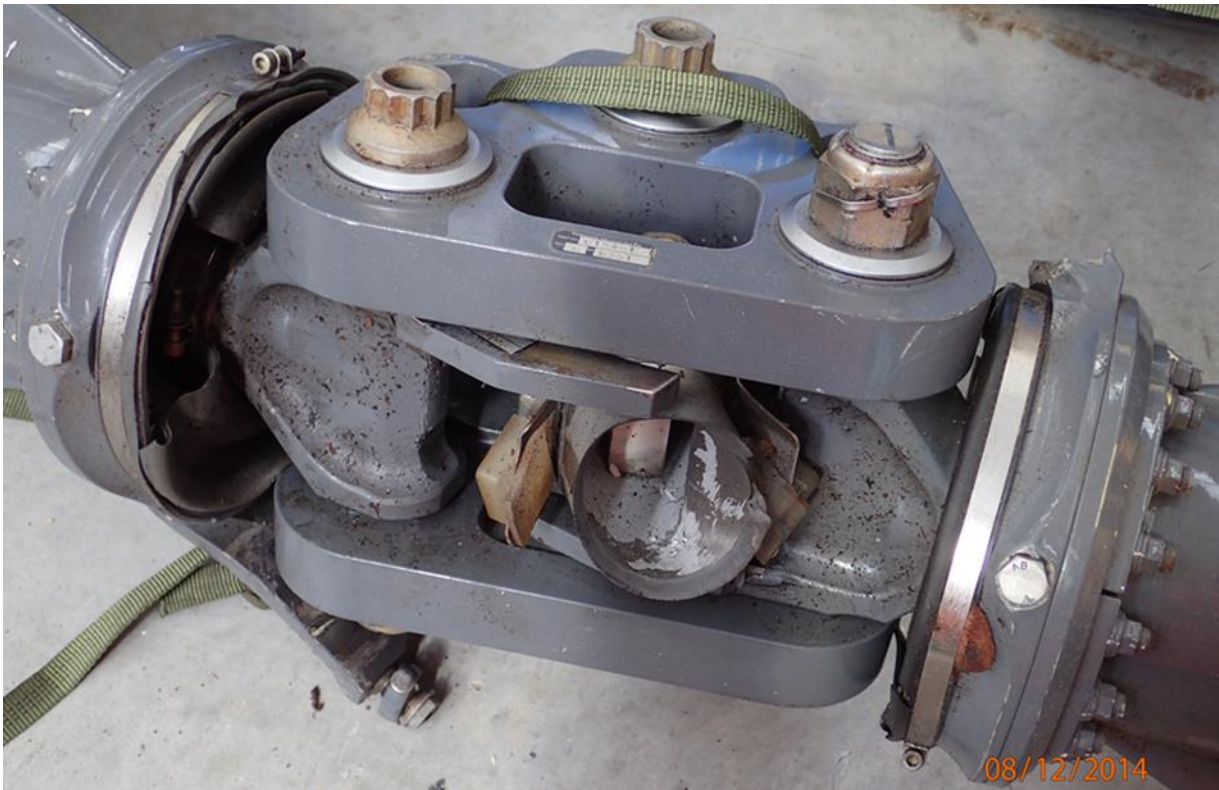
Figure 4
Main rotor driveshaft damage

3.6.4. The damage to the cabin and main rotor blades showed that one of the main rotor blades had entered the cabin and wrapped underneath the helicopter under rotation. The outboard section of this blade had then broken off when its leading edge struck the rear skid cross tube in an upward direction.

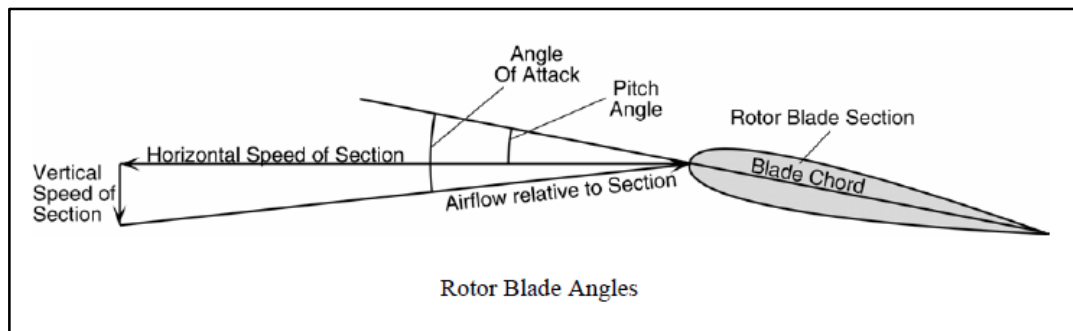
Figure 5
Main rotor blade angles (source: AAIB)

- 4.2.2. One of the main rotor blades was bent in an upward direction, with creases in the upper surface of the blade. This could have been caused by excessive coning of the blade in a low-rotor-RPM situation, where the lift produced and the centrifugal forces on the blade would have been overcome by the weight of the helicopter, and the blade bent up towards the tips. It could also have been caused by an uncontrolled blade going into a very high angle of attack³⁵, with the subsequent high aerodynamic drag loads resulting in bending in an upwards and rearwards direction opposite to the direction of rotation.

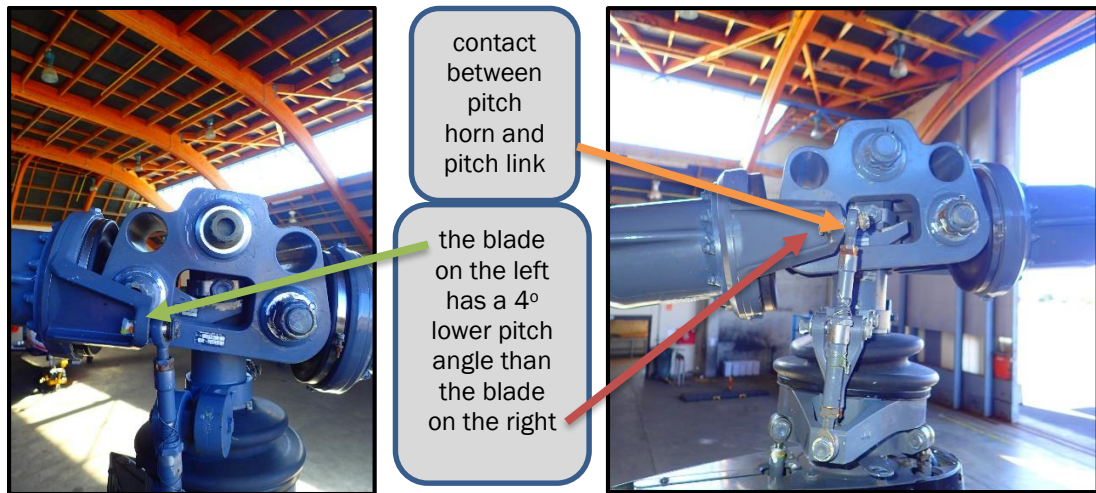
Teeter (flap)-pitch coupling (delta-three hinge) and contact between pitch link and pitch change horn

- 4.6.16. Another unique design feature of the Robinson rotor head is that the pitch horn input is inboard of the coning hinge axis (see Figure 9 and Appendix 4), which means that a change in a blade's coning angle results in a change to its pitch angle. During the low-G conditions in the main rotor flapping survey flights, while the main rotor was partially unloaded, the coning angle of both blades was reduced by about 5 degrees, which would result in a decrease in the pitch angle of both blades by about 2 degrees. Although a small decrease, it would reduce the lift produced by the main rotor during low-G conditions and lead to a further reduction in G.

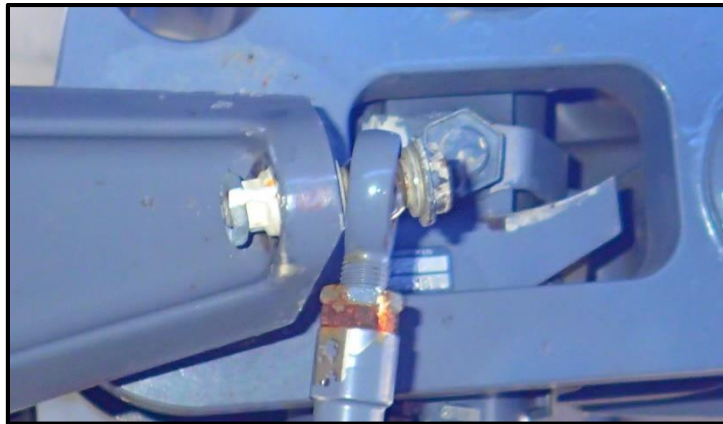
Figure 11
Contact between the pitch link and the pitch horn at the teeter limit (7.4 degrees)

- 4.6.17. At some point after the mast-bumping starts and the rotor hub has teetered beyond the limits, the pitch change links fail due to excessive reverse bending cycles and compression loads, likely after contact with the pitch change horns (see Figures 9 and 11) due to the limited range of movement the connection allows⁶⁷. This would render the main rotor blades uncontrollable in pitch, and they could assume extreme positive or negative angles of attack, causing rotor divergence. The centre of gravity of the blades is forward of the pitch change axis, which creates pitch instability during blade rotation. A blade rotating with a negative angle of attack produces lift in a downwards direction and would bend down into the cabin and underneath the helicopter with the airflow.
