Interim report MO-2017-203: Burst nitrogen cylinder causing fatality on board the passenger cruise ship *Emerald Princess*, 9 February 2017

Marine inquiry MO-2017-203

Burst nitrogen cylinder causing fatality on board the
passenger cruise ship *Emerald Princess*

9 February 2017

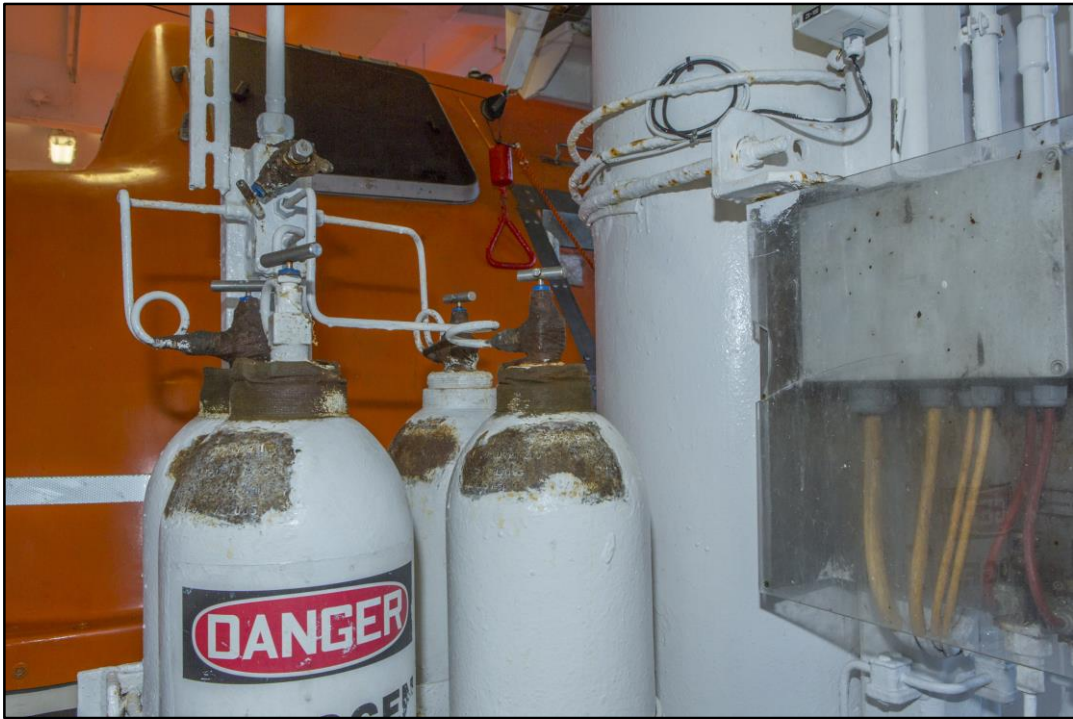
Figure 1
Typical four-cylinder installation on the *Emerald Princess*

- 1.12. The banks of nitrogen cylinders were fitted on a covered but open deck and as such were exposed to salt spray and sea air.
- 1.13. Each bank of four cylinders sat within a steel frame unit, secured by a steel band approximately three-quarters of the way up the base of the cylinder. The base of each cylinder was fitted with a steel foot, which had been heat shrunk around the base of the cylinder to allow the cylinder to stand upright in the base of the steel frame unit (see Figures 1 and 2).

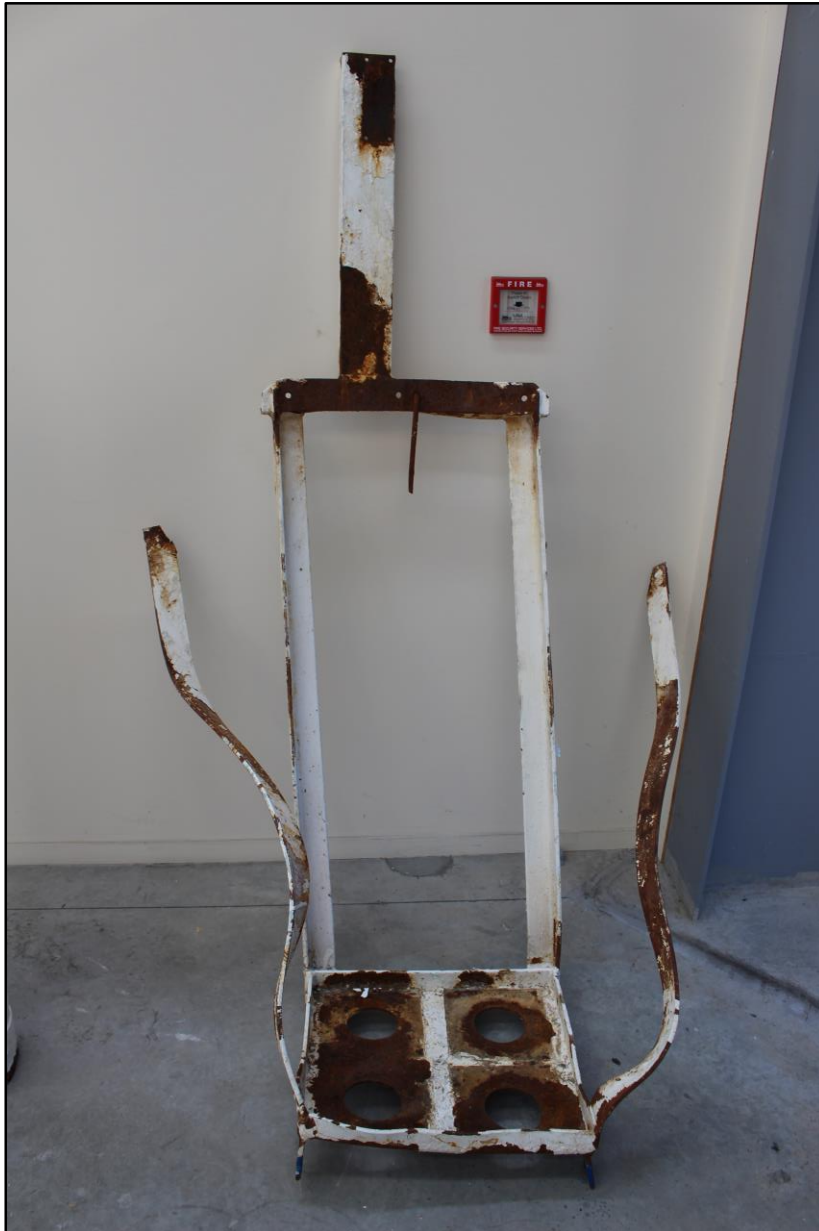
Figure 2
Damaged storage frame that held the burst cylinder

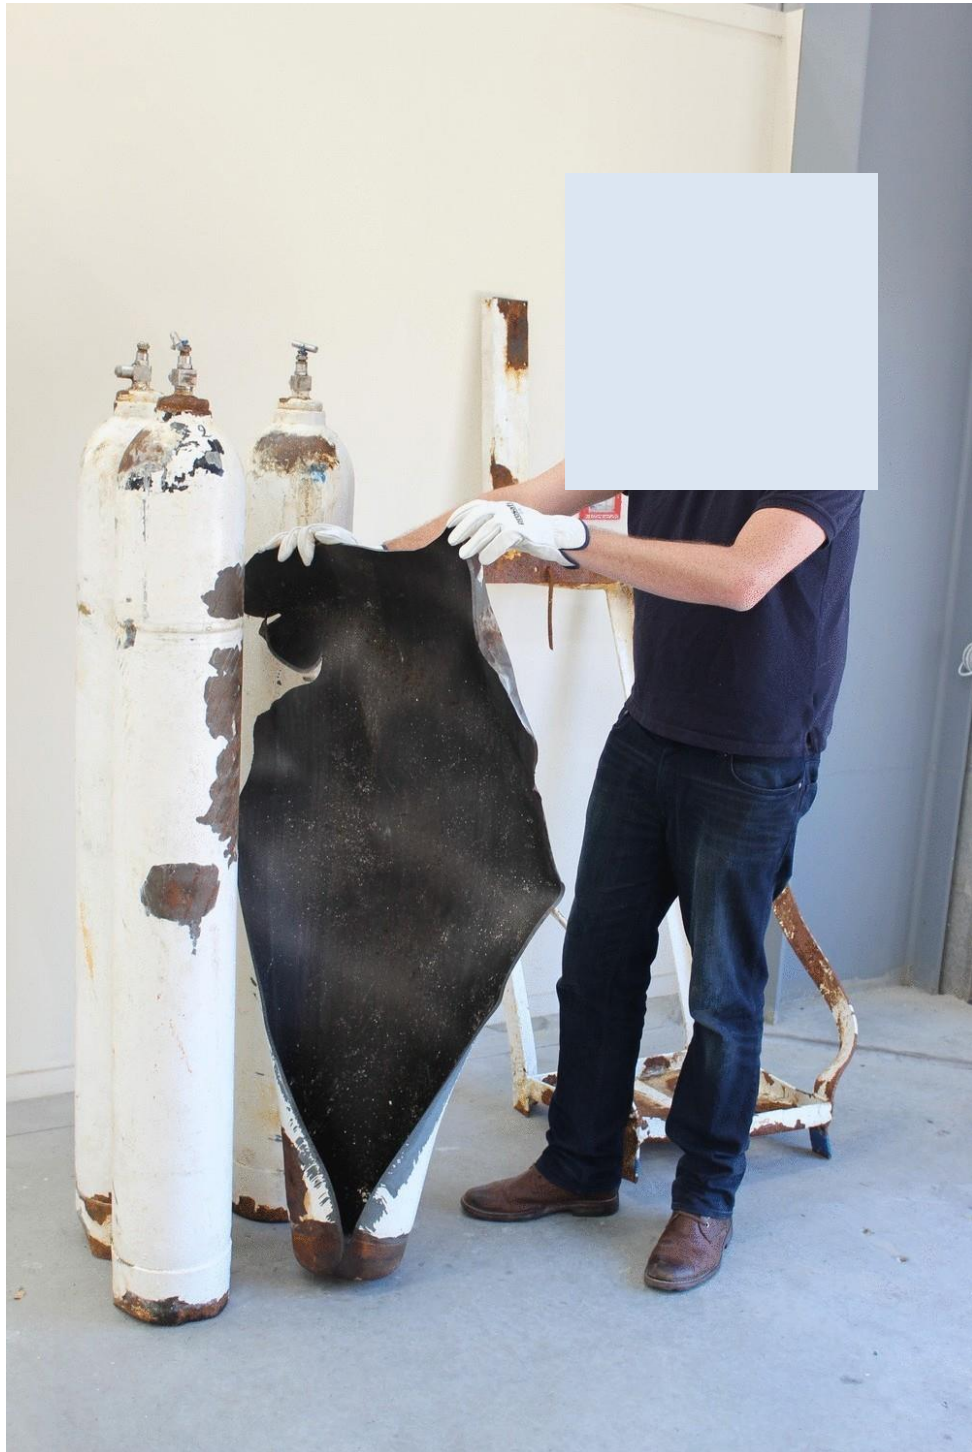
- 1.14. The remains of the burst nitrogen cylinder were recovered together with the other three cylinders from the same frame. The top of the burst cylinder was never found, having possibly been ejected into the sea. A randomly selected representative cylinder from another bank of cylinders was also retained.

Figure 3
Burst nitrogen cylinder together with the other three cylinders in the set

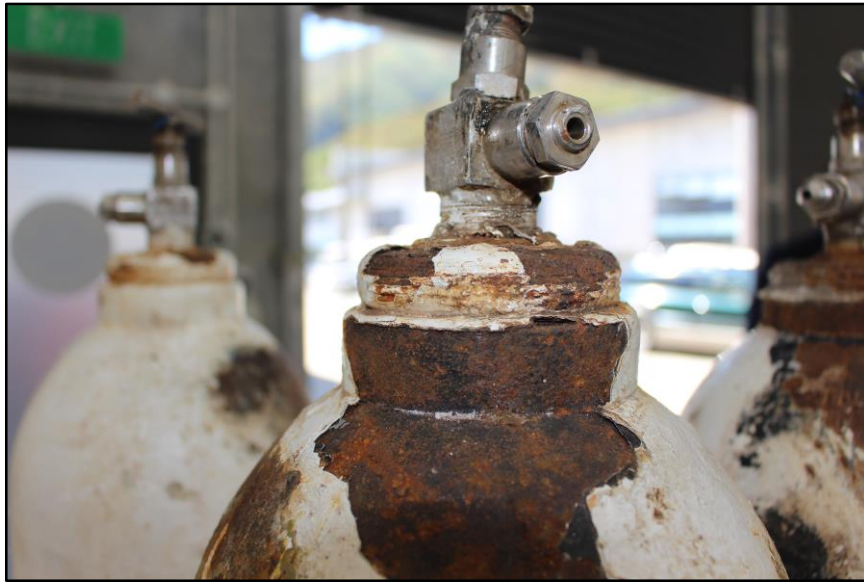
- 1.17. The metallurgist's initial assessment was that the failure had occurred as a result of overload caused by corrosion thinning.
- 1.18. A number of other cylinders on board the ship were observed to have similar corrosion-related damage. Significant corrosion damage was also observed on the accumulator, which is the pressurised vessel connecting the nitrogen cylinders and the stored energy system.

Figure 4
Significant corrosion around the top of other cylinder in the bank

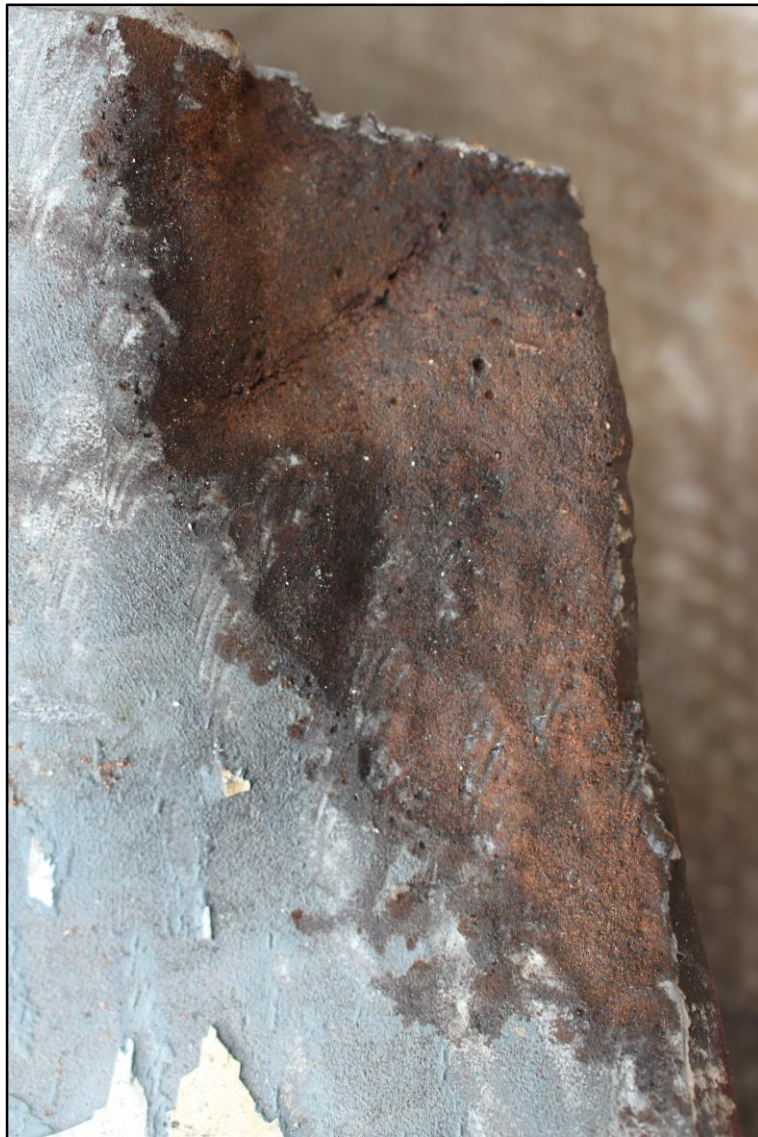
- 1.16. The burst nitrogen cylinder had suffered significant corrosion at the point of failure, which was situated approximately 150 millimetres below where the steel securing band had clamped the cylinder within its frame. The corrosion had developed on the outside of the cylinder. The internal surface was clear of corrosion. Corrosion had reduced the thickness of the cylinder wall by about 75% at the point of failure (from six millimetres to about 1.5 millimetres). A second area of corrosion was noted near the bottom of the cylinder and a third area where the protective coating had been scraped away to observe the cylinder's identification details.

Figure 5
Significant corrosion at the point of failure

On 10 April 2017 the Commission recommended to the manufacturer that, as a matter of urgency, it contact all known ship owners that have the same or similar emergency launching and recovery systems installed on their vessels, informing them about the circumstances of this accident, and advising them to have the systems inspected immediately by a competent person to check whether the nitrogen cylinders and other pressure vessels associated with the systems are fit for purpose. Any nitrogen cylinders deemed unfit due to corrosion should be removed for further assessment. (010/17)
