Wellington City Council Targeted Assessment Programme

following the
Kaikoura Earthquake of 14 November 2016

Technical Report

7 May 2017

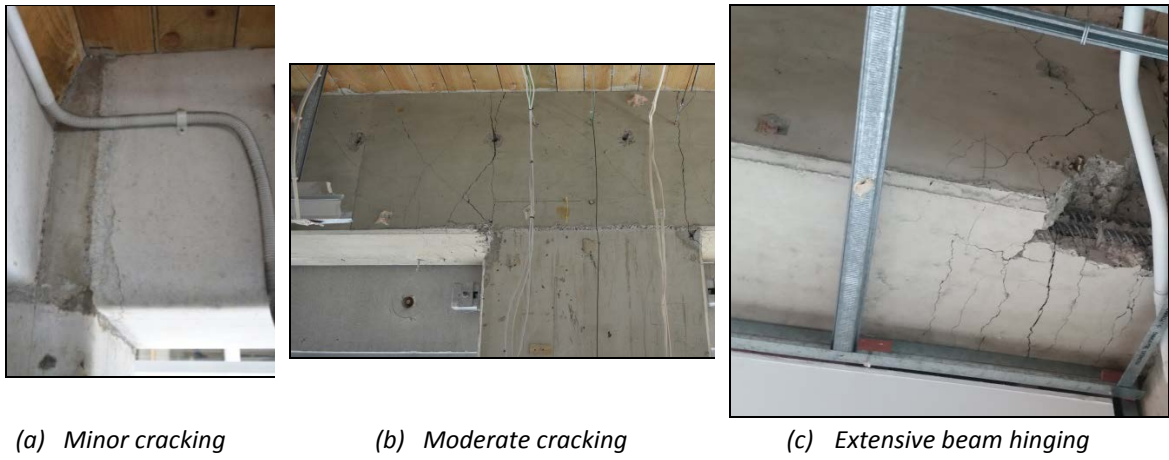
Figure 8: Examples of beam plastic hinging

Only 25% of TDE buildings exhibited beam hinging exceeding the criteria set for CDS C1. With few exceptions, this occurred in 10 to 15 storey buildings. While diagonal cracking was observed in some plastic hinge regions, the predominant response of beams was flexural. Initial minor cracking often initiated at the cold joint between the precast beam and cast-in-place joint; however, further demands would typically lead to a distribution of cracks in the beam.

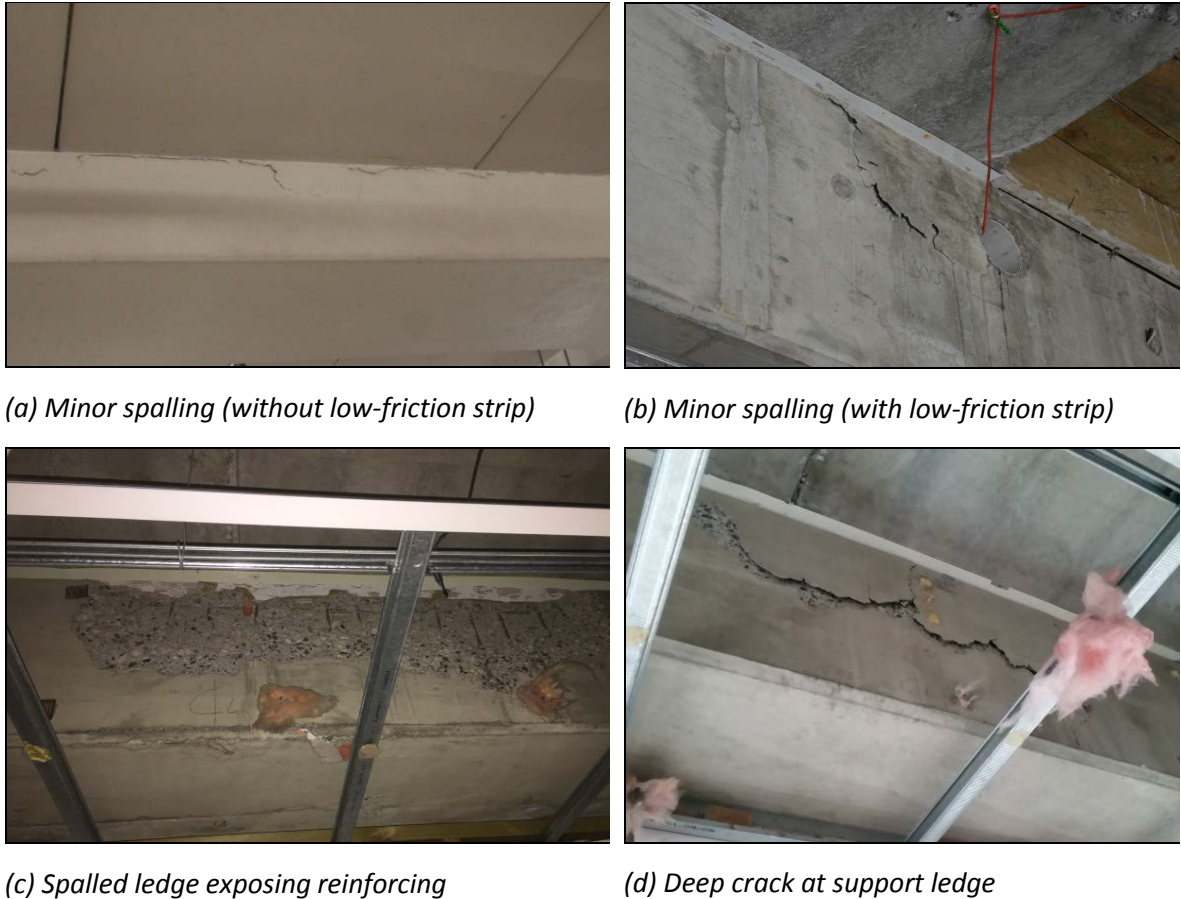
Figure 12: Examples of support ledge spalling

The presence of beam elongation generally reduced the seating width for units spanning into corners, but with the exception of Statistics House, sufficient residual seating of precast units was maintained. In restrained beams away from the corners, hinging was often less significant, with cracks that had generally closed up leading to minimal residual elongation.

In addition to beam elongation, the building drift and associated rotation of the support beam can also lead to damage at the support. Minor spalling of the support ledge was observed in many buildings with hollowcore floor units seated directly on the support beam, as shown by the example in Figure 12a. The use of a bearing strip, as required by NZS 3101:2006 and used since the mid-2000s, can delay the onset of such minor spalling by allowing the unit to slide relative to the support beam. However, spalling of support ledges is still observed (e.g. Figure 12b) when the building is subjected to high drift demands with bearing stresses and prying effects increased. Examples of significant spalling of the support beam are shown in Figure 12c and d where the entire cover concrete has been lost. The seating length in this building was adequate to ensure that a residual bearing area was maintained to prevent complete loss of support and potential collapse of the floor units. Despite the extensive damage observed, Figure 12c highlights the importance of changes to design standard requirements in NZS 3101:2006 where seating lengths must be sufficient to accommodate demands due to both elongation and rotation, as well as the loss of bearing area due to spalling.

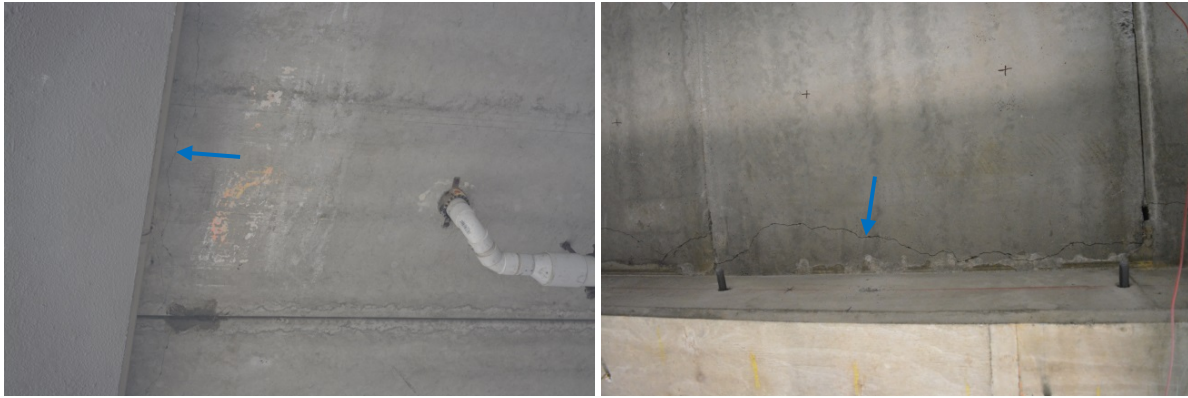
Figure 19: Transverse cracking of hollowcore close to support

Figure 19 shows examples of transverse cracking within 100 mm of beam support, where prestress in the strand is unlikely to be significant. In addition, transverse crack at approximately 300 mm from the support were observed in some buildings, as shown in Figure 20. Typically the location of the cracks on top surface corresponded to the end of the starter bars, and in many cases the crack was found to extend vertically for the full depth of the unit. Given the distance of the transverse crack from the support, prestress strand bond is likely sufficient to sustain gravity loads, but further widening of the crack in aftershocks was still a concern. Further research is needed to understand the cause of this cracking pattern and the residual capacity when considering both gravity loading and demands in aftershocks.

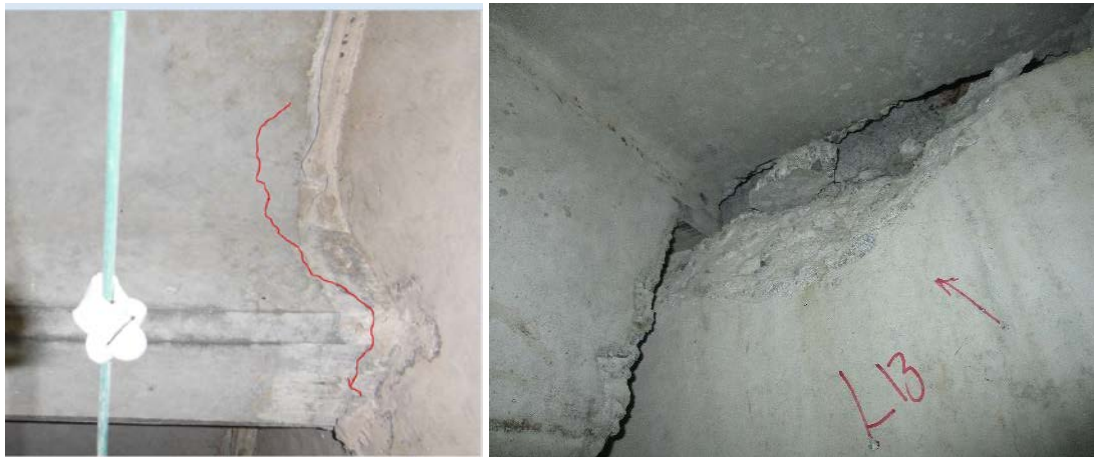
The beam hinging and frame dilation in the five TDE buildings with double tees was significantly less than that measured in Statistics House. Only minor spalling of ledges occurs, with no significant risk of loss of seating (see Figure 21b).

(a) Cracking of embedded tee rib
(crack drawn for clarity)

(b) Spalling of support ledge

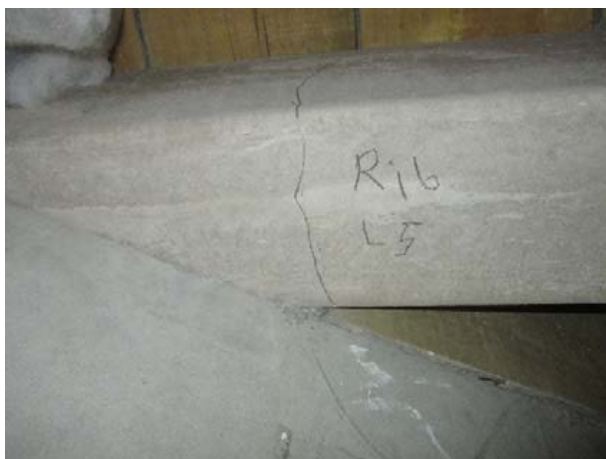
In general, the damage to buildings with rib and timber floors was less severe with only a few cases of damaged floors discovered. Of the 12 TDE buildings with rib and timber infill floors, only 4 were found to have critical damage states. Damage to precast ribs was discovered in two buildings. This damage consisted of transverse cracking through the ribs close to the support (see example in Figure 22). In one building this was an isolated case with just a single unit damaged, whereas in the other the damage occurred to multiple units in several floor levels. Transverse cracking in ribs typically results from the end of the rib being trapped in the support beam, causing flexural damage in the ribs when the building deforms. This transverse cracking can result in similar failure modes to hollowcore units, due to the lack of development of prestress at the cracked section close to the end of the rib. However, the cracks observed were almost all vertical and did not pose an immediate collapse risk. No cases of significant damage or spalling were observed at rib supports.

Figure 22: Transverse crack at end of rib (crack drawn for clarity)

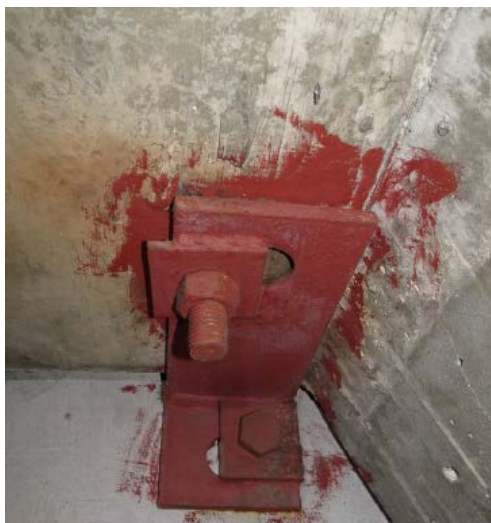
Figure 23: Precast cladding panel connection with limited movement capacity

Where these issues were identified, the engineers have recommended to owners that these connections should be reviewed and remediated where found necessary, and these recommendations should be actively followed up on by the owners.

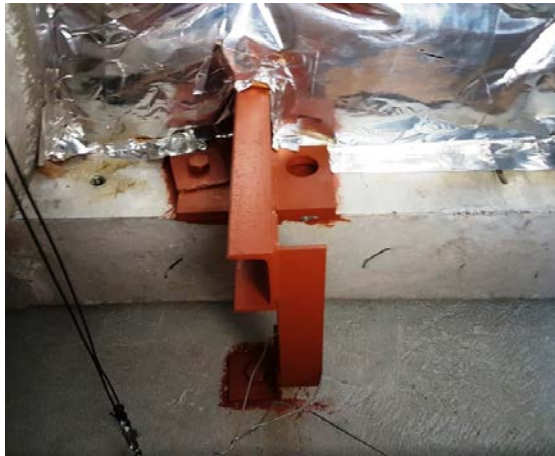
There were also some reports of loose bolt fixings to panels and bolts not being installed (refer Figure 24).

Figure 24: Precast cladding panel connection with fixing bolt not installed
