Final report RO-2016-101: Signal passed at danger leading to near collision,  
Wellington Railway Station, 28 May 2016

Rail inquiry RO-2016-101  
Signal passed at danger leading to near  
collision

Wellington Railway Station

28 May 2016

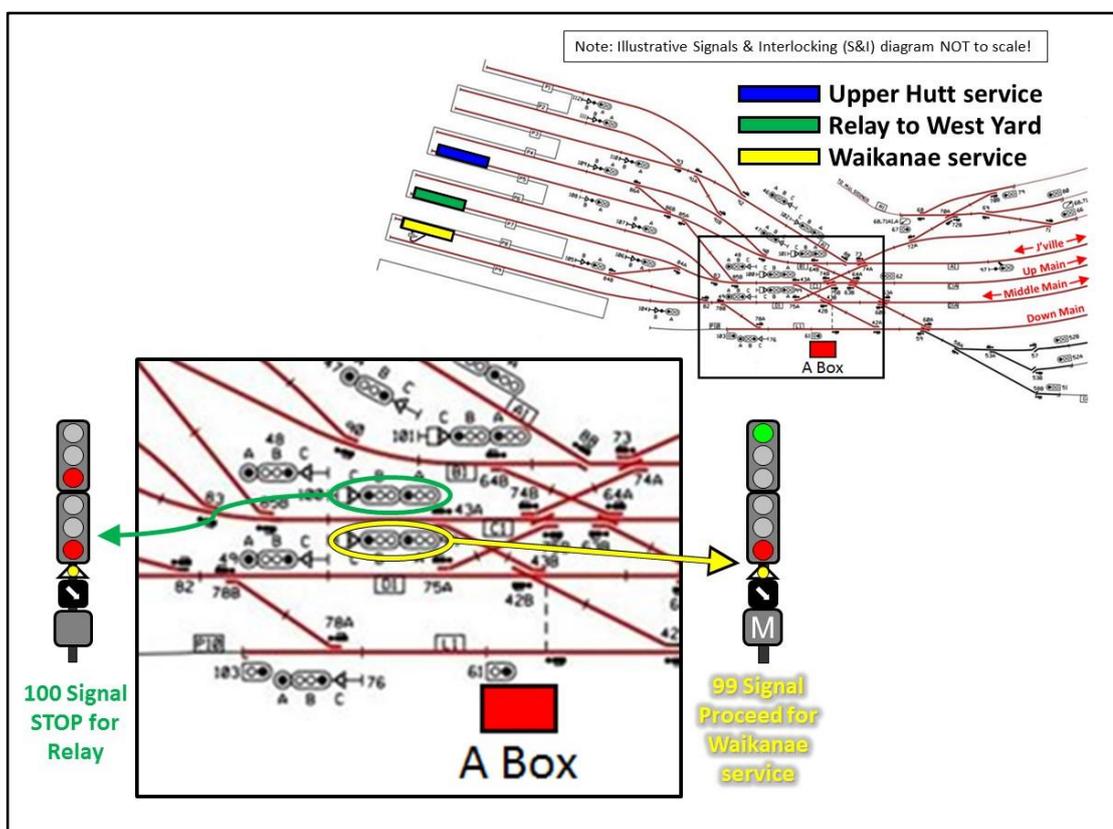
Figure 3  
Signal set-up for signals 99 and 100 that the relay driver saw  
(for full image of signal set-up for all three trains see Appendix 1)

- 3.2.3. The signaller had pre-set the signals for all three trains departing Wellington. For the Upper Hutt service from Platform 5 all signals were set to 'Green - Proceed' to the Up Main. The Relay was signalled to leave Platform 7 with a 'Yellow - Caution-to-Stop' signal while the next signal (100) was set to 'All Red - Stop'. The Waikanae service was held on Platform 8 by an 'All Red - Stop' signal, but the next signal (99) was pre-set to 'Green - Proceed' with its route indicator displaying 'M' for the Middle Main (see Figure 3).

- 3.2.4. The relay departed from Platform 7 authorised by the signal displaying a 'Yellow over Red - Caution-to-Stop' indication. This meant the next signal at that time was set at 'All Red - Stop'.
- 3.2.5. Within seconds of the relay departing the platform, the passenger service destined for Upper Hutt departed Platform 5 with 79 passengers on board.
- 3.2.6. At 0007, the relay approached signal 100 on the left-hand side of the track, which was still displaying an 'All Red - Stop' indication. However, signal 99 on the right-hand side of the track was displaying a 'Green - Proceed' indication. Although it had a route indicator displaying an 'M' for the Middle Main, the relay driver mistook the signal on his right to be for his relay and

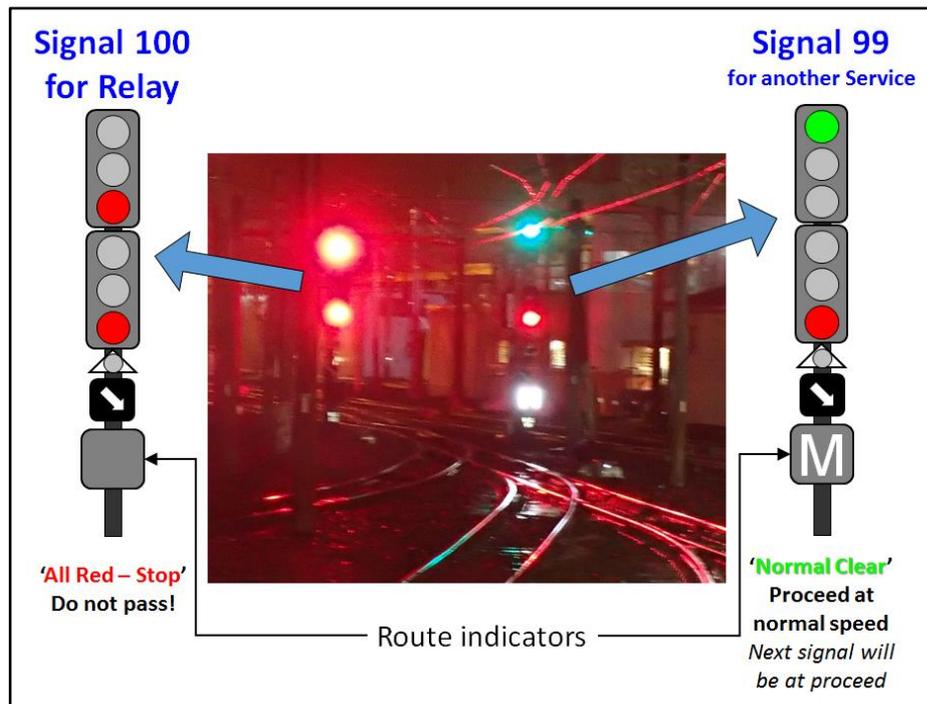
Figure 4  
Signal 100 (left) and 99 (right) as seen by the relay driver

did not stop his train, passing signal 100 at 'All Red – Stop' (see Figure 4). Passing a signal displaying this indication is classed as a SPAD A<sup>6</sup> (signal passed at danger category A).

- 3.2.7. The relay driver realised his mistake as he drew level with the 'Stop' signal and applied the train brakes, bringing the relay movement to a full stop 30 metres (m) beyond the signal.
- 3.2.8. Simultaneously, the signaller noticed that the relay train had passed the signal at 'Stop' and waved vigorously out of the window in an attempt to get the relay movement to stop.
- 3.2.9. The Upper Hutt service crossed through the set of points directly in front of the relay train 13 seconds after it had stopped. (see Figure 5)
- 3.2.10. The distance between the relay train and the passing Upper Hutt service was 12 m.
- 3.2.11. The incident was reported to Train Control and the driver was relieved of the relay train and taken for drug and alcohol testing.

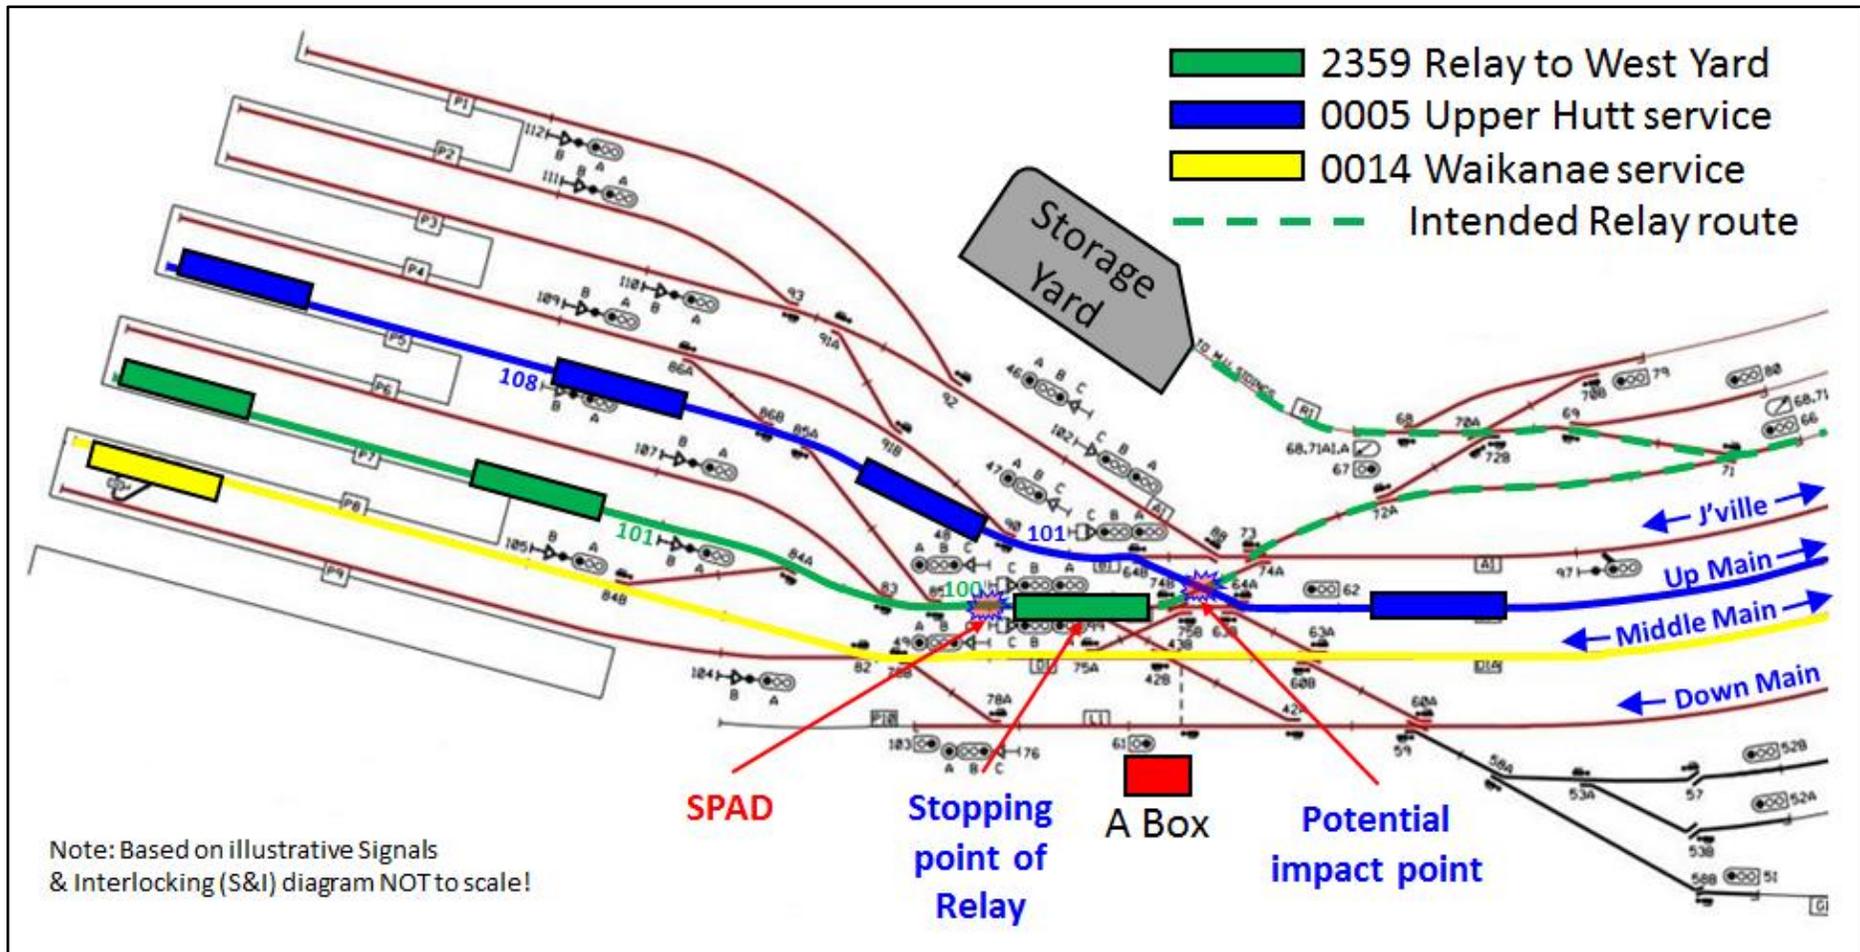
Figure 5  
Schematic of train movements

- 4.2.6. The driver quickly realised his error and stopped his train 12 m short of the cross-over points, thereby narrowly averting a collision with the Upper Hutt train, which passed through the cross-over 13 seconds later.

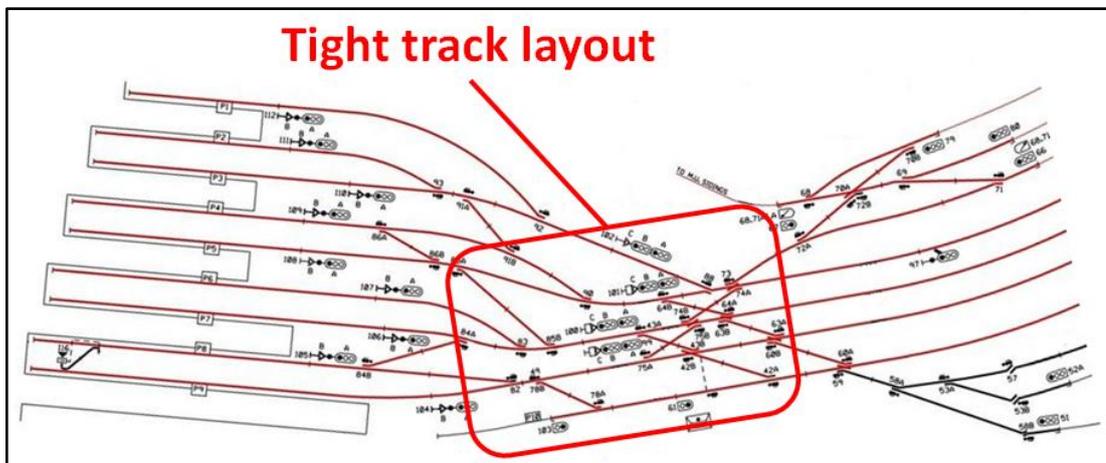
Figure 6  
Congested track area north of Wellington Station

- 3.4.1. The signals between Wellington Station through to Ngāuranga are manually controlled from the Wellington Signalbox known locally as A Box.
- 3.4.2. Part of the track layout just north of Wellington Station is congested due to a lack of available land (see Figure 6), There are multiple sets of points and possible direction or track changes available over a short distance.

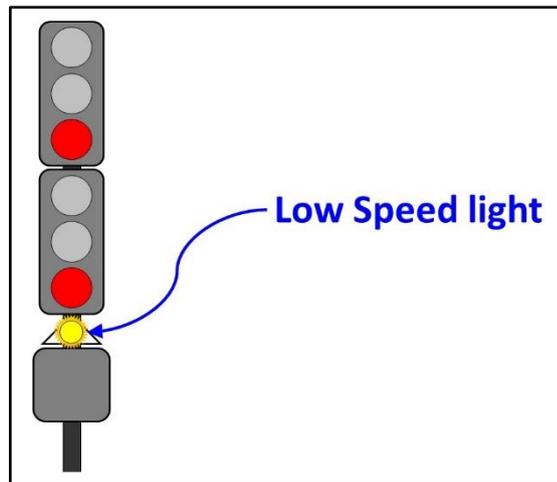
Figure 10  
A low speed light below two Red lights

4.2.5. Additionally, the signal required to get from the platform to the storage yard would be a 'Red over Red light with a Low Speed Yellow light', so the driver should not have taken a 'Green Proceed' indication on either signal (see Figure 10).

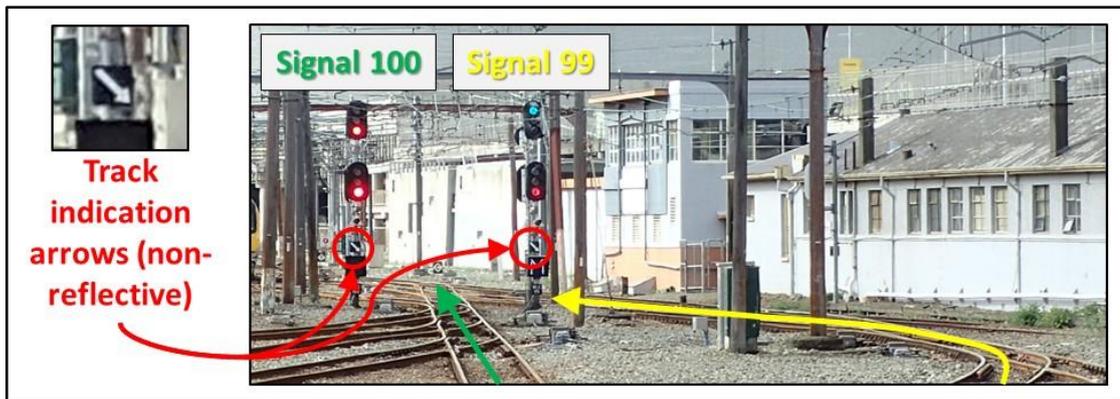
Figure 12  
Track indication arrows

- 4.4.13. The potential for a driver to confuse signals 99 and 100 was partially addressed in 2005 by the addition of non-reflective arrows on the signal poles, pointing to the respective track the signal is controlling (see Figure 12). The arrows are effective during daylight hours, but they are not illuminated or reflective and are difficult to see at night.

- 4.4.14. In Figure 12, signal 100 controls the track depicted by the green arrow, which is the track the relay train was travelling on. Signal 99 controls the track to the right depicted by the yellow arrow, which was the track the Waikanae bound train was scheduled to travel on.

- 4.4.15. Illuminating the arrows may have assisted the relay train driver in recognising which of the two signals applied to his train. The Commission has recommended that the Chief Executive of KiwiRail conduct a review of current arrangements and take any opportunities they can to reduce the risk of unsafe train operations in the area.

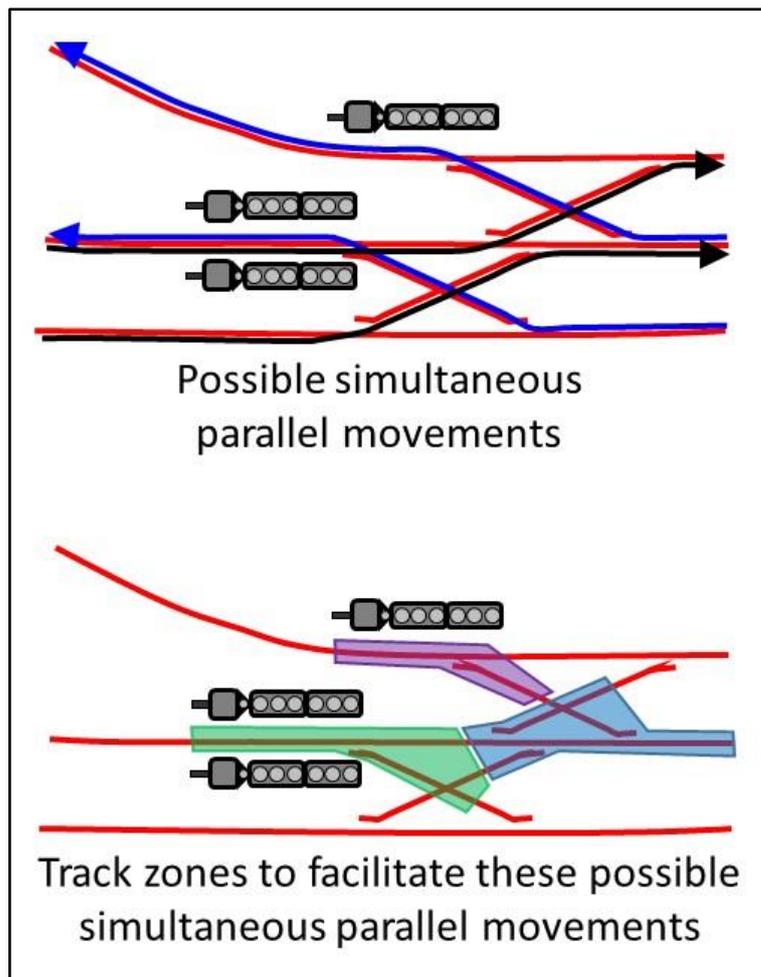
Figure 13  
Possible parallel movements and associated track zones

- 4.4.18. To allow simultaneous parallel train movements through adjacent sets of point on adjacent lines with the relatively simple electro-mechanical logic system in the existing Wellington Signalbox, sections of track have been linked to form zones (see Figure 13). This limits the sensitivity of the system and was the reason why the insulated joint was not located immediately adjacent to signal 100.

4.4.19. This meant that the signal for the Upper Hutt service, displaying a 'Green - Proceed' indication, did not revert to 'All Red - Stop' despite the incursion of the relay movement towards the same convergence of points. It is debatable whether the Upper Hutt service would have had time to stop before colliding with the relay train if the relay had continued into the conflict area. However, had the signals for the Upper Hutt bound train reverted to Red as soon as the relay train passed the Red signal 100, the driver of the Upper Hutt bound train would have had more opportunity to slow his train before both trains reached the convergence points.

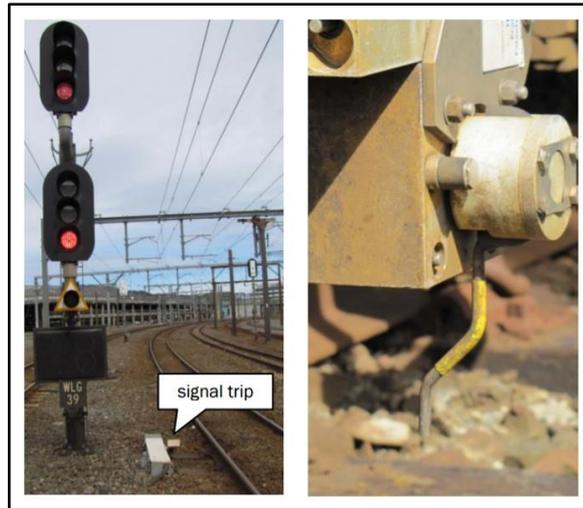
**Figure 14**  
A signal trip installed at Signal 39 (left) and the brake trip lever on a Matangi train (right)

4.4.20. A number of key signals in the Wellington Station area are fitted with signal trips<sup>12</sup> (see Figure 14). However, there are no automatic signal trips fitted to signals 99, 100 or 101, which would automatically engage the train brakes in the event of a SPAD. The reason given for signal trips not being fitted to these signals is that the signals are too close to the conflict zone for a train to stop before it occupies the points area. However, in this case the driver was able to stop his train just short of the conflict zone and avoid a potential collision. There may therefore be some safety benefit from having such devices installed in some cases.
