FIRE INVESTIGATION REPORT

87-93 Wellesley Street West, Auckland Central, Auckland

F2866954

High Value Loss

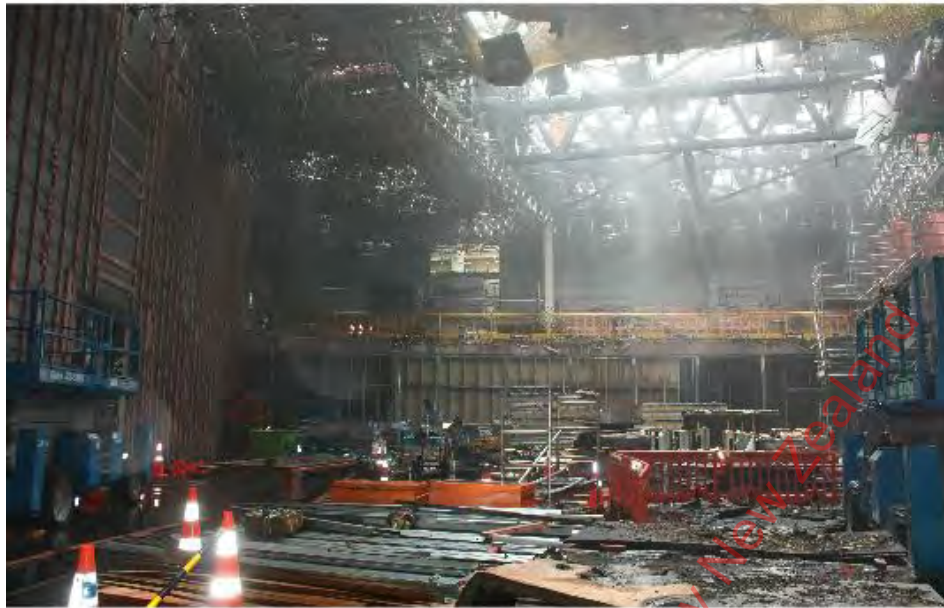
Photo 3: View of Level 5 atrium from the south side looking north.

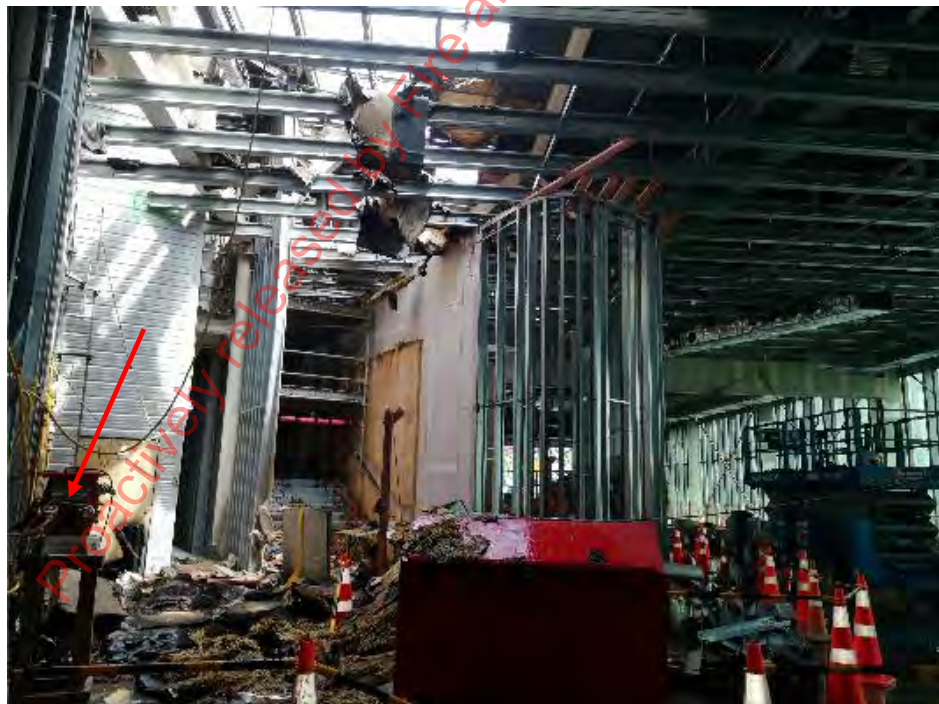
Examination of western side of Level 5 showed considerable fire damage in the ceiling and some fire damage from drop down⁹ burning as evidenced in Photo 4 below. The lack of combustible items in this area contributed to the limited fire development observed.

Photo 4: Western side of Level 5 showing limited fire damage at floor level other than from burning items dropping down. Largely unburnt remains of Durra Panels® can be seen amongst the floor debris. An electrical distribution box is visible to the left of the photo (red arrow).

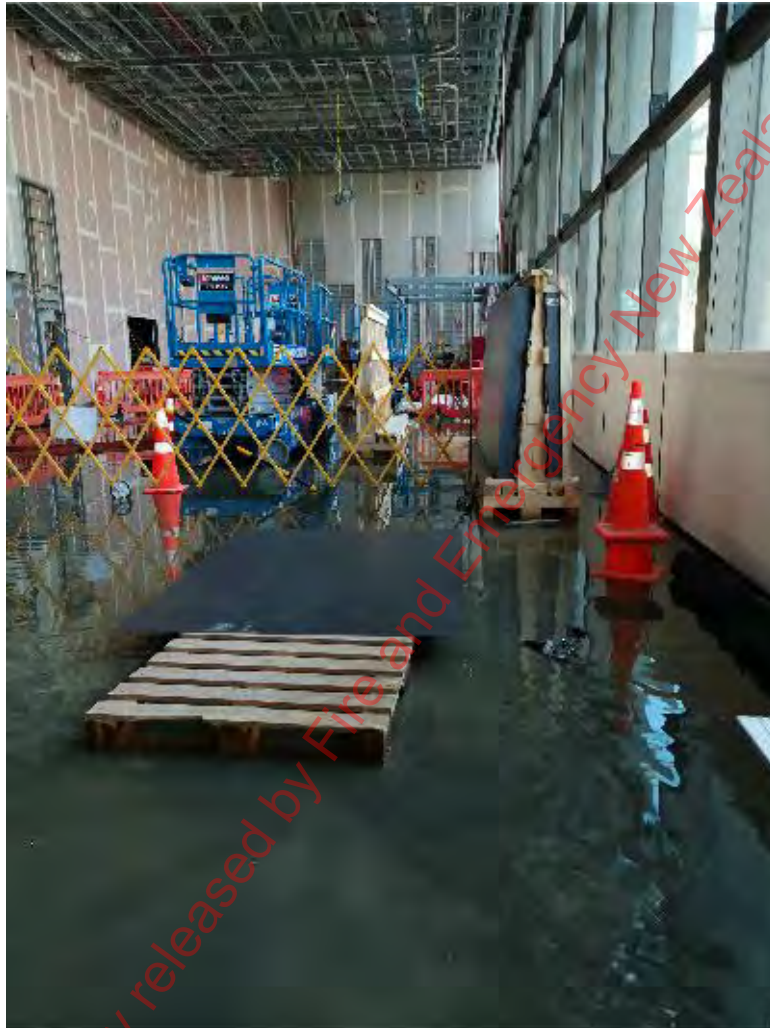
Damage to the southern and eastern sides of Level 5 appeared largely confined to occasional burning debris dropping down from the ceiling and roof above as well as firefighting water.

Photo 5: Level 5 south side with no visible fire damage.

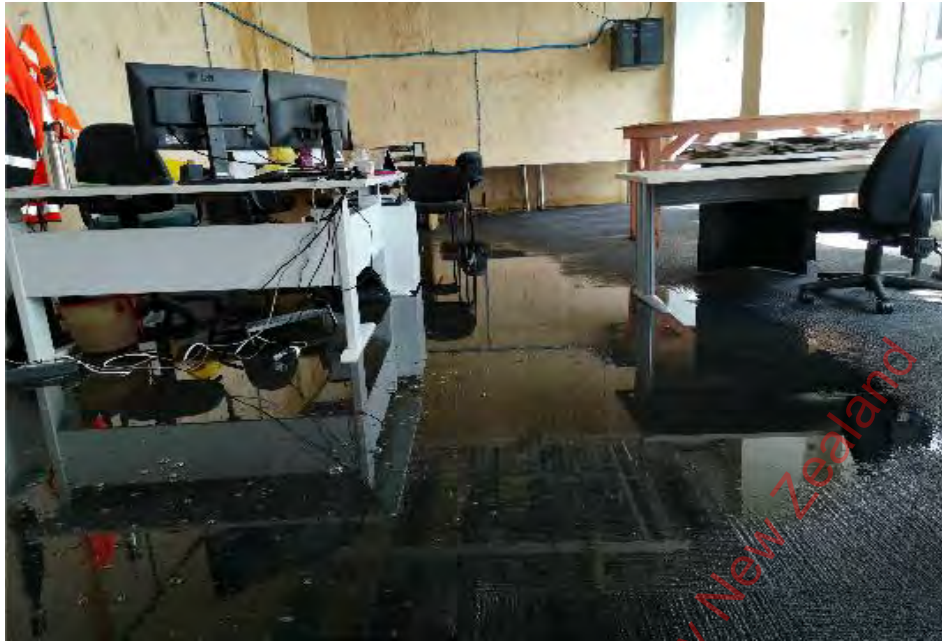
Level 4 and lower floors were examined to ascertain the extent of fire spread in the building. No thermal damage or fire products were observed to have penetrated the Level 5 floor and only firefighting water reached levels below Level 5.

Photo 6: Level 4 showing water damage.

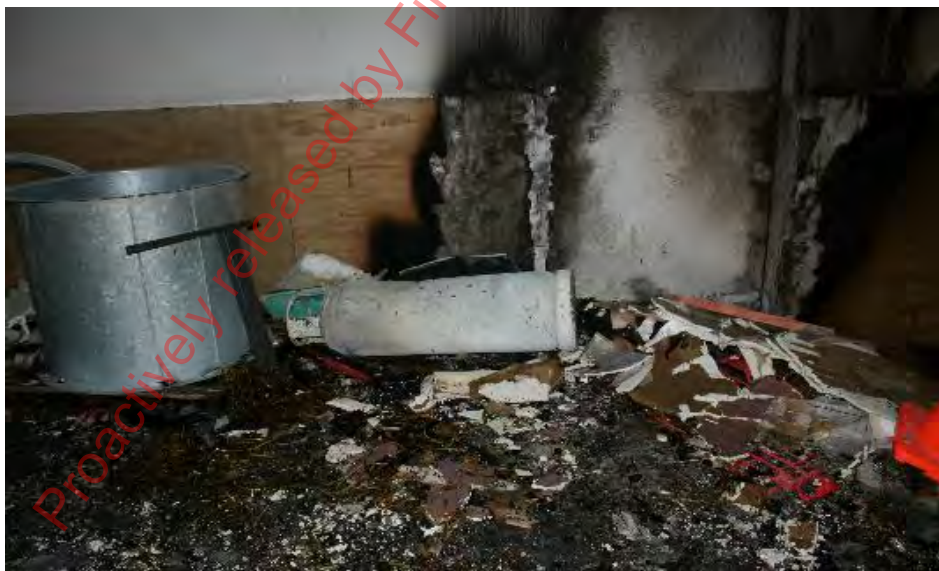
There were some mezzanine floors above Level 5 which had sustained considerable fire damage. Examination of the damage showed it was largely attributable to drop down from above introducing burning within the rooms or from fire gases penetrating through incomplete fire separations¹⁰ and igniting combustibles. A gas cylinder was located in 1 room with visible impact damage on the side of the gas cylinder. This cylinder appears to have vented directing an ignited gas jet against the adjacent wall.

Photo 7: A gas cylinder which has fallen in a mezzanine floor with visible denting on the top side. Venting gas has ignited creating a clearly visible burn pattern on the rear wall.

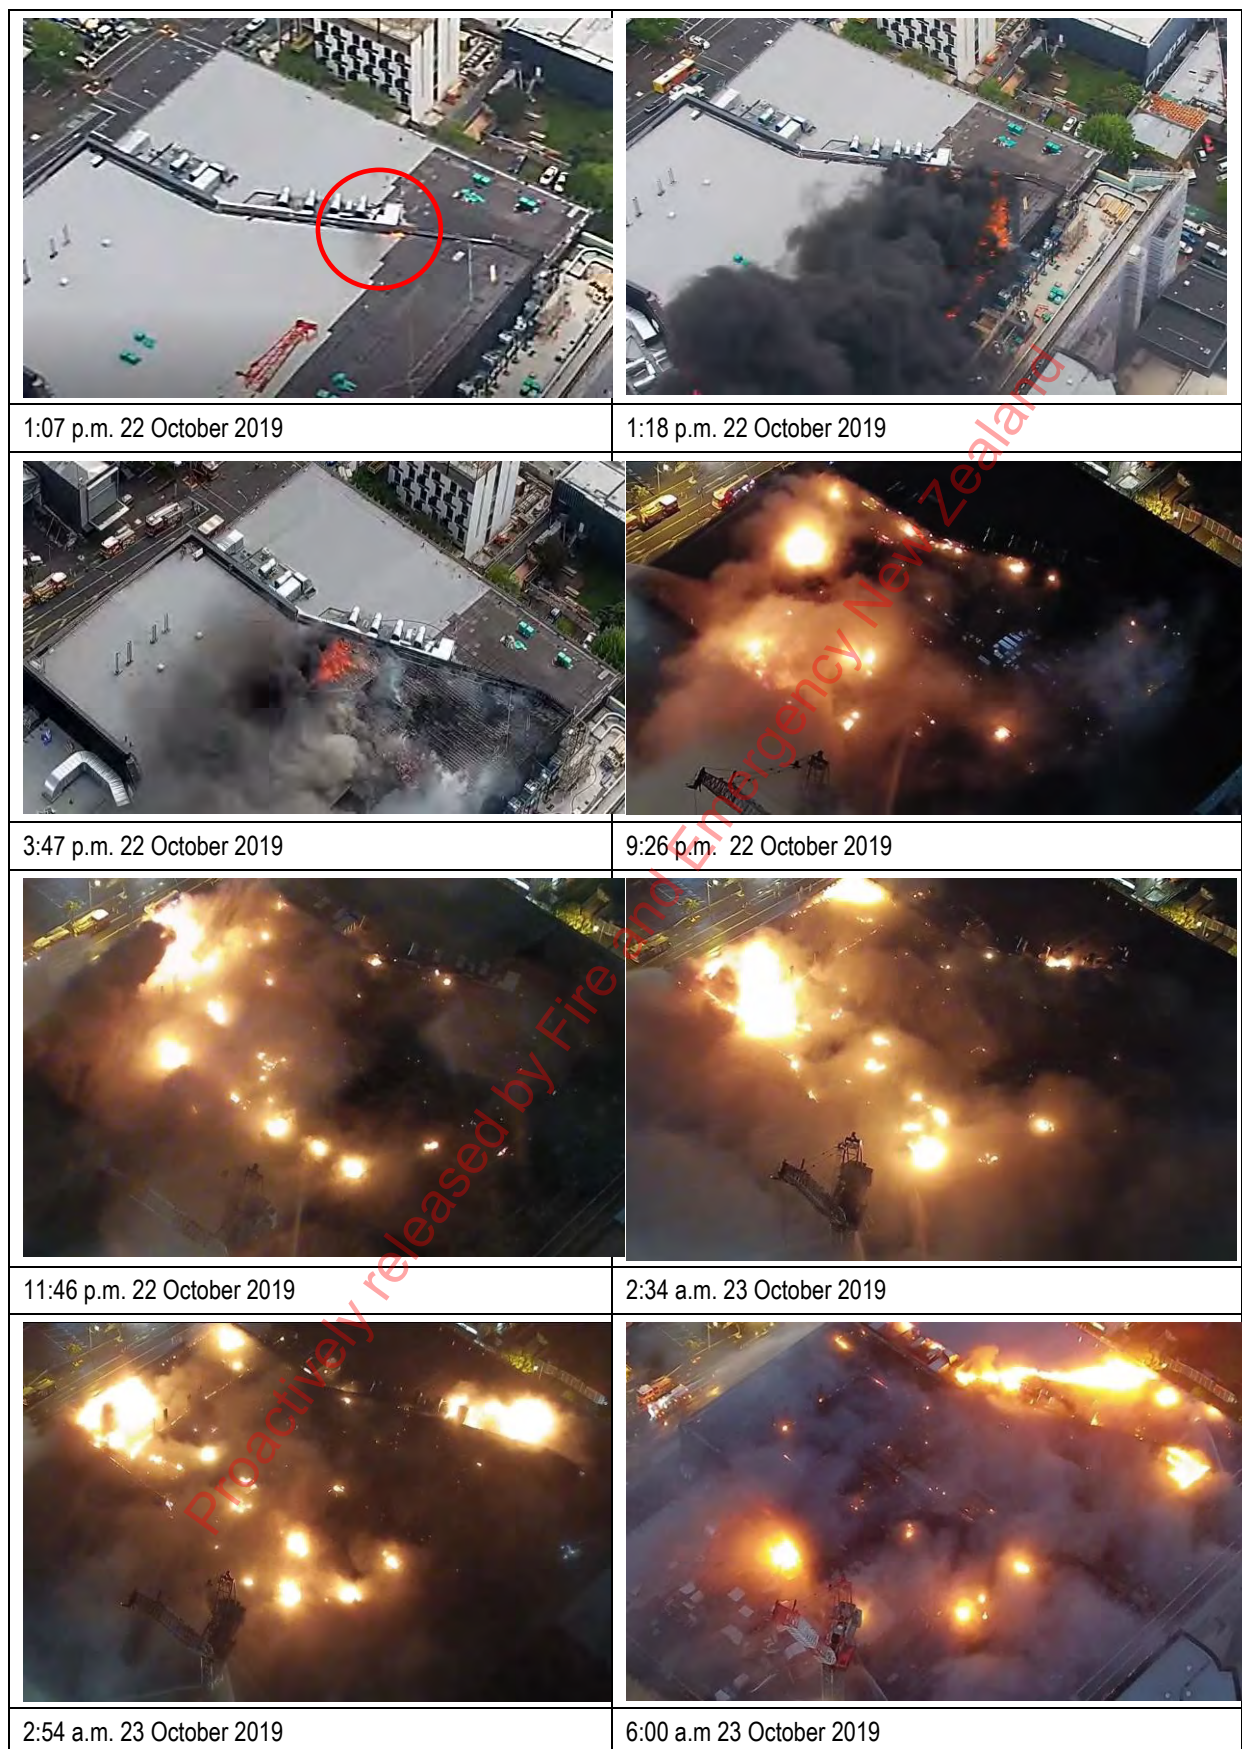
Study of continuous video from the time of discovery of the fire showed gradual progression of the fire towards the south face along the western guttering of Level 7. By 9:26 p.m. on 22 October 2019 fire had reached the southern face closest to Wellesley Street. At 11:46 p.m. on 22 October 2019 the first signs of fire breaking out on the western side of the building on Level 6 were visible, most likely a result of burning materials dropping down from Level 7 and heat transferring through openings in the wall. This wall was constructed of Speed Wall, a non-combustible product with a metal exterior filled and a concrete like centre. Openings in the wall for doorways, air conditioning and other services permitted fire transfer to other parts of the building, notably the plant room.

Photo 9: Progression of fire development. Images taken from video provided by Auckland Transport Operations Centre (ATOC).

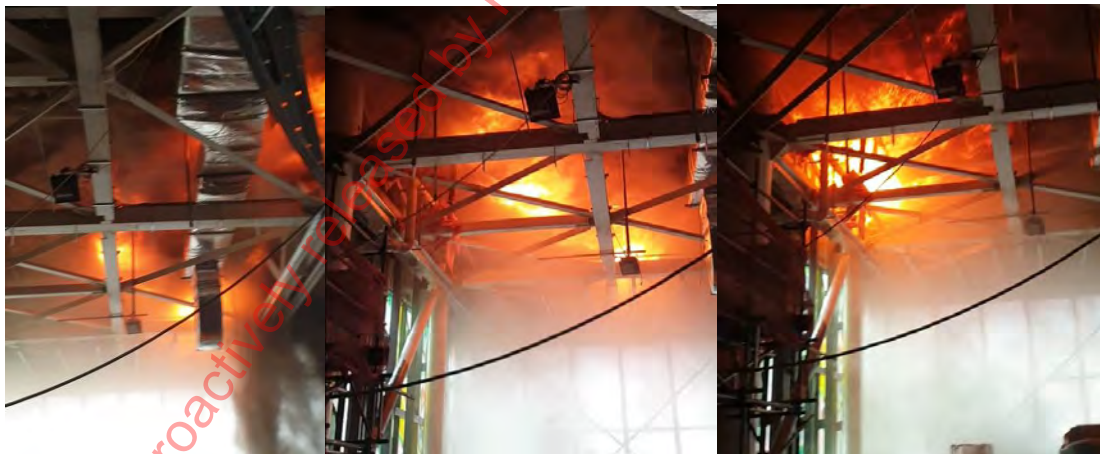
Through the examination of Level 5 and Level 6, the burn patterns and the video footage of fire development enabled the investigation team to conclusively ascertain that the fire originated above those levels. The fire travelled to those levels progressively spreading primarily through drop down in cavities and from ceilings, venting gas cylinders and flameover¹². Witness information, photographs and video footage captured during the fire provided examples of each of these mechanisms of fire spread.

Photo 10: Shows ignition of smoke tracking across the ceiling within a period of 4 s and igniting combustibles several metres away adding to fire spread.

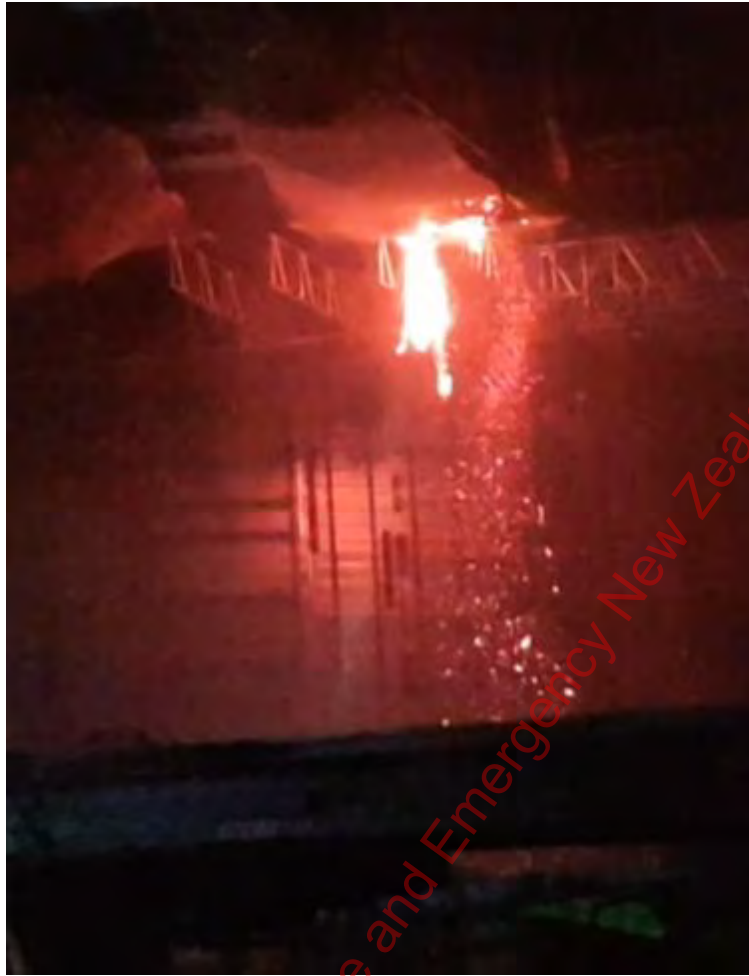
Photo 11: Burning elements within the ceiling construction collapsing on Day 2 providing a mechanism of fire spread to combustibles below.

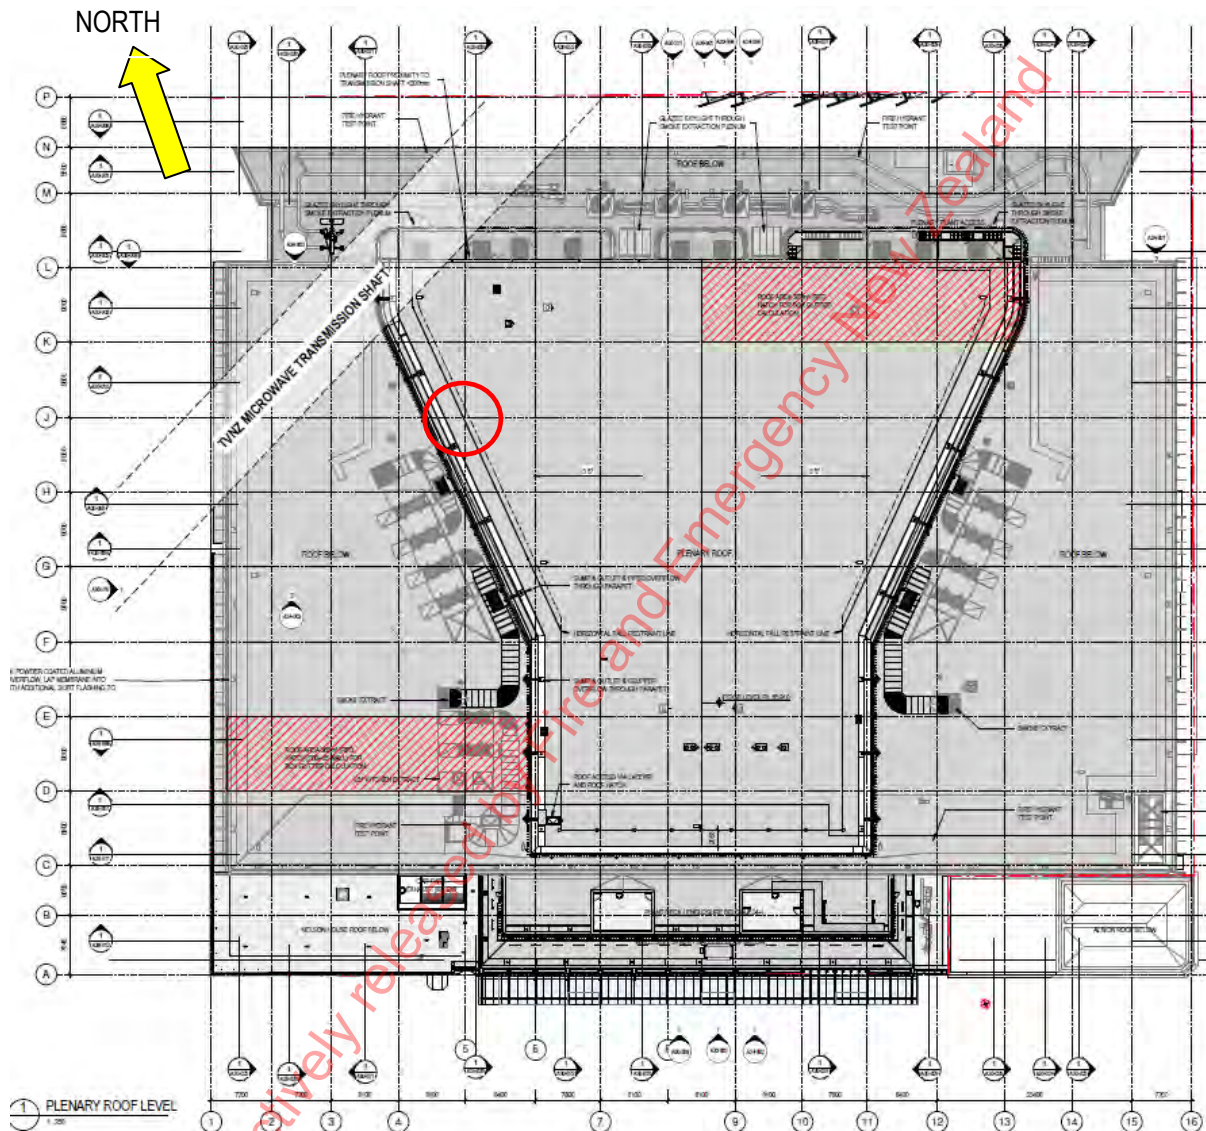
Video footage of the NZICC viewed from the Sky Tower showed the first wafts of visible white smoke appearing near the western edge of Level 7 roof (Grid J- 5) at about 1:03.38 p.m. on 22 October 2019 with intermittent flame visible less than 1 minute later.

Image 3: Approximate location of first visible smoke and flame (red circle).

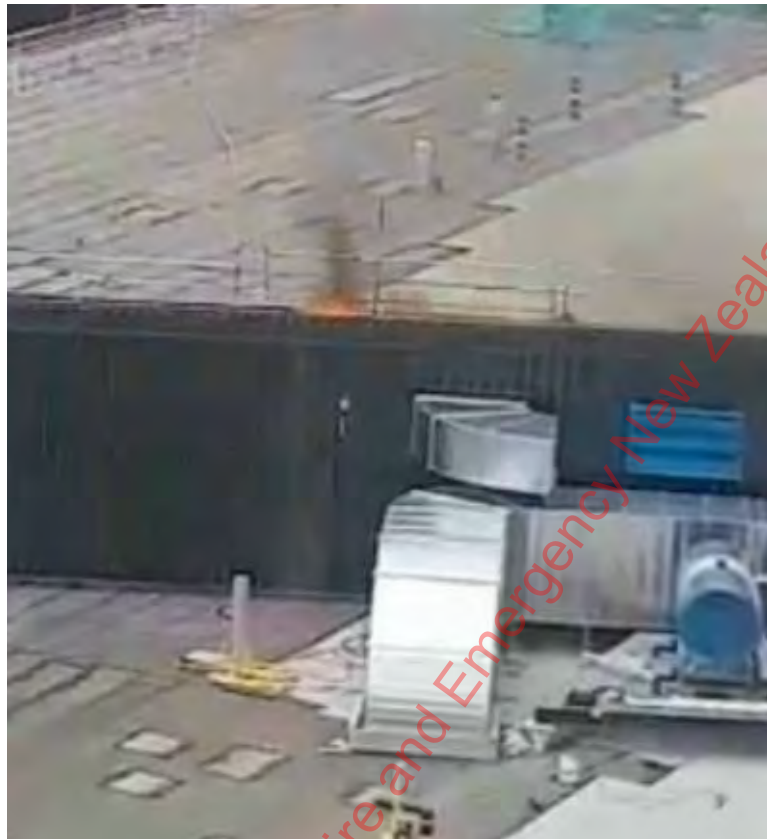
buffeting the flame and smoke, momentary lapses in gusts showed the location of the source of flame to be in the area of the guttering approximately 1-2 m to the left of the large air ducting penetrating the Level 7 western wall.

Photo 12: During a lull in wind gusts (indicated by the vertical smoke position) the flame was clearly visible from the crane located to the west at the Sudima hotel construction site. Photo from witness.

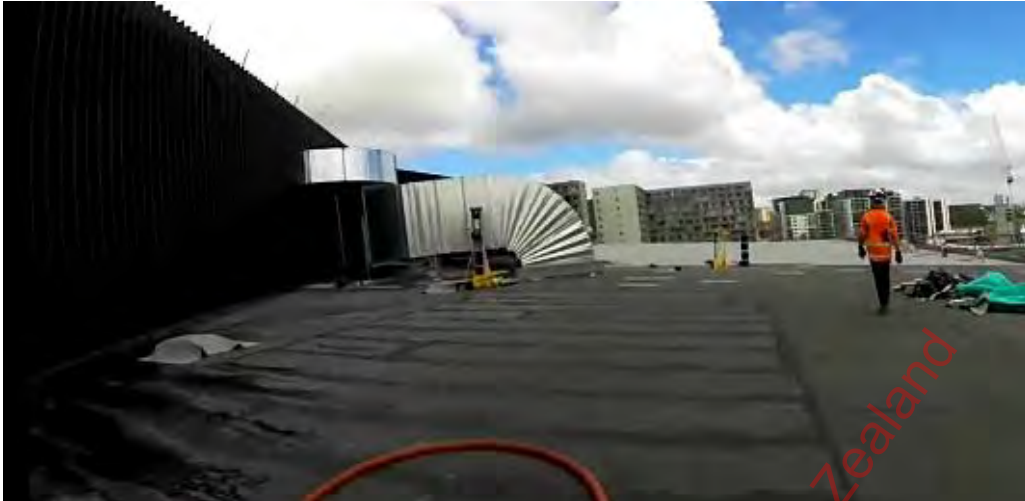
Examination of the Level 6 roof area immediately below where the flame was first observed showed the absence of any fuel packages¹⁴ that could have provided sufficient heat to transfer fire to the height of the Level 7 roof. A fire involving the membrane of Level 6 was ruled out as an initial fuel first ignited¹⁵ due to the absence of smoke or flame that would have been produced from a fire with sufficient thermal energy to transfer fire to the Level 7 roof, some 6 m above it. Video of this area, Photo 13, at 2:23 p.m. on 22 October 2019, 1 hour and 20 minutes after the fire started showed no visible sign of fire at this level.

Photo 13: Western side of Level 6 showing no signs of fire 1 hour and 20 minutes after the fire was first observed on Level 7.

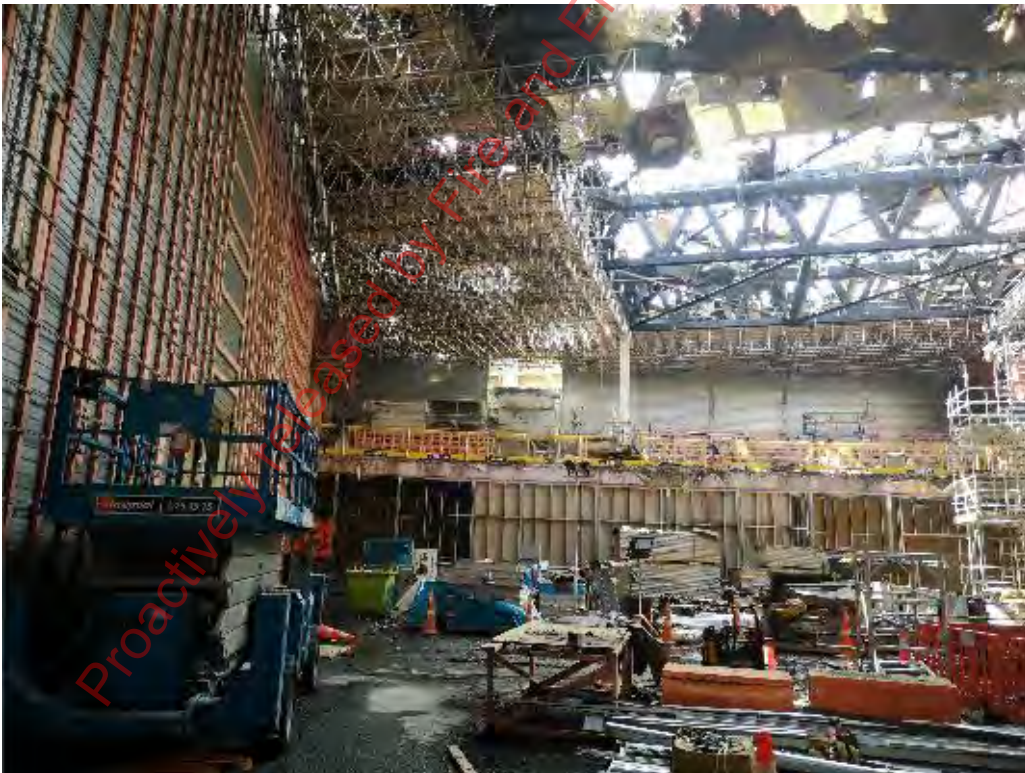
The inside of the Level 7 western wall descended from the Level 7 roof to the atrium floor of Level 5. This area was examined from Level 5 for indications of fire damage and potential for a fire start. Apart from some remote damage caused by drop down, the wall and the immediate adjacent areas were largely free of fire damage.

Photo 14: Level 5 western atrium wall (left) with minimal fire impact. The 'Birds Nest' scaffolding is visible top left under the ceiling.

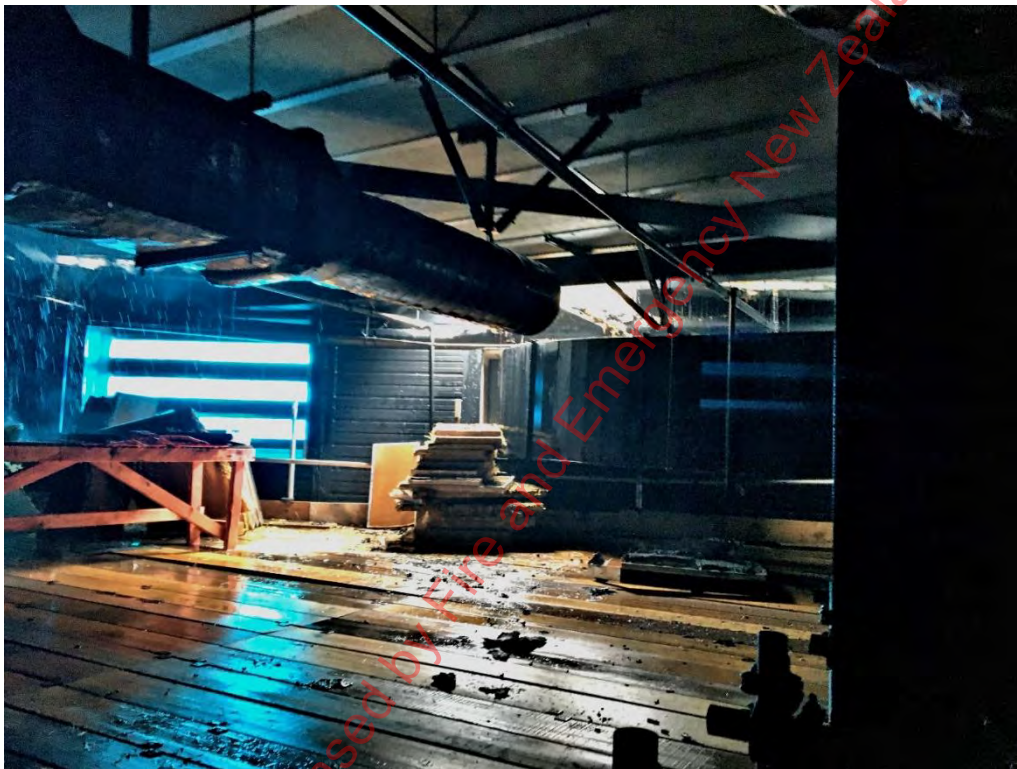
A scaffolding platform, referred to as the "Birds Nest", was suspended from the Level 7 roof structure. This was still largely intact and damage that was visible had occurred from burning debris dropping from above. A photo taken by Witness 1, who accompanied firefighters to this location, 30 minutes after

Photo 15: View across the Birds Nest taken approximately 30 minutes after the start of the fire. Visibility was clear and the only fire impact at this stage was from drop down from above. Photo provided by Fletcher Construction.

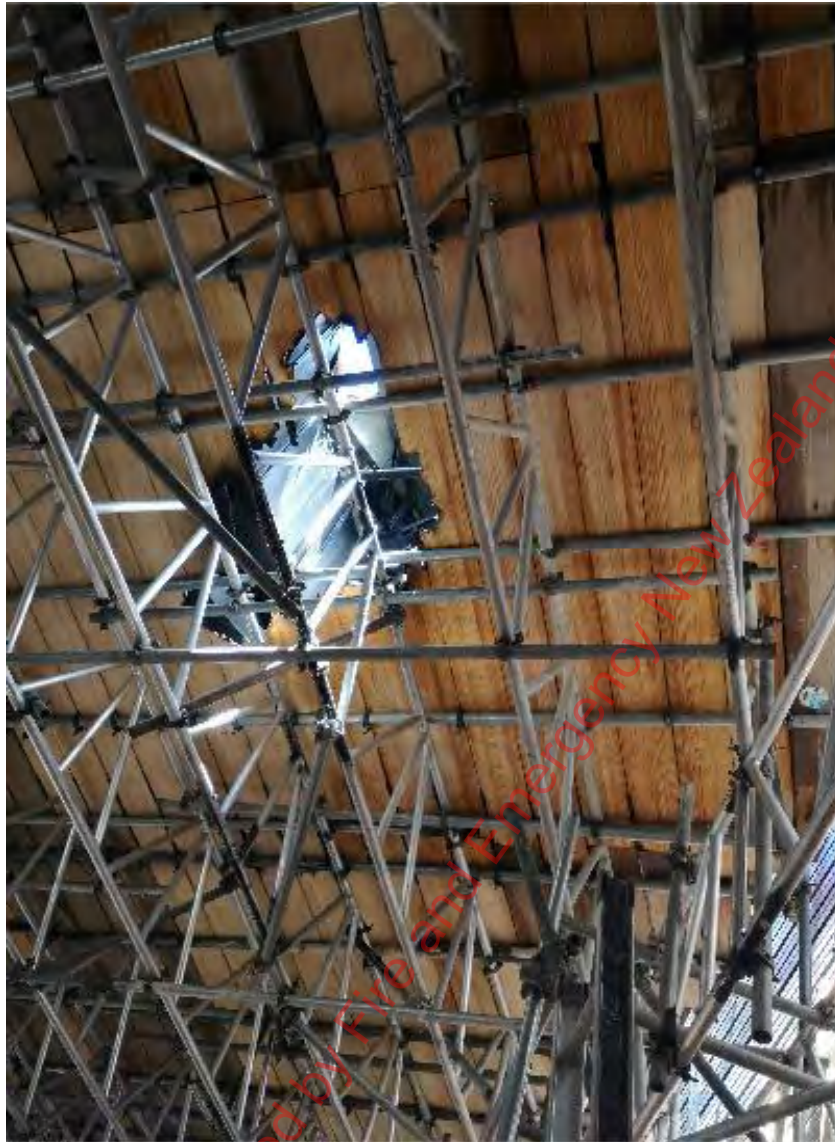
Photo 16: Burn damage to 'Birds Nest' floor caused from burning debris dropping from above the scaffolding floor.

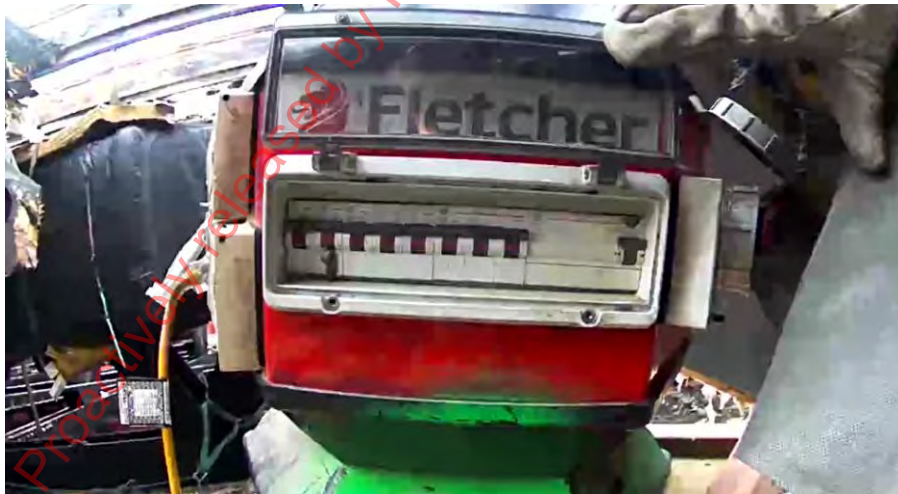
Photo 18: Power box with circuit breakers showing none had tripped.

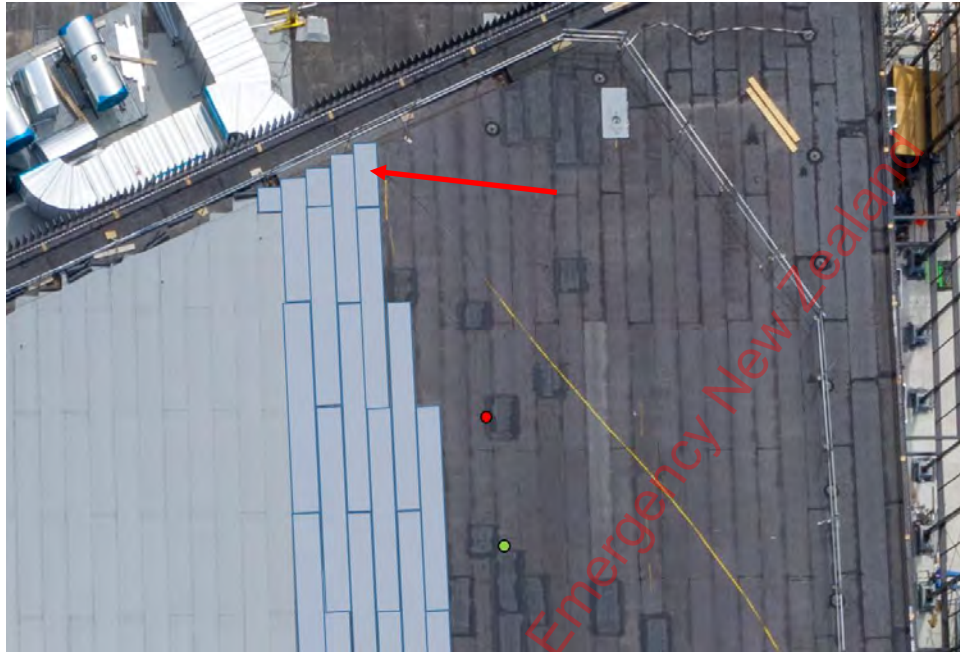
Photo 19: Shows position of the last short length of Cap Sheet laid to the gutter ~12:20 p.m. on 22 October 2019 (red arrow). Location of the 2 gas cylinders marked with red and green circles.
Photo supplied by Fletcher Construction – additions by Fire and Emergency.

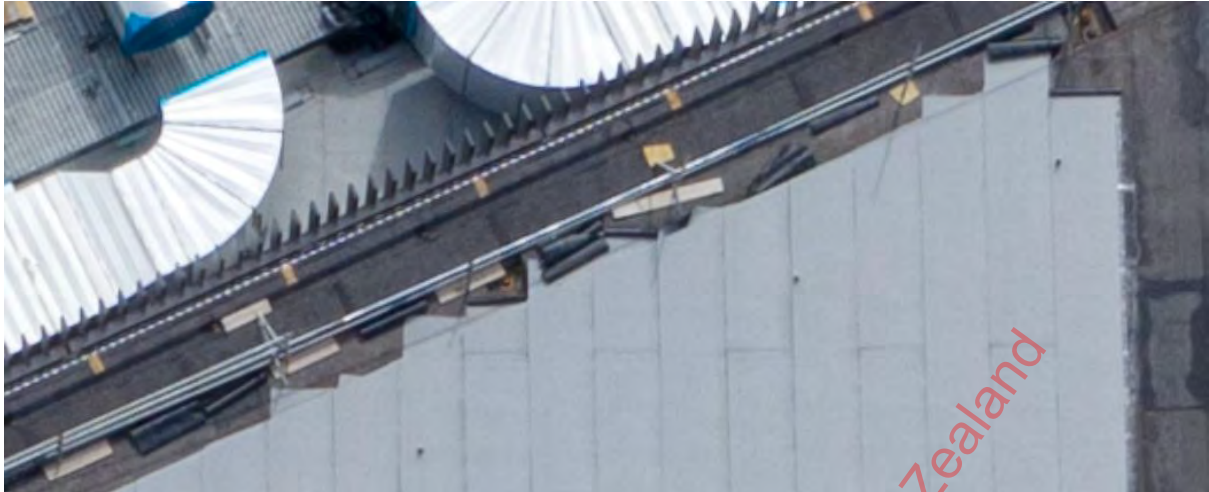
Photo 21: A photo taken 2 days before the fire shows the Cap Sheets laid to the edge of the gutter and residual rolls left lying in the gutter area. Photo supplied by Fletcher Construction.

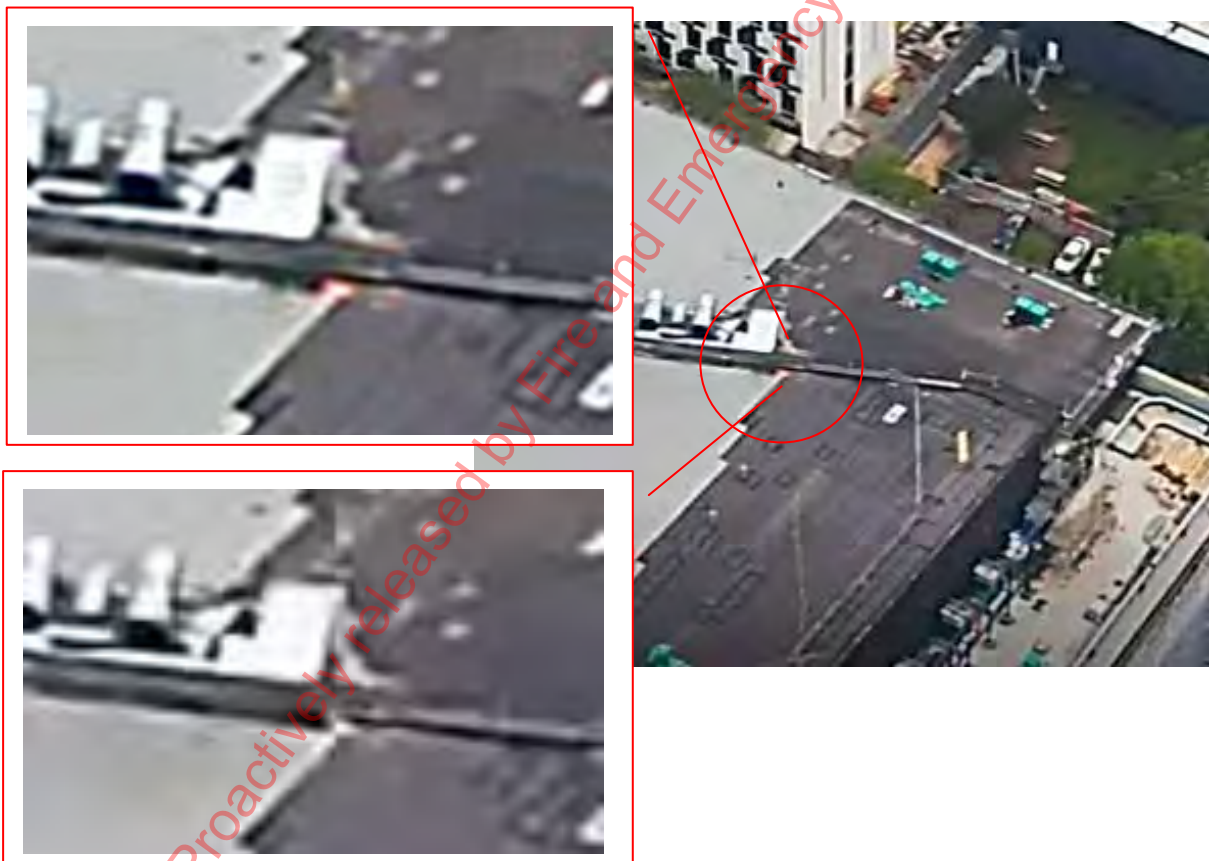
Photo 22: Left top and bottom images show early signs of the fire with a distinct gap between the flame and smoke and the parapet. The shadow of the parapet is visible behind the flame. This suggests the area of origin was in the gutter rather than the parapet area. Video images from ATOC.

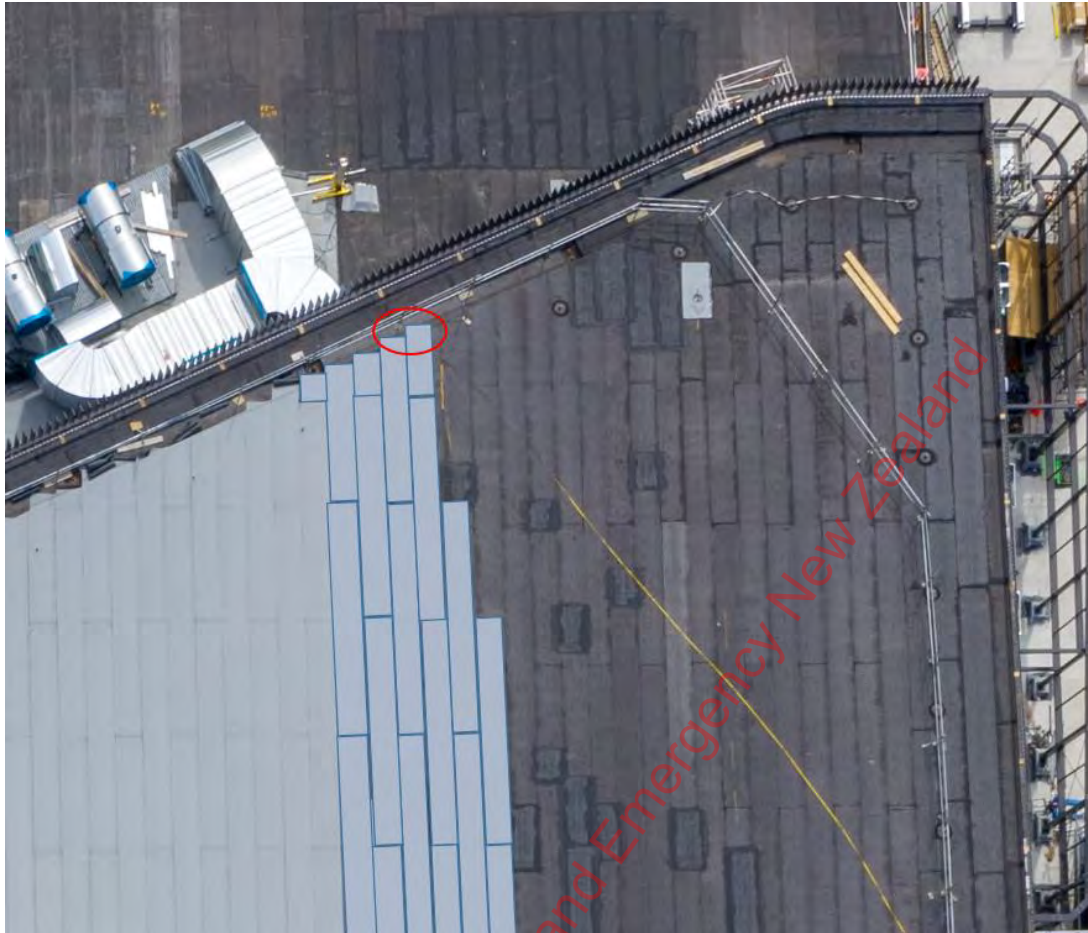
Photo 23: Showing area of origin (red circle). Photo supplied by Fletcher Construction.
Addition by Fire and Emergency.

Within the area of origin, examination of the video footage of the fire in its incipient stage, the fire patterns¹⁹ and thermal impact on the structure reveal the point of origin²⁰ as being in the gutter, about 1.8 m north of the large air conditioning ducting visible in Photo 23.

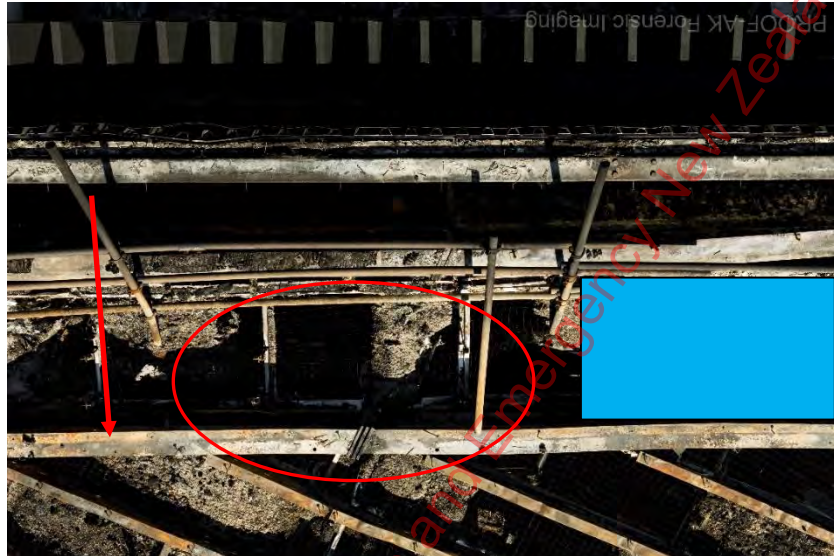
Photo 24: Photo taken from above. The red arrow points to the steel I beam that supported the eastern side of the guttering at the point of origin (red circle). The approximate position of guttering floor is indicated by blue rectangle.

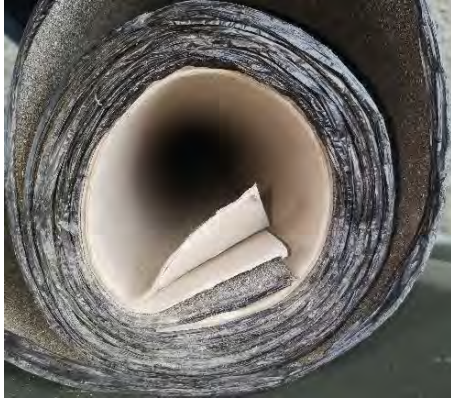
The probable cause³ of this fire is believed to be an inadvertent ignition of the cardboard centre of a roll of waterproofing membrane. The cardboard centre of the roll smouldered for a period of up to 38 minutes

Photo 26: Shows cardboard Centre inside Cap Sheet membrane roll.

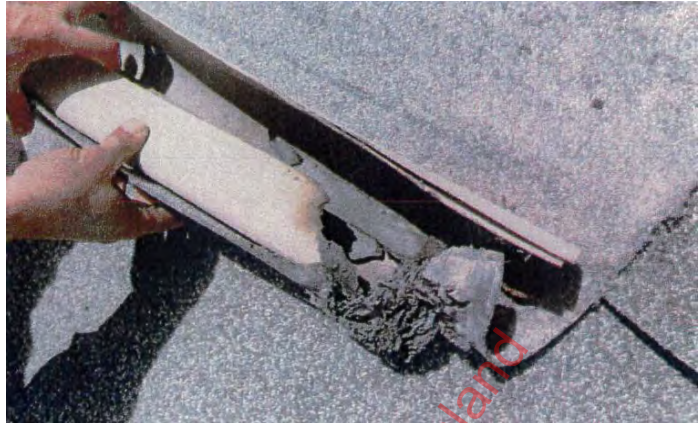
Photo 27: Shows cardboard Centre of a roll of membrane from 15 November 2019 fire reported to investigation team. Photo supplied by [REDACTED].

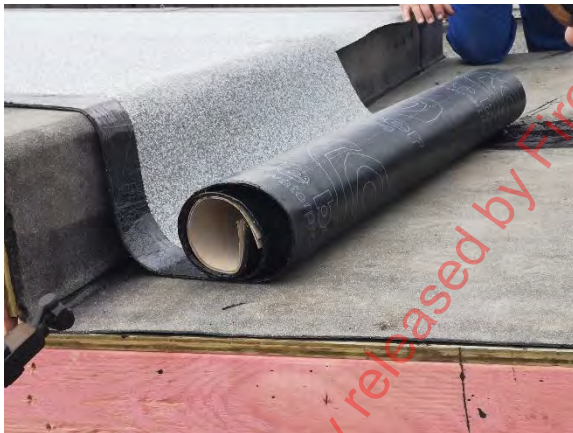
Photo 28: Cap Sheet torched on with residue roll left in gutter initially presenting little evidence of smouldering.

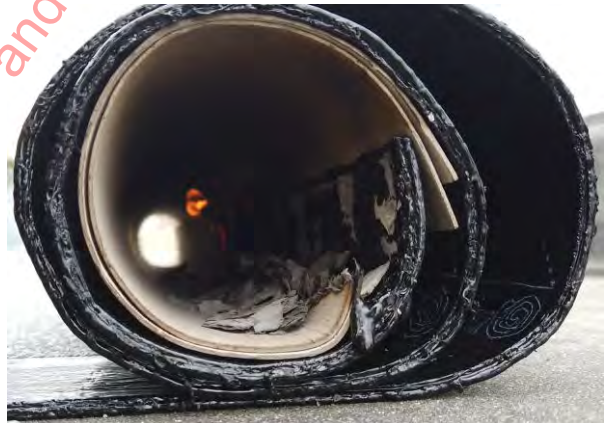
Photo 29: Gradual smouldering tracked inside the roll with occasional flickering flame returning to smouldering.

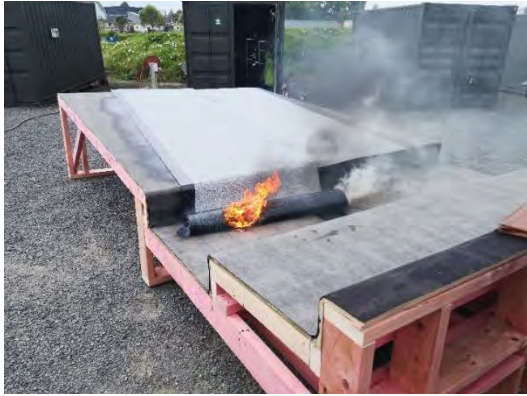
Photo 30: Flame penetrating through membrane on the roll. Notable is the white puffing smoke similar to that observed at the NZICC.

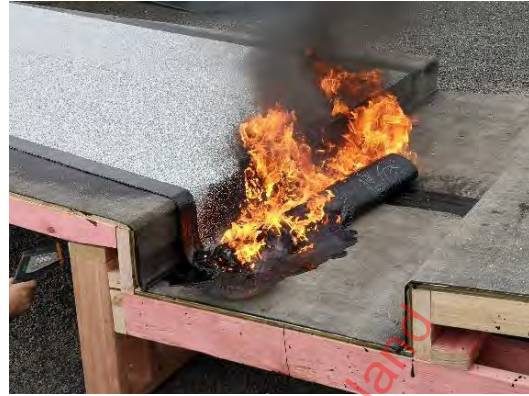
Photo 31: Fire developing beyond the roll to the vertical gutter surface and beginning to extend to the horizontally laid Cap Sheet representing the main roof surface. Smoke is becoming black.

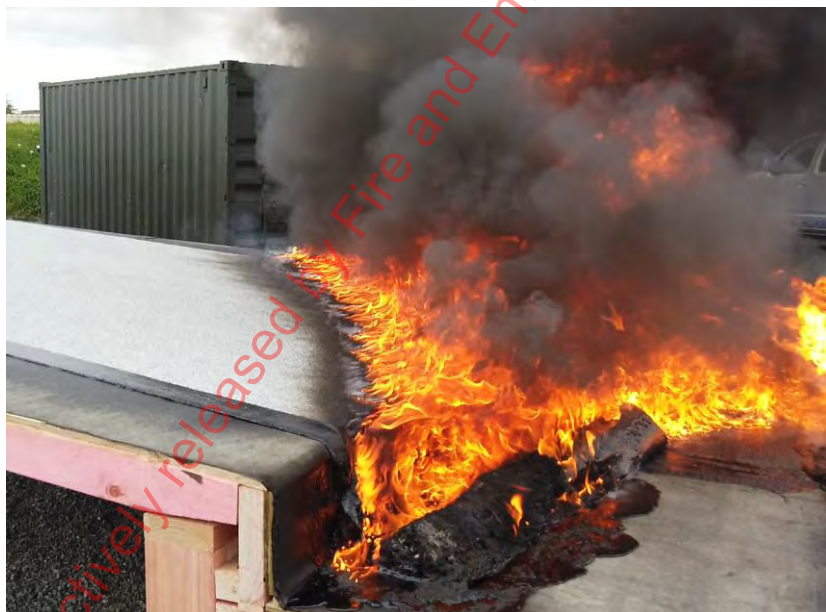
Photo 32: Fire development at 5 minutes 30 s from when only the roll was burning.

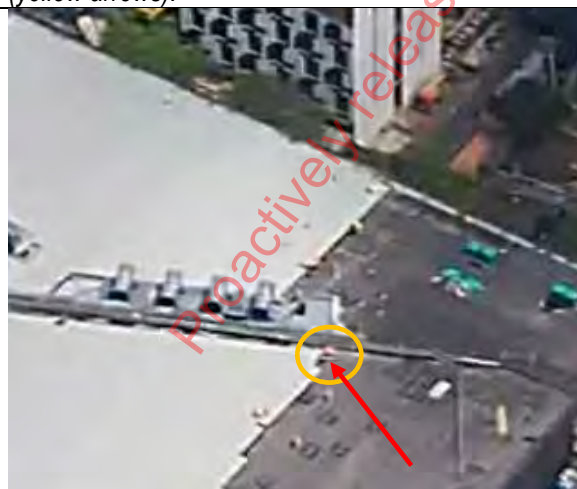
Photo 37: Roofer deposits horizontal object (red arrow), believed to be a roll of Cap Sheet.

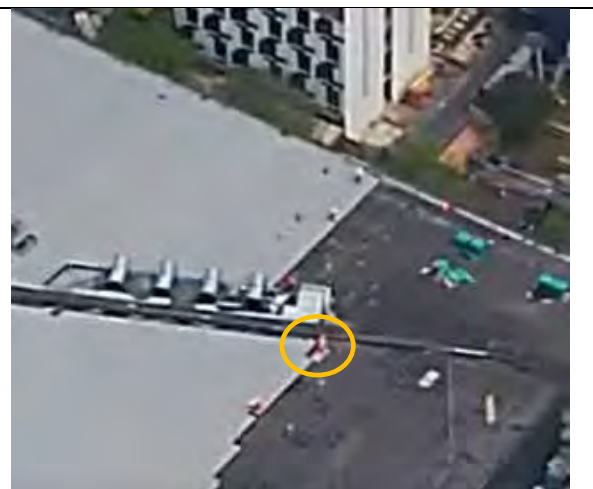
Photo 38: Roofer extends Cap Sheet to gutter while walking behind it. This would exclude the Cap Sheet being an unrolled section which could not be positioned if the worker was standing on it.

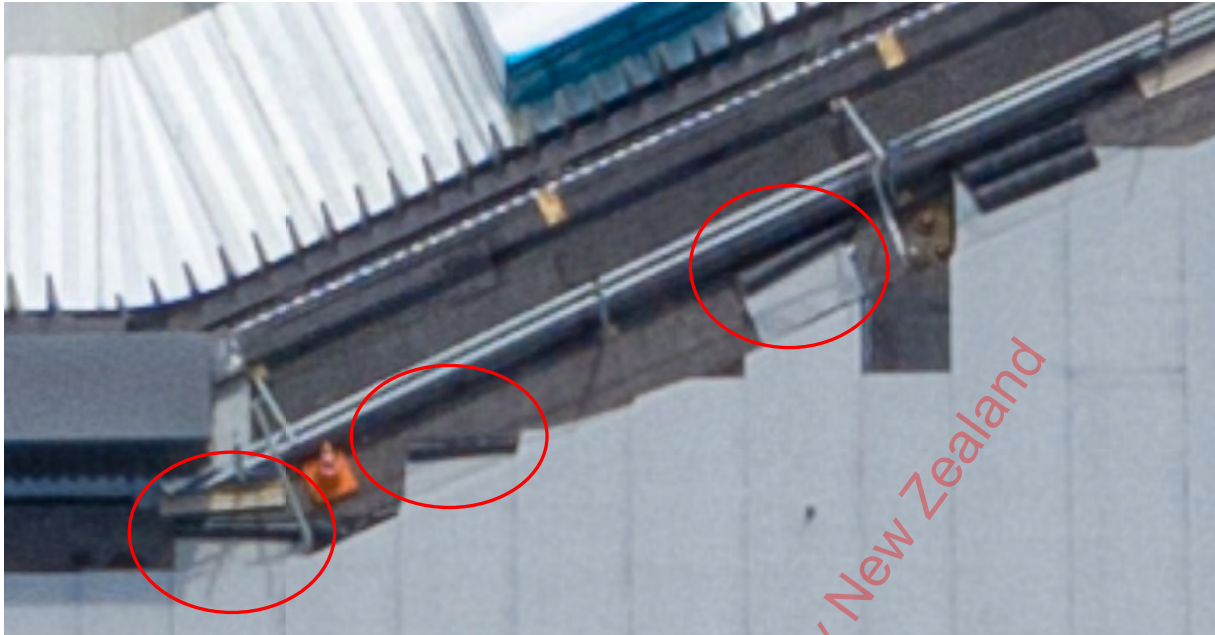
Photo 39: Three examples of residual rolls appearing to be still joined to laid Cap Sheet.

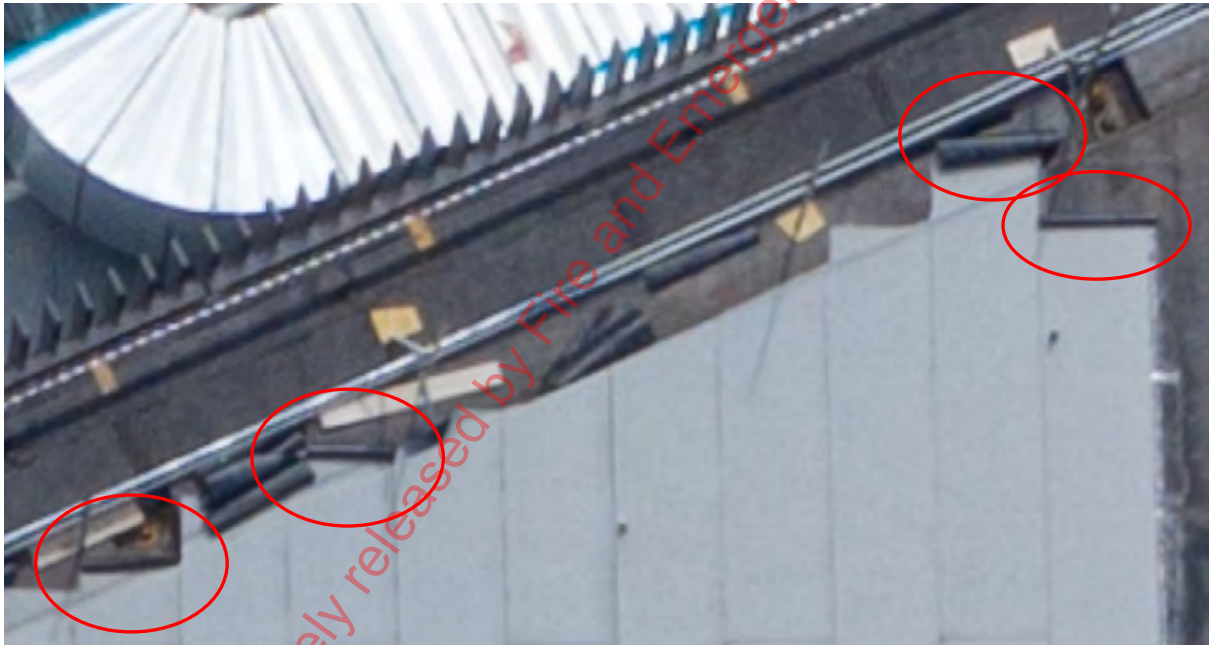
Photo 40: Four examples of residual rolls appearing to be still joined to laid Cap Sheet.

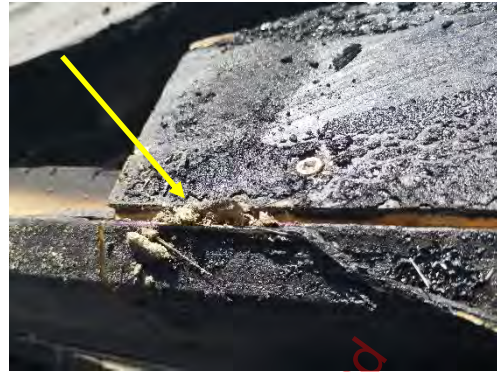
Photo 42: Example of roof on eastern side of Level 7, with residue sawdust in space between joints of plywood sheets (yellow arrow) extracted by investigators.
