FIRE INVESTIGATION REPORT

87-93 Wellesley Street West, Auckland Central, Auckland

F2866954

High Value Loss

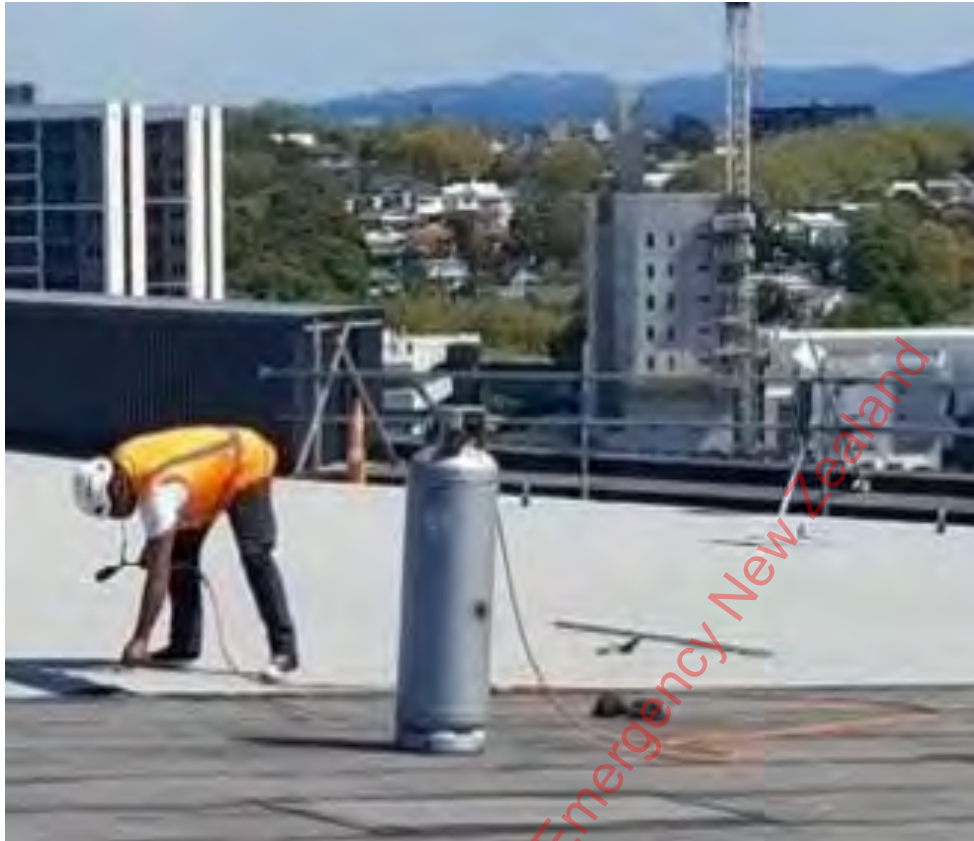
*Photo 45: Shows an un-tensioned gas hose falling slack beside
A gas cylinder and slack in the hose on the ground. Photo provided by Worksafe.*

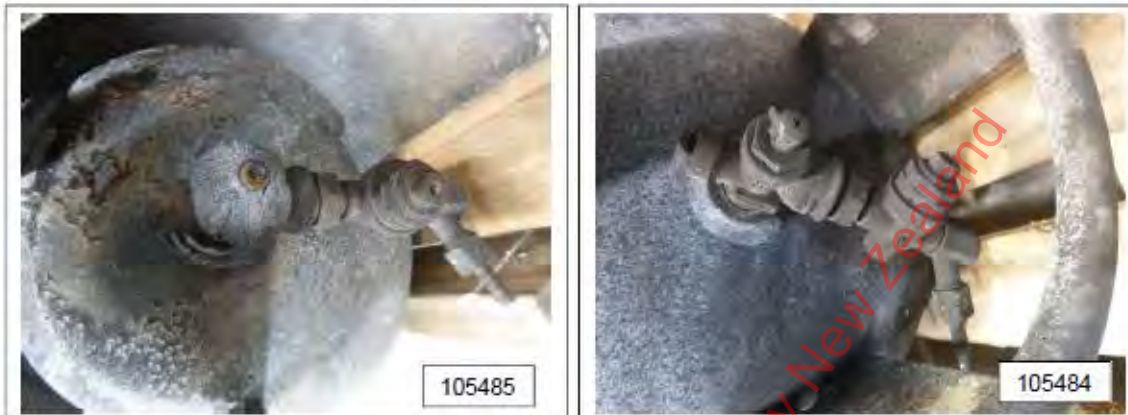
Figure 4: Valves of both cylinders in as found condition
