# Air quality 2006/07

# Natural hazards 2006/07

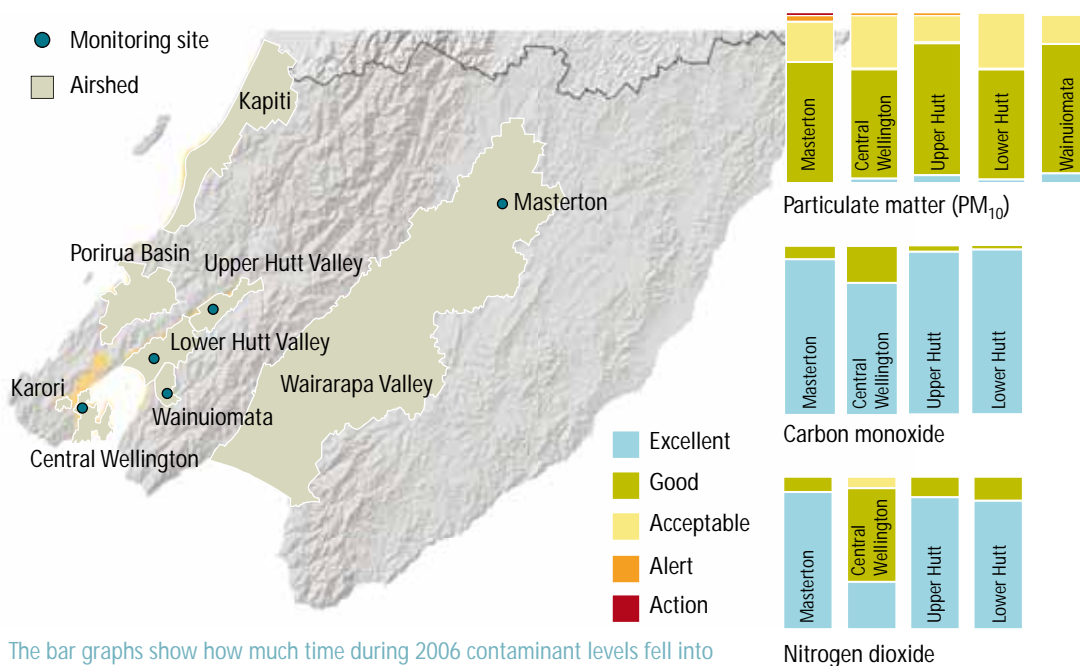
The bar graphs show how much time during 2006 contaminant levels fell into five different air quality categories that grade pollution levels according to their relative health risk. The lowest level of risk is "excellent" and the highest level of risk is "action" which also means that the national environmental standard for a contaminant has been exceeded.

Pollution levels in the region were low in the 2006 calendar year. Carbon monoxide and nitrogen dioxide levels measured across the region were mostly “excellent”. As expected, the level of nitrogen dioxide at the central Wellington monitoring site was higher than at the other monitoring sites but was still mostly “good” (between 10 percent and 33 percent of the national environmental standard).

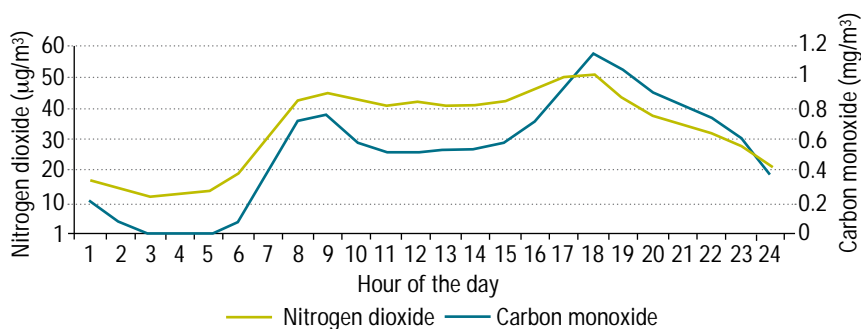
This graph shows a full year of data for two pollutants averaged hour by hour at the central Wellington roadside monitoring station during 2006. Concentrations of carbon monoxide and nitrogen dioxide have noticeable peaks during the morning and afternoon rush hours, when traffic volumes and congestion are highest.

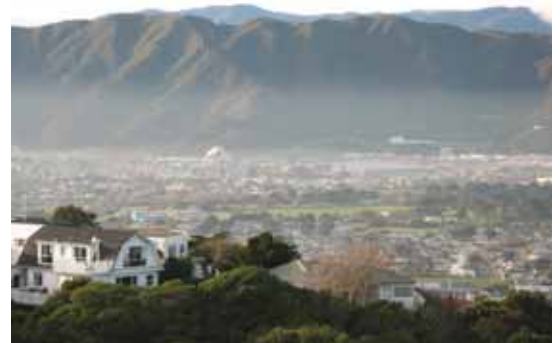
Lower Hutt the morning after. Although the smoke pollution from the night before is reducing visibility, the levels of particulate matter (PM<sub>10</sub>) on this winter morning in July 2007 were in the “acceptable” category and met the national environmental standard.

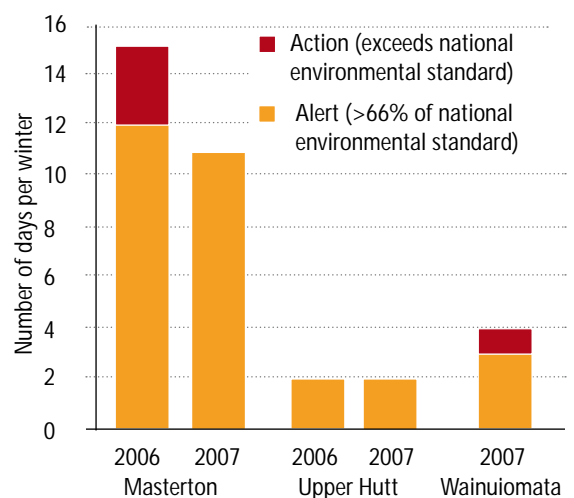
This graph shows the number of days during the last two winters where particulate matter (PM<sub>10</sub>) concentrations were at the “alert” or “action” level and so failed to meet Greater Wellington’s long-term target of having “acceptable” air quality or better. During the 2007 winter there was one day in Wainuiomata where PM<sub>10</sub> levels reached the “action” level and exceeded the national environmental standard. No continuous data were available for Wainuiomata during the 2006 winter.

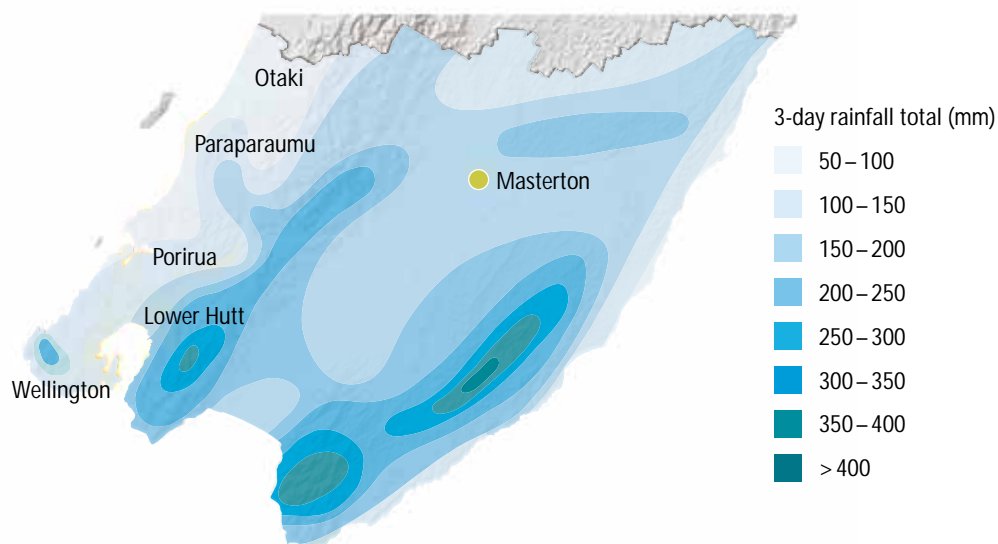
Rainfall from 9am on 4 July to 9am on 7 July 2006. The map shows that the areas of highest rainfall were the south eastern Wairarapa hills, Aorangi Range, and Orongorongo Range. See the *Natural hazards* report card for a photo of the Gladstone area in flood after this rainfall event.

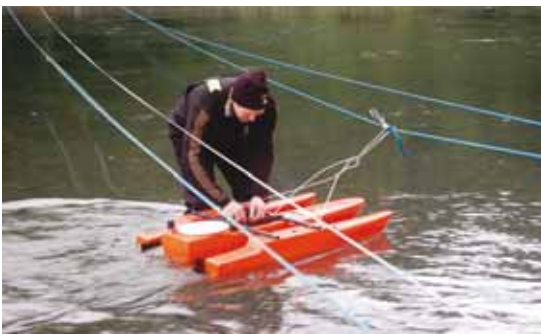
A Greater Wellington staff member testing the new river flow measurement equipment on the Otaki River.

Greater Wellington has recently purchased two Acoustic Doppler Current Profilers (ADCP) for measuring river flow. The ADCP units are mounted on small flotation devices and use wireless technology to communicate with a computer. The main advantage of this is that when flows are too high and dangerous to wade through, but are not high enough to use more traditional flood gauging gear, they can still be measured accurately. Accurate river flow measurements are vital for flood analysis.

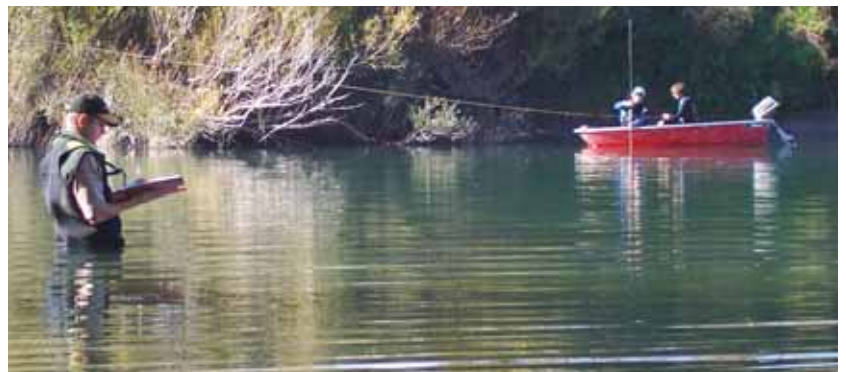
Greater Wellington staff members measuring flow and hydraulic characteristics of the Lower Ruamahanga River. This information is fed into a model which calculates how fish habitat is affected by changes in river flow.

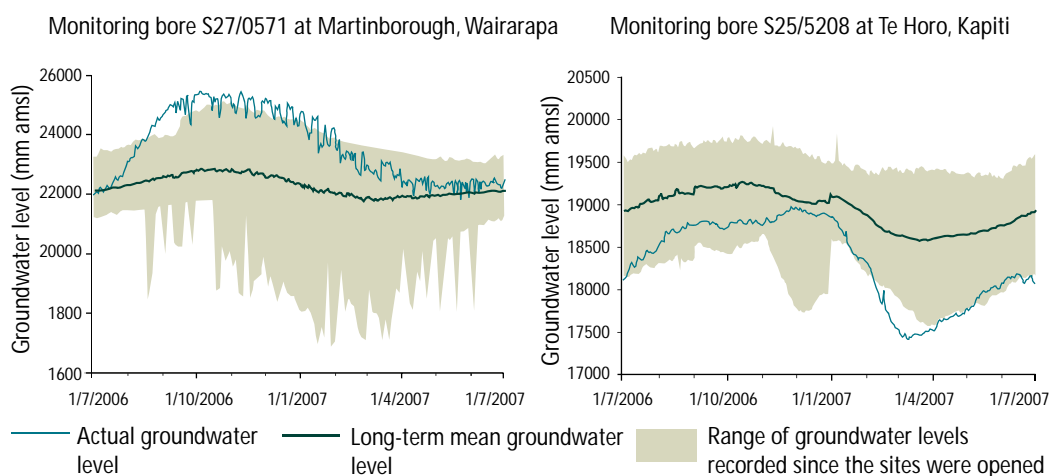
Groundwater levels in the shallow aquifer around Martinborough (left) reached record highs after above average rainfall recharge over spring. In contrast, the deep confined aquifer in the Te Horo area (right) had below average levels throughout the year, some the lowest on record. This is shown by the blue line dropping below the grey shaded area, which shows the lowest groundwater levels recorded since monitoring began. Next year Greater Wellington plans to investigate the effects of changing groundwater levels on a wetland system in the Te Horo area.

Deeper confined aquifers on the Kapiti Coast and in the Wairarapa did not respond as strongly to these weather extremes. While they recovered to average levels after the wet spring, they generally fell back to below average later in the year, reflecting abstraction pressures and long term effects of reduced recharge over the last decade.

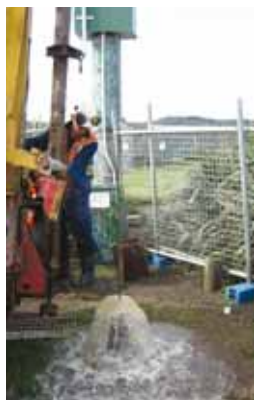
Construction of a new saline intrusion monitoring bore in early 2007 at McEwan Park in Petone. The completed bore will supplement the existing monitoring network and help safeguard the Waiwhetu Aquifer in Lower Hutt. Saline intrusion can occur when an aquifer flows into the sea (such as in Lower Hutt) and too much fresh groundwater is pumped from the aquifer allowing sea water to move inland. Seawater contaminates water in aquifers, making it unsuitable for drinking. Good groundwater management and monitoring can help reduce the risk of saline intrusion occurring.

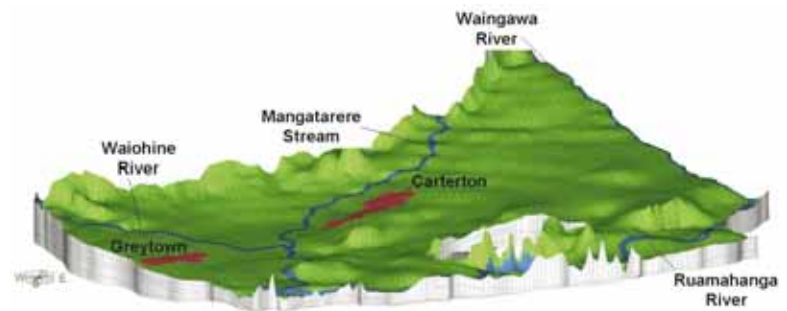
A three dimensional view of the first of three detailed modelling areas between Greytown and the Waingawa River in the Wairarapa. The picture outlines the land surface and a stretched thickness of the aquifer system being modelled.

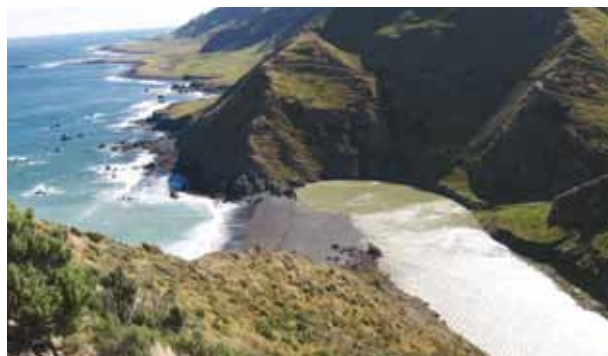
Many river estuaries on the eastern Wairarapa coast are extremely susceptible to water and sediment quality degradation when the river mouths are blocked. This is the case for the Rerewhakaaitu River (pictured). The closing of the river mouths is a natural process – in high river flows, the mouths are reconnected with the sea and are flushed clean.

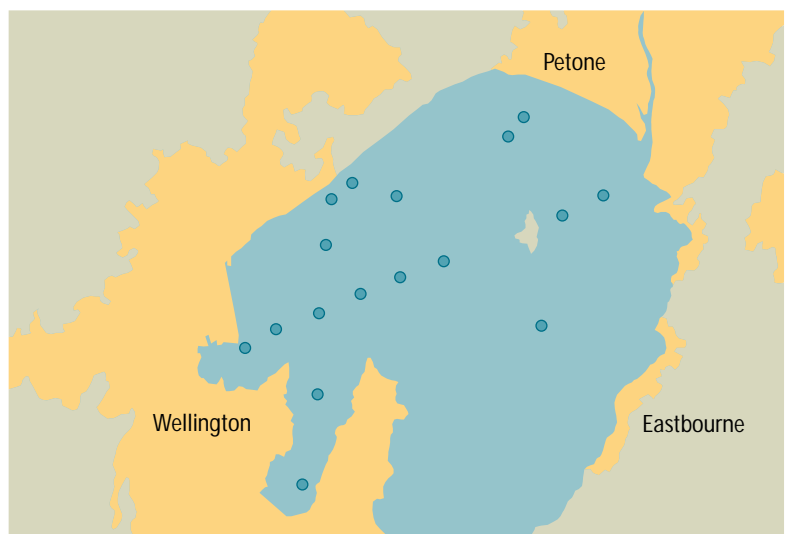
These 17 sites in Wellington Harbour were sampled for sediment and benthic fauna (animals that live on or in the sea floor) over October-November 2006. At each site, scuba divers collected 25 sediment cores and 8 benthic fauna cores.

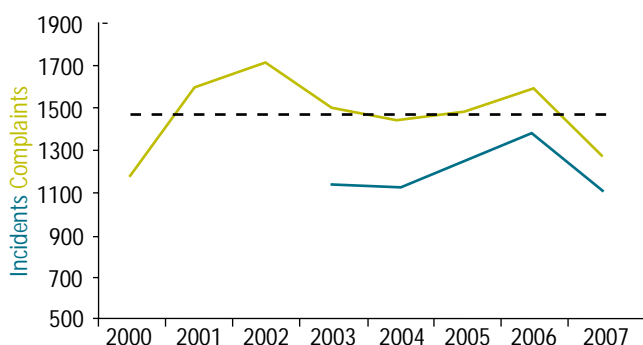
## Environmental incidents in the Wellington region

There was a 20 percent reduction in both complaints and environmental incidents from those reported to our Pollution Hotline in 2005/06. Objectionable odour affecting neighbours still makes up the largest proportion of reported incidents, though is less than previous years.

The decrease in odour complaints is attributed to continued odour control improvements at key source sites including the sewage treatment plant at Moa Point, the landfill, composting plant and sewage sludge de-watering plant at Careys Gully in Wellington, and Taylor Preston's meat processing plant in Wellington.

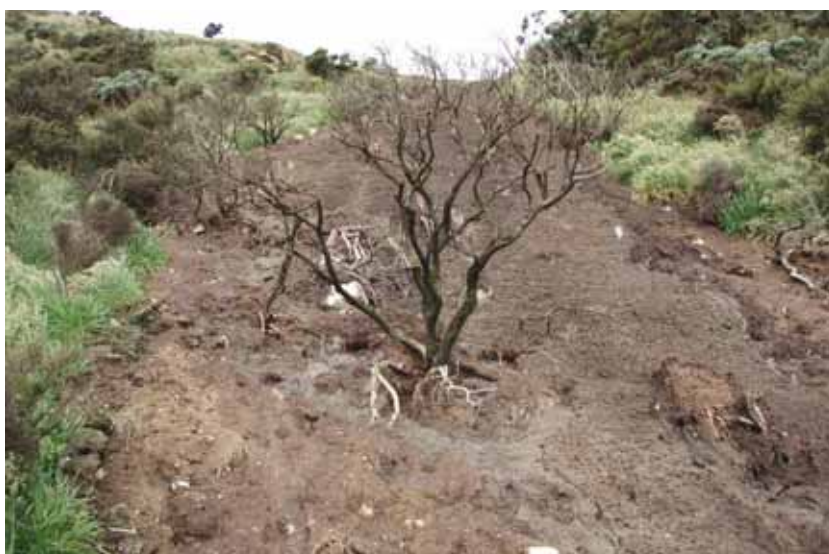
A complaint in early January 2007 alerted us to this chicken waste which had been dumped down a gully on Terawhiti Station in Makara, Wellington. The waste appears to have killed all vegetation in its path and may have been dumped there over a long period of time. After extensive investigation, we laid eight charges against four parties on 4 May 2007 for the unconsented disposal of the waste to land. This case is yet to be heard by the Environment Court.

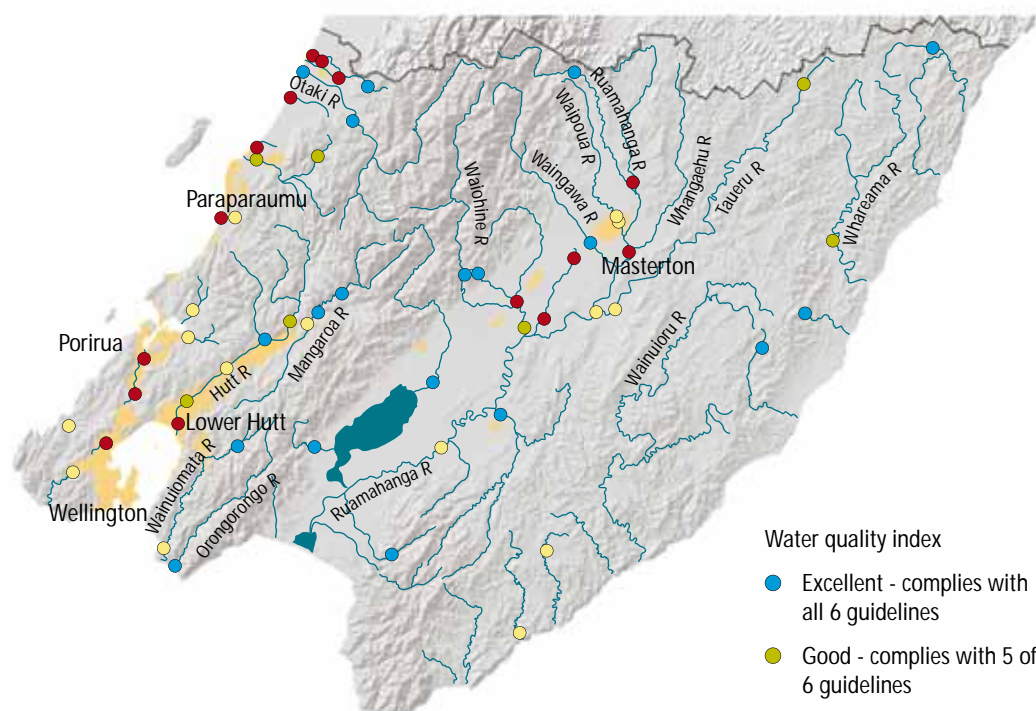
The level of compliance with guidelines for six key water quality indicators (water clarity, dissolved oxygen, dissolved reactive phosphorus, nitrite-nitrate nitrogen, ammoniacal nitrogen and *Escherichia coli*) gives us an overall picture of water quality in the region's rivers and streams. The water quality index ratings shown here are based on monthly data collected between July 2006 and June 2007.

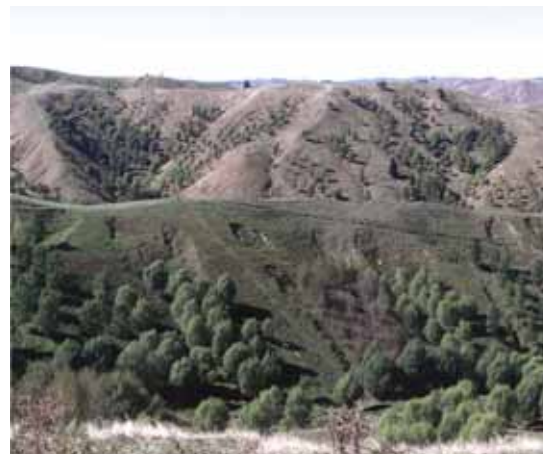
Poplars and willows are used by many hill country farmers in the Wairarapa to stabilise erosion prone land. They can be established relatively easily, are cost effective and can be planted in the presence of grazing animals. Without them, more soil would have washed off this farm near Masterton during the July 2006 storms that hit the property. Eroded hill sides can take more than 30 or 40 years to recover to 80% of their uneroded pasture production potential.

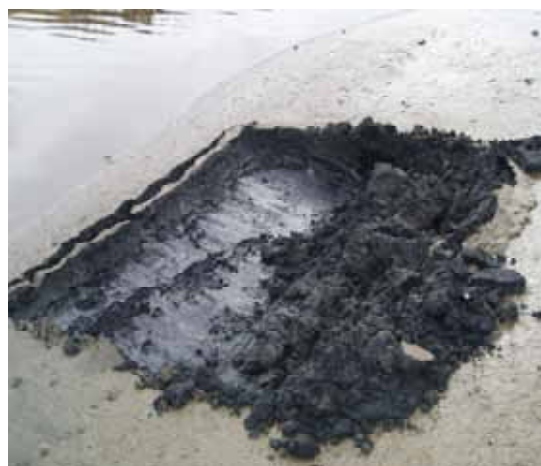
Heavy metals and other contaminants bound to the sediments of the Waiwhetu streambed are a legacy of industrial waste that was discharged to the stream for fifty years until 1978 when a trade waste sewer was installed.

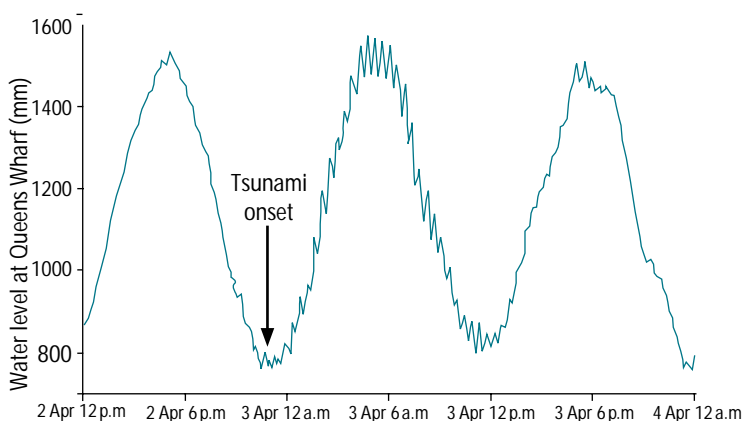
Tide gauge record from Queens Wharf showing the tsunami as it was recorded in Wellington Harbour. The tsunami, with an amplitude of around 0.1-0.2 m can be seen fluctuating on top of the tide from just before midnight on 2 April. The tsunami was generated at 8.40 am that morning and took some 15 hours to reach Wellington. Water levels in the harbour were disturbed for over 12 hours.

With over 500 km of shoreline, the Wellington region is at risk from tsunami from almost all directions, with Wairarapa most at risk and Kapiti least at risk. On 2 April this year, a magnitude 8.1 earthquake near the Solomon Islands generated a large, locally destructive tsunami. The earthquake was big enough to be felt in New Zealand and 1.1 metre waves generated by the tsunami were recorded on the West Coast of the South Island. In Wellington Harbour and on the Kapiti Coast, the wave was much smaller, at around 0.2 m, but still big enough to be detected by the sea level gauges on Kapiti Island and Queens Wharf (see graph).

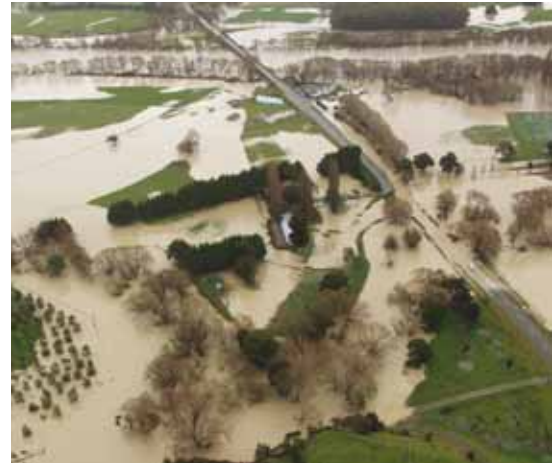
Two storms in early July caused widespread surface flooding in the Wairarapa. The Gladstone pub and some haybales, visible at the top centre of the photo, are two important resources to have escaped flood water. The river at the top of the photo is the Ruamahanga. For more information on this flood event, see the [Rainfall and river flows](#) report card.

The 2006/07 year got off to a very wet start, with two storms in quick succession in July 2006 resulting in flooding in parts of the Wairarapa (see photo in *Natural hazards* report card). More than 300 mm of rain fell over 72 hours between 4th and 7th July in the eastern Wairarapa hills, Aorangi Range and Orongorongo Range (see map). Severe surface flooding occurred on the Wairarapa plains and there were very high river flows in many of the region's rivers including the Wainuiomata, Mangaroa, Ruamahanga and eastern Wairarapa rivers.

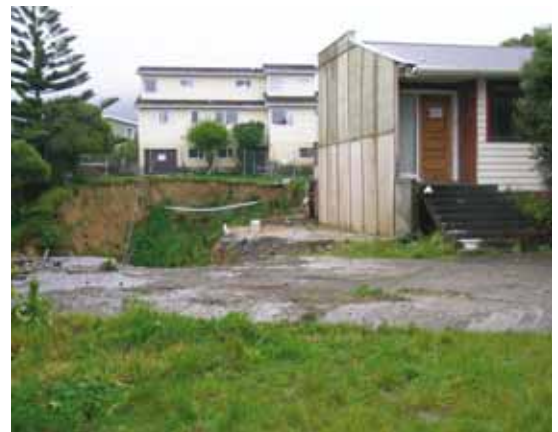
A large slope failure in Vista Grove, Kelson, Lower Hutt on 8 August 2006 generated nationwide media coverage. Four houses still remain threatened by the slip.

In August, a large slip in the hill suburb of Kelson occurred after ground was saturated by months of rain and a suspected broken sewer main (see picture). Sewage from the broken pipe also contaminated the local stream (for more information, see the Pollution Control report card). Continued rain over following days led to continued slipping and eventually a house, garage and sleep-out were destroyed and a further four houses were left in danger of damage.

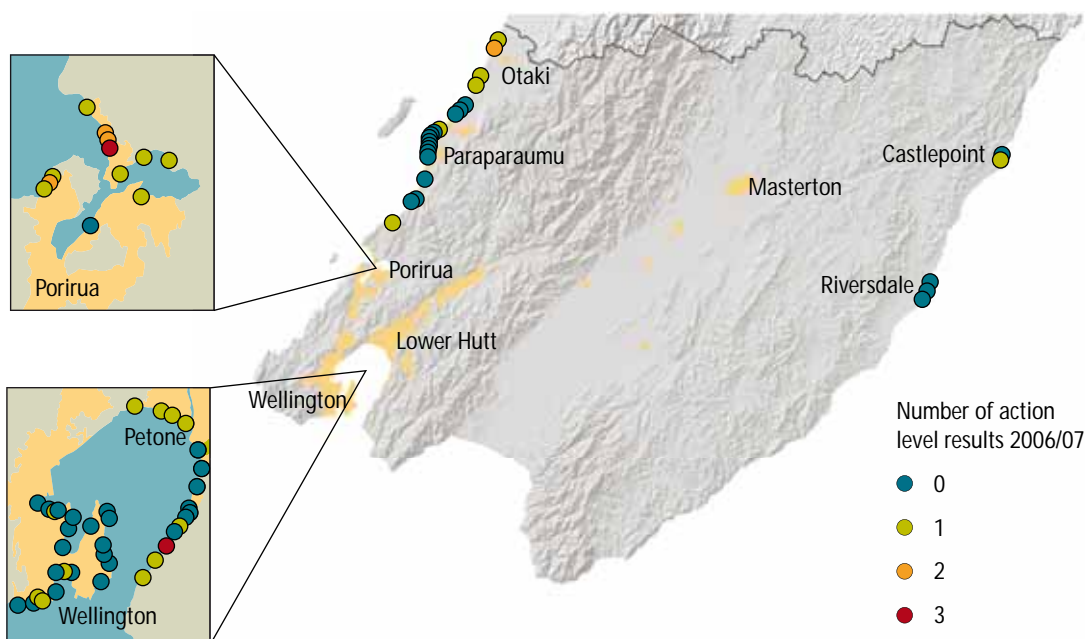
Summary of compliance with the recreational water quality guidelines for 76 marine bathing sites monitored over the 2006/07 summer. For up-to-date results about bathing water quality, check our website at <http://www.gw.govt.nz/on-the-beaches> during summer.

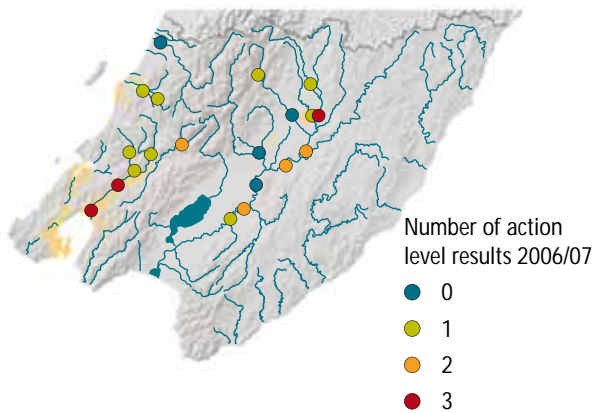
Summary of compliance with the recreational water quality guidelines for 20 freshwater bathing sites monitored weekly over the 2006/07 summer. Just two sites on the Hutt River exceeded the action guideline more than twice.
