**HAWKE'S BAY**

**THE STATE OF OUR  
ENVIRONMENT**

# DECEMBER SUMMARY

## Regional Council Science Summary

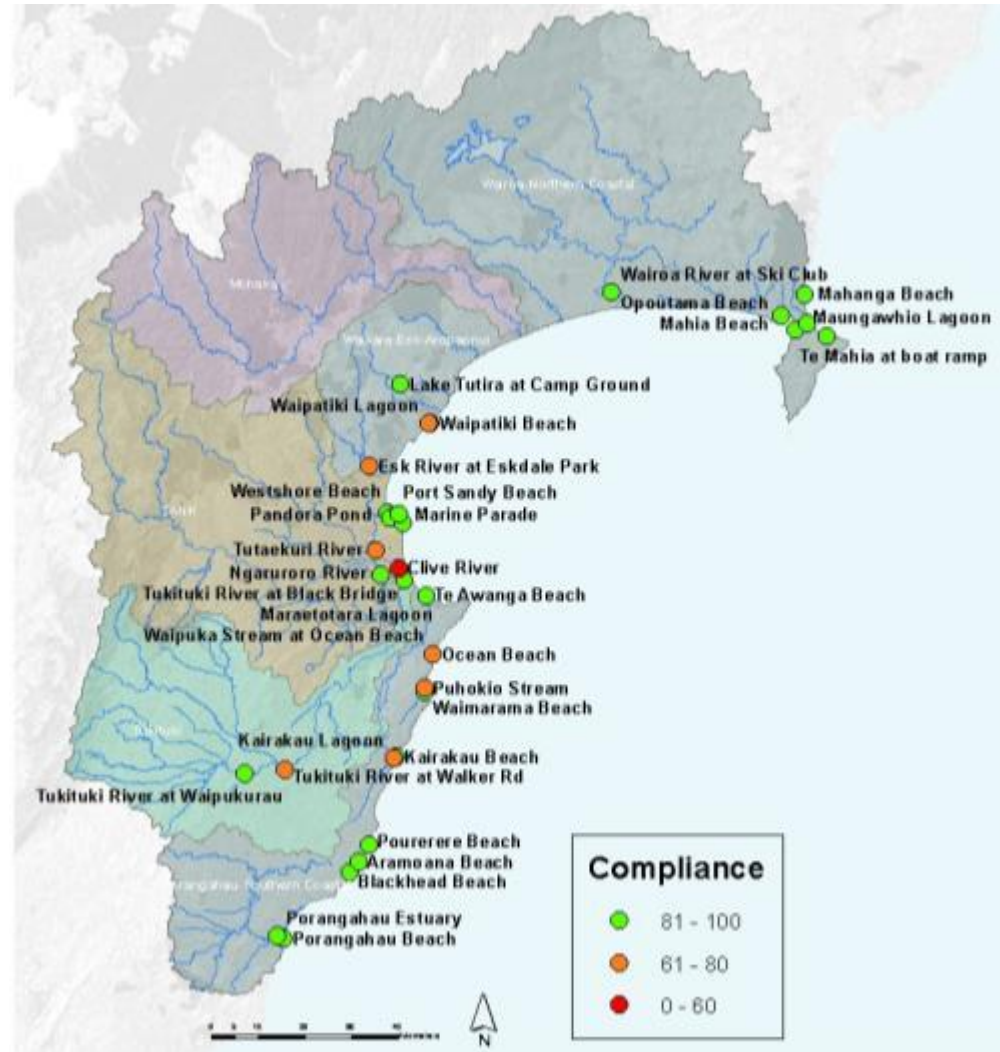
## RECREATIONAL WATER QUALITY

Our second month of the swimming season saw a few water quality exceedences in our fresh water and coastal environments. The Clive River site failed twice and extra samples were sent away for faecal source tracking.

All site exceedences were rainfall-related, with more than 8mm rainfall in 72 hours before the samples are taken. This amount of rain is enough to move bacteria in surface runoff from agricultural land.
