KAIKOURA EARTHQUAKE UPDATE

WEEKLY BULLETIN – no. 7

10 March 2017

This weekly bulletin aims to give you the latest information on all the work underway to rebuild and repair the road and rail networks damaged by the Hurunui/Kaikoura earthquakes in November 2016. The bulletin is provided by the North Canterbury Transport Infrastructure Recovery (NCTIR) – an alliance representing the NZ Transport Agency and KiwiRail, on behalf of Government. We're keen to hear from you with any questions about our work, or with any feedback on this bulletin. Drop us a line via email at info@nctir.com or give us a call on **0800 NCTIREQ** (0800 628 4737) – we'd like to hear from you.

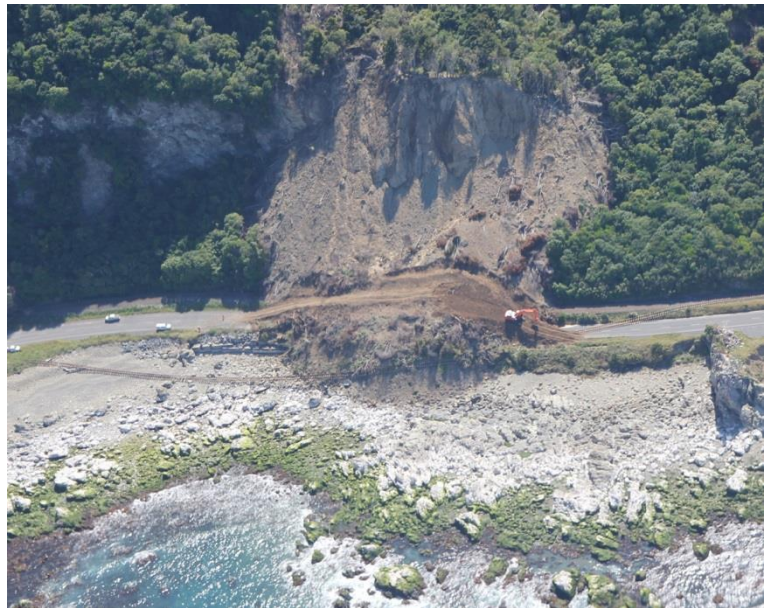
- Access tracks have now been built around seven of the nine slips to the north.
- Two excavators are now at the top of Site 3 working to clear the 5000 cubic metres of material from this site.

- Vegetation has been cleared for an access track to be built around Site 4 and 5, at Half Moon Bay, once a section of railway line has been removed from this area.

- Helicopter sluicing and removal of loose rocks and debris has made safe one of the three large chutes on the northern side of Site 7, south of Paparoa Point, enabling an excavator to begin cutting an access track to top of the chute and begin clearance of the slip next week.

- Excavators are about to begin clearing the slip at Site 8 (Okiwi Bay), with an access track having been built to the top.
- Next week machinery will be on site 6, at Ohau Point, beginning to clear vegetation and slip material from the south. Our remote-controlled excavator has arrived on site from the north.

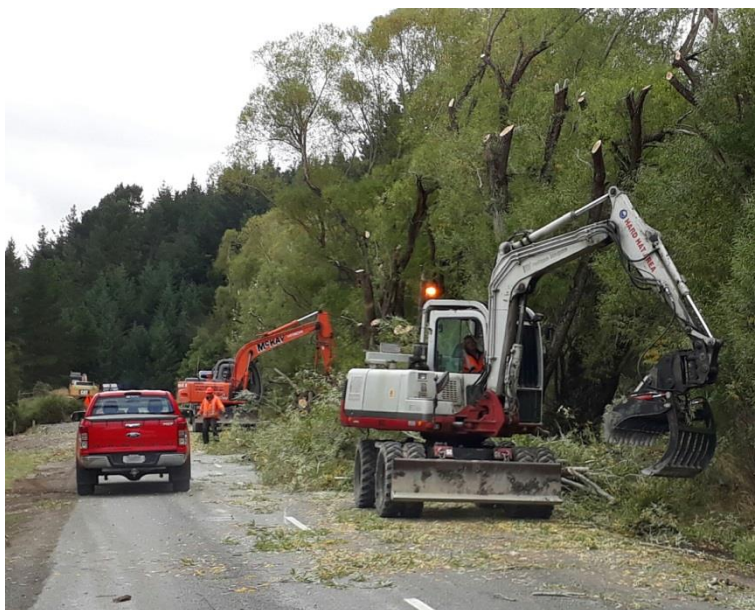
- The severe weather this week presented a number of challenges for the team in keeping open both lanes along the Inland Road (Route 70), especially at the Whales Back slip site. This site remains fragile and vulnerable to rockfall during weather events.
- Work progresses on getting all sections of the road damaged by the earthquake sealed before winter. Please take care around these work sites, follow all signs and observe the 30km/h speed restriction.
- Work continues removing trees along the route that shade the road to improve winter driving conditions.

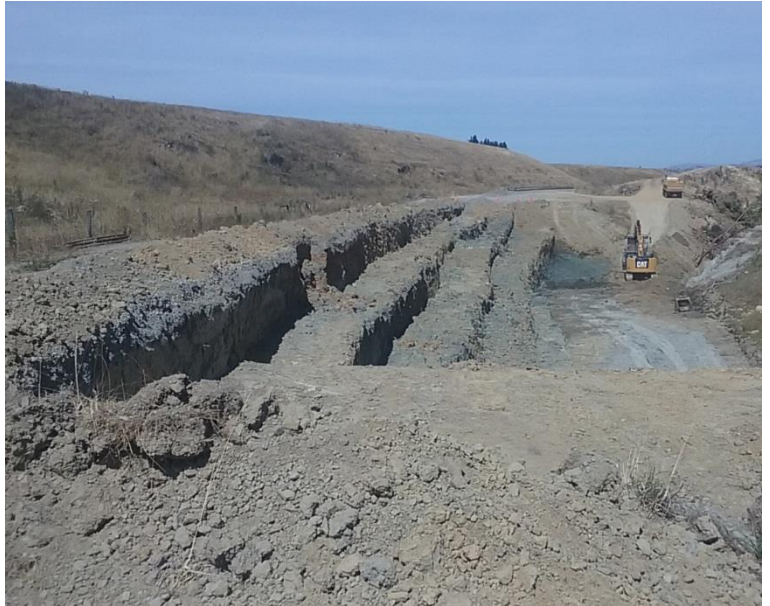
- Maintenance trains have begun running on the Main North Line between Picton and Christchurch, from the north and south. These trains are carrying ballast and other materials to work sites along the railway line for the rebuild. During the repair work, the track will be lifted, ballast will be packed underneath the sleepers and finally the alignment of the rail corrected. Good progress has been made on the 750 damaged railway sites. Everyone is asked to take extra care along the railway corridor.

- Strengthening of the Rail Bridge near Spy Glass Point (Bridge 95) is underway, including piling and concrete reinforcement works.
- Piling and structural steel for the temporary Rail Bridge at Ferniehurst (Bridge 90), south of the Hundalee, arrived on site this week. Piling work is already underway.

- Near Hawkeswood, just north of Parnassus, work is progressing on the repair of more than 200m of track, including culverts and retaining walls, which have slumped. Excavation work is now complete.

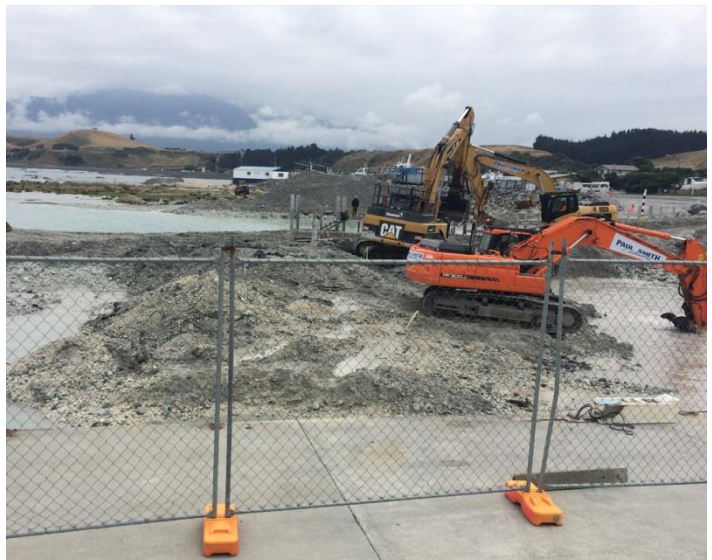
- Dredging of the inner basin is now about 25% complete. This material is being used to construct a platform within the basin from

which machinery can access to continue to deepen the harbour.

- The Dolphin Encounter jetty has been demolished and disposed of, including the piles.
- Services from the Whale Watch jetty have been disconnected and the jetty will be removed once the above platform is complete and able to be used.
- Both Dolphin Encounter and Whale Watch continue to operate their daily services from temporary facilities located within the harbour area.
