# KAIKOURA EARTHQUAKE UPDATE

KAIKOURA EARTHQUAKE UPDATE - no. 14

28 April 2017

## MOVING MOUNTAINS TO OPEN BY DECEMBER

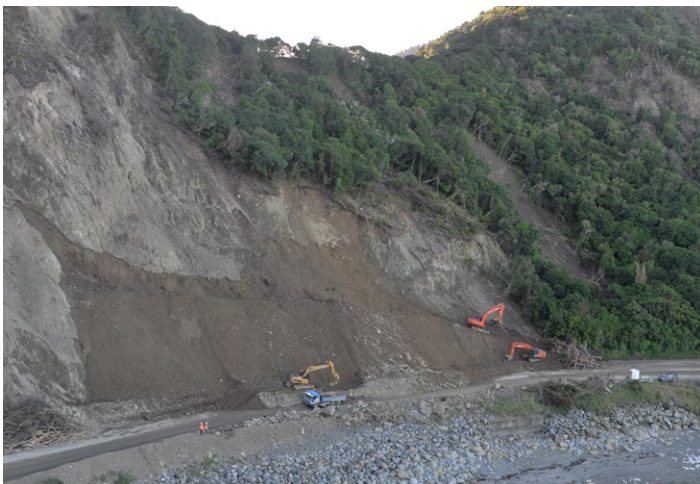
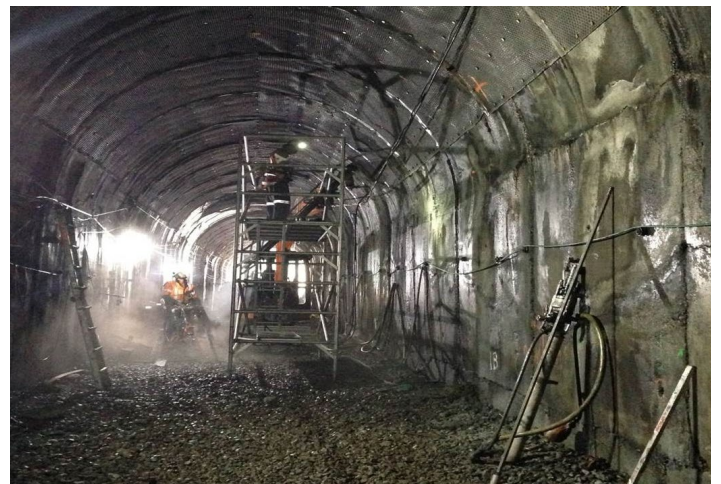
The speed of repairs does depend on the alliance's ability to move mountains, with slips currently closing sections of SH1 and railway between Cheviot and Grassmere. The slips may be an even bigger job than first anticipated. In recent weeks, ex-cyclones Debbie and Cook worsened existing landslides. Additionally, other slopes which had partially failed due to the earthquake let go – creating further large landslides to clear.

While these landslides may actually make the land more stable longer-term, the amount of slip material that must be removed from the coast may be significantly more than was first thought. Crews are working from dawn to dusk to clear slips as quickly as possible and, generally, this work will continue through winter.

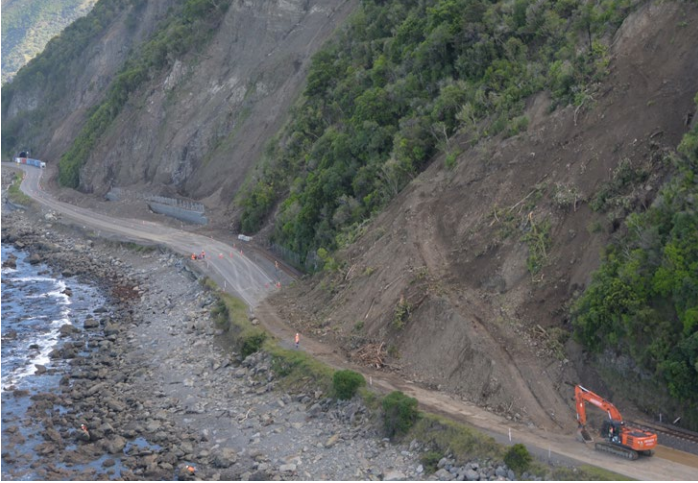
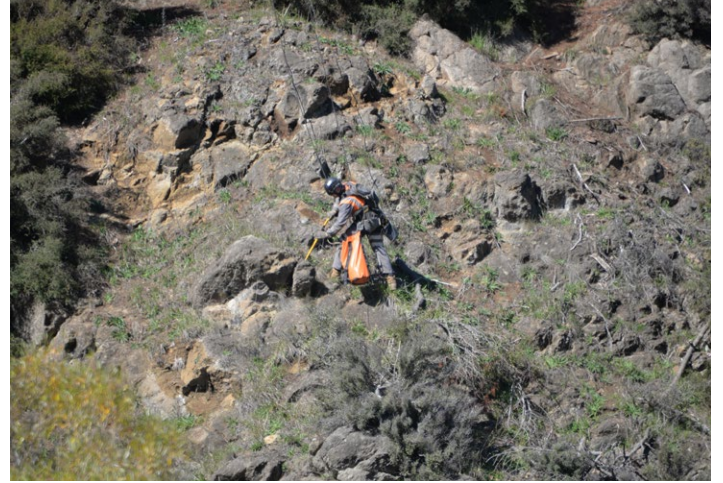
This section of SH1 has been closed so the large slip that came down at Easter, 3 km south of Peketa, can be cleared. When the slip is no longer blocking the road, crews can continue with the slope stabilisation works.

On the inland road, abseilers have been removing boulders this past week as part of the slope stabilisation and rock fall mitigation work at the large slip on the Whales Back saddle. The temporary road that was built to carry traffic around that slip remains in use.

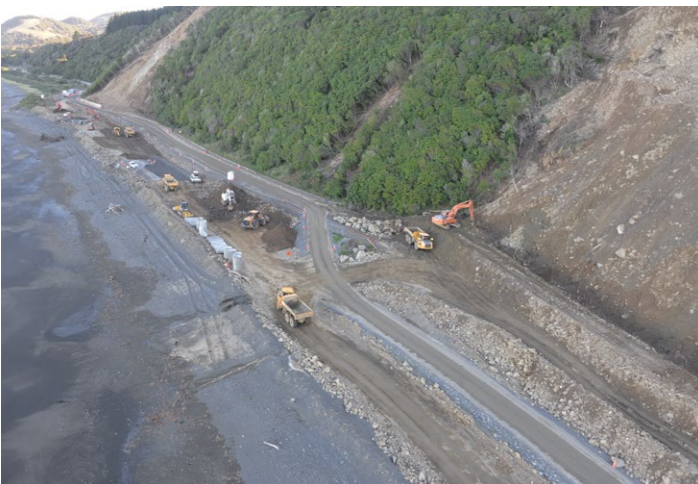
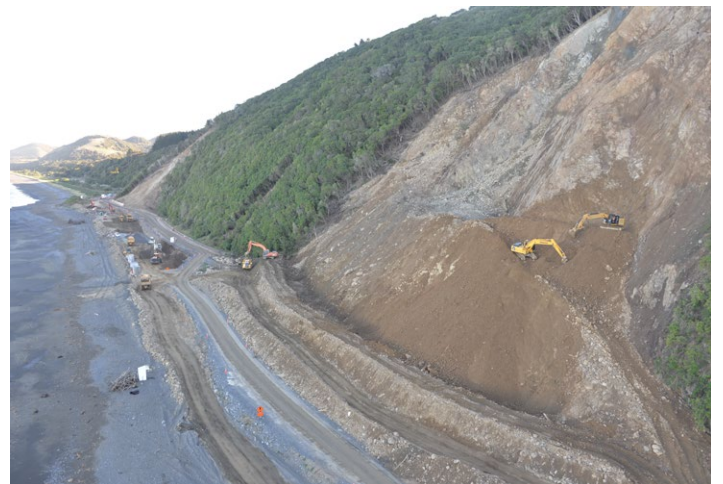
Work on the new rail and road alignment is progressing well at Site 1, near Maungamanu. The photographs below show how the transport corridor is taking shape; at this location, SH1 will be slightly more seaward than it was before the quake. Investigations are also underway for a new bridge site within a new alignment at Site 2.

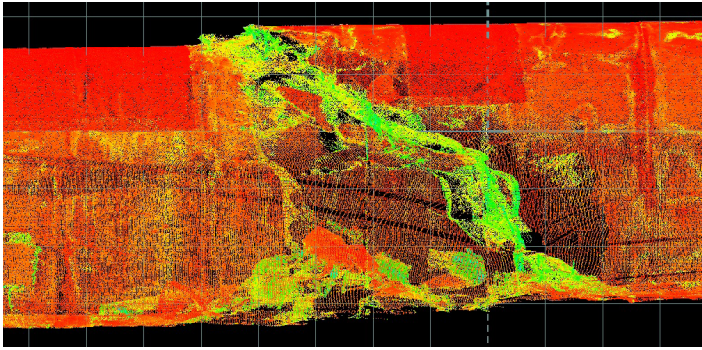
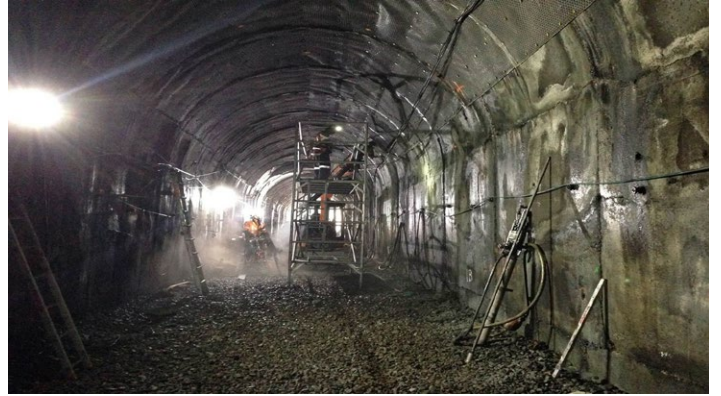
Four out of the damaged 20 rail tunnels on the line have now been repaired to the extent that work trains can pass through them, repairs are underway at a further eight tunnels, with the remainder to commence soon. Tunnel 18 (pictured right) suffered significant structural damage: it's effectively been cracked in two. The Hope fault is only 70m from the tunnel's northern portal. The reverse upward movement across the fault sheared the tunnel's concrete lining. In the laser image, the green lines show where the force from the jolting fault hit the tunnel, and you can see how part of the tunnel floor moved by 500mm. The second image shows the same crack in the tunnel's interior.

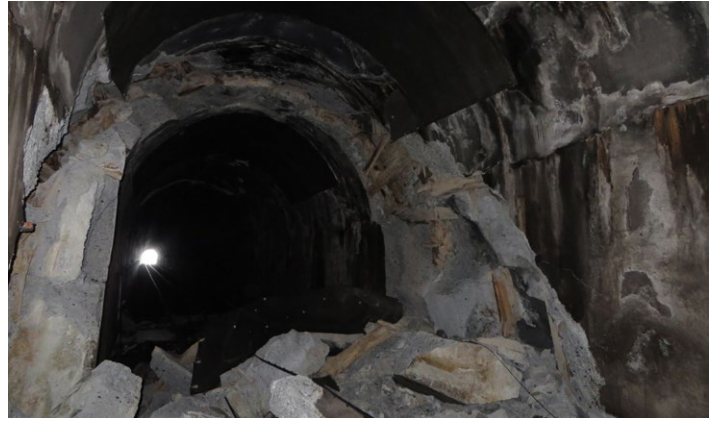
Tunnel 16 (pictured below) underwent 'squeezing' during the earthquake, leading to longitudinal tension and compression cracks. The picture below shows rock bolts being used to re-secure the tunnel's damaged concrete lining to surrounding rock.

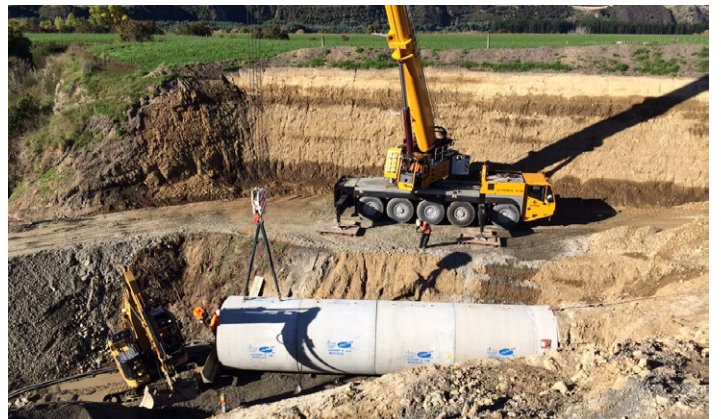
Repairs to an earthquake-damaged culvert near Ferniehurst are well underway (pictured). The crew have excavated the downstream face of a rail embankment to a 12m depth in order to expose a large (15m long, 2.5m high) concrete-lined tunnel that formed a culvert under the railway. The underground damage to the tunnel meant the crest of the embankment had slumped by up to a metre. After the culvert is repaired, the embankment will be reinstated to its full height.

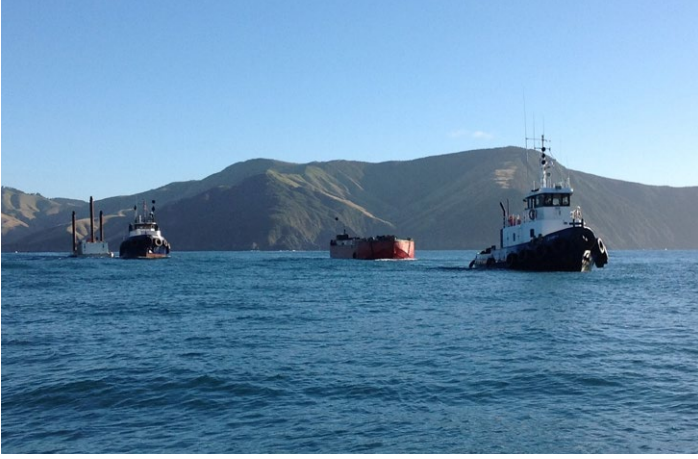
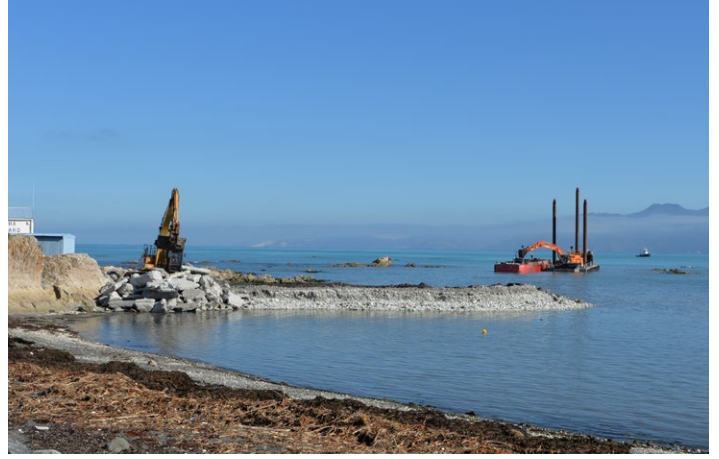
Kaikoura harbour repairs have reached a new milestone with the arrival of the dredging barges - one has a 47-tonne excavator aboard while the other is a hopper barge for carrying waste material. The two barges work in tandem: the excavator dredges up to 400 cubic metres a day from the seabed and deposits it onto the hopper. A tug boat then pulls the hopper out to sea, depositing the excess material approximately 2km from the shore. Dredging is required because the earthquake raised the seabed under the marina by about a metre; deepening of the harbour is ongoing work. These photographs show the trio of vessel as they left Picton last week and in Kaikoura yesterday.

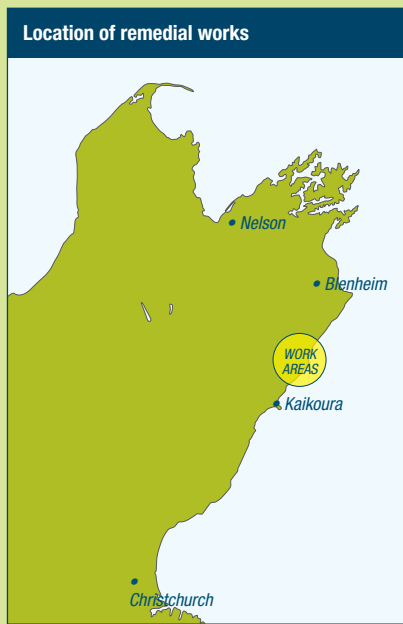
**SITE 9:** 3,000m<sup>3</sup> of slip material

**SITE 8:** 41,000m<sup>3</sup> of slip material

**SITE 7:** 20,000m<sup>3</sup> of slip material

**SITE 6:** 110,000m<sup>3</sup> of slip material

**SITE 5:** 6,000m<sup>3</sup> of slip material

**SITE 3:** 5,000m<sup>3</sup> of slip material

**SITE 4:** 44,000m<sup>3</sup> of slip material

**SITE 2:** 10,000m<sup>3</sup> of slip material

**SITE 1B:** 112,000m<sup>3</sup> of slip material

**SITE 1A:** 23,000m<sup>3</sup> of slip material
