# Canterbury Earthquakes Royal Commission

FINAL REPORT

VOLUME 4  
EARTHQUAKE-PRONE BUILDINGS

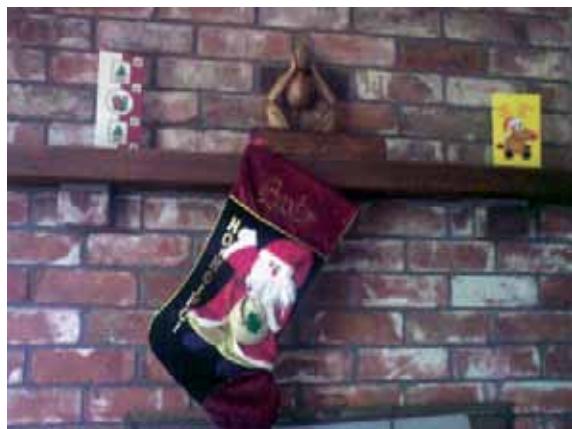
Mrs Baird has said that in the 1980s the internal chimney breast was remodelled by removing the mantelpiece and re-bricking from floor to ceiling with the original mantelpiece retained, resting on bricks that jutted out as part of that new brick work.

Figure 4: The internal chimney breast at 39 Bishop Street

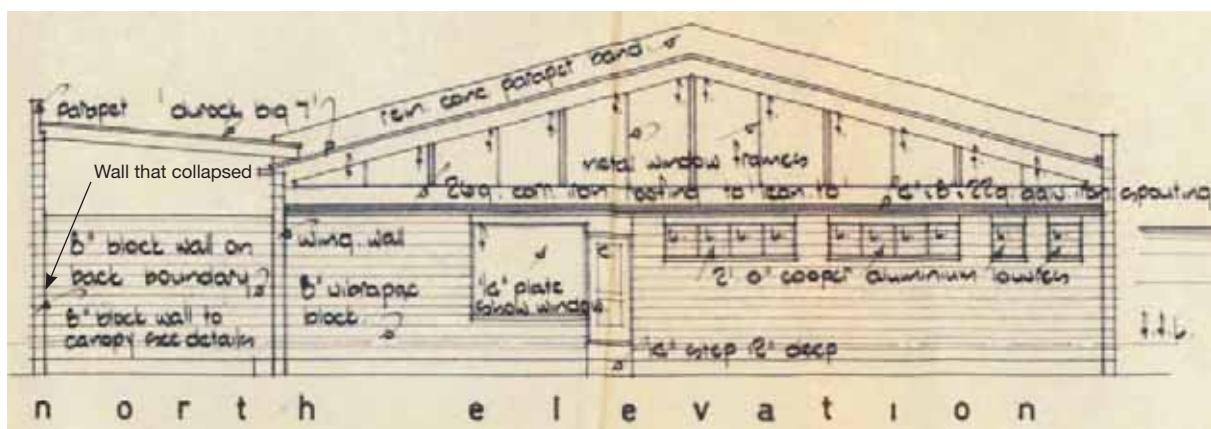
Mr Peter Smith stated in his report to the Royal Commission that the wall had two reinforcement rods (both approximately 20mm in width), one at each end. The owner has since advised the Royal Commission that there were four vertical reinforcing rods in the wall. Whatever the position was, it is apparent that the wall was inadequately reinforced to resist the effects of the February earthquake.

Figure 11: A section from the original plan of the building, showing the wall at left with its lean-to roof attached

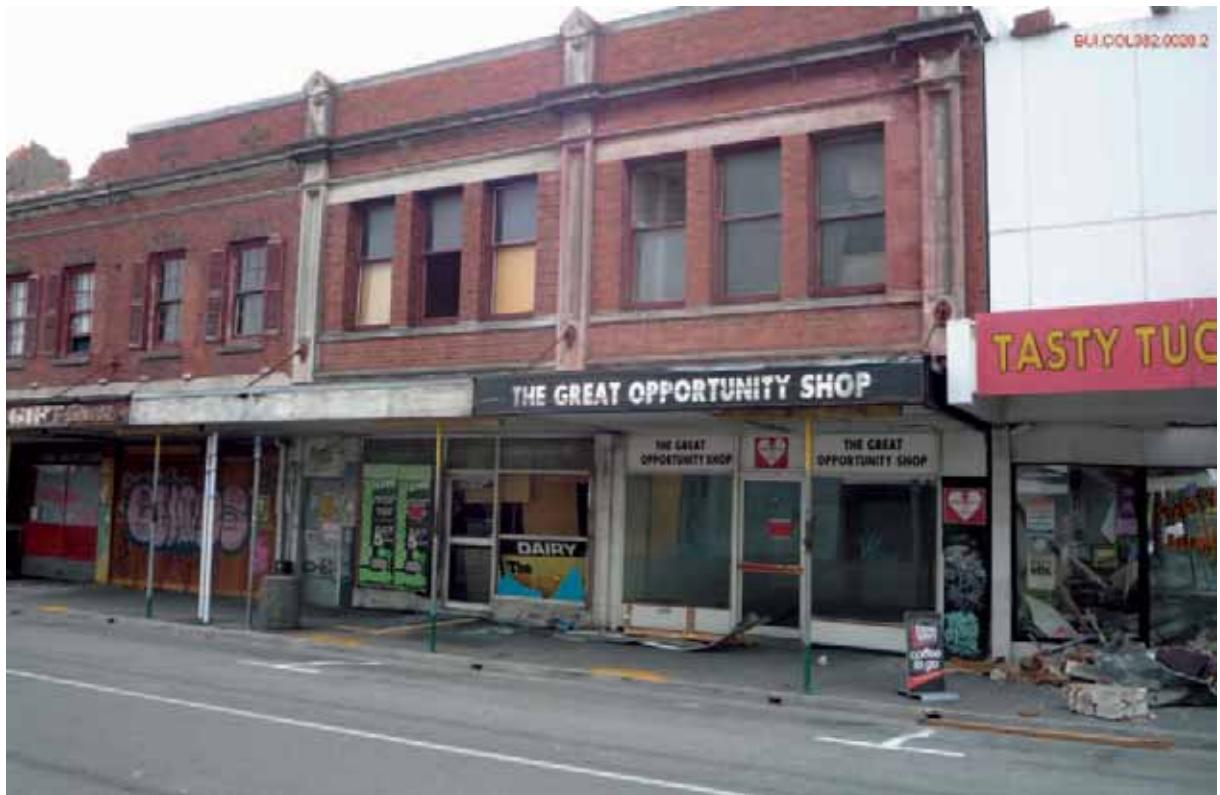
In the February earthquake, the parapet wall of the southern end of 382 Colombo Street collapsed outwards and through the roof of the Tasty Tucker Bakery.

Figure 13: 382 Colombo Street and (at right) the Tasty Tucker Bakery, after the February earthquake

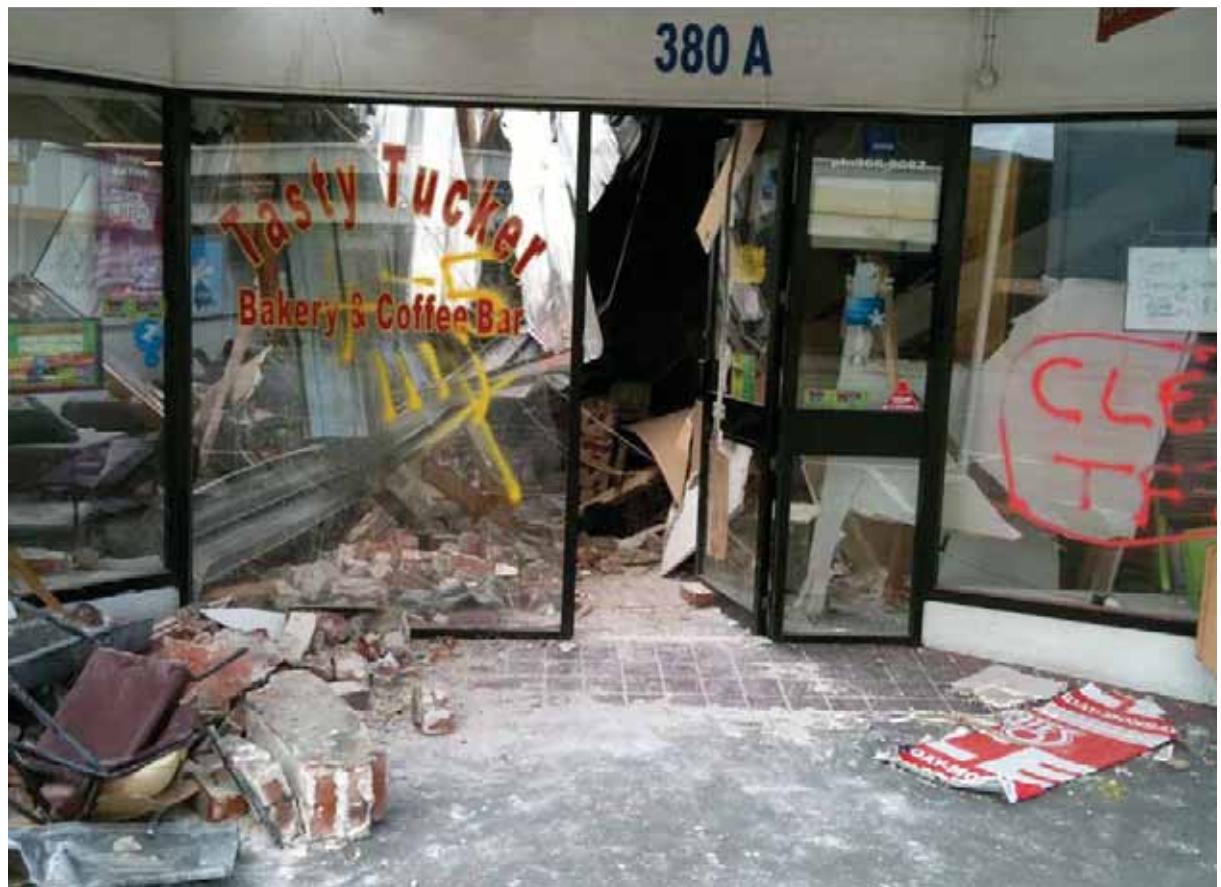
Figure 16: The Tasty Tucker Bakery and Coffee Bar after the February earthquake

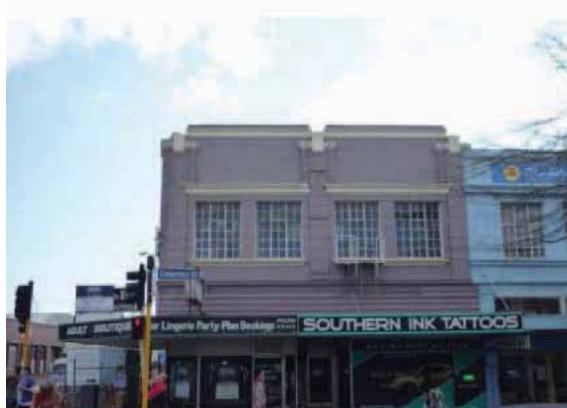
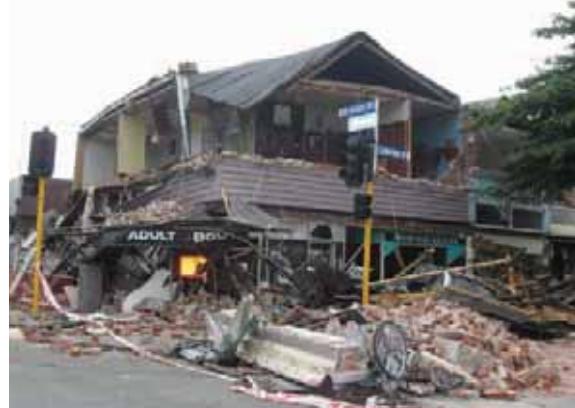
Figure 17: 593 Colombo Street pictured before and after the February earthquake

It appears that no structural strengthening had ever been carried out and the building was essentially in its original condition on 4 September 2010. As there had been no applications for building consents in the past, the owners had not been required to carry out any structural strengthening.

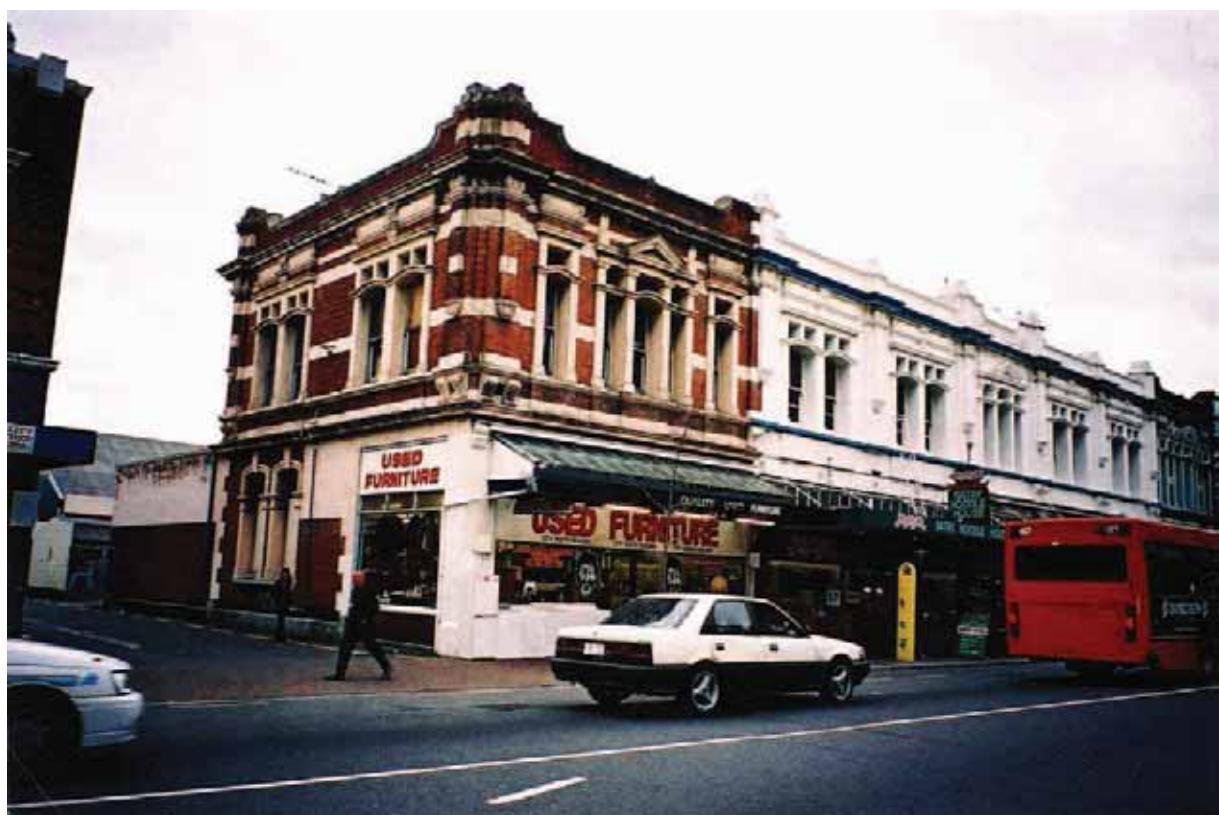
Figure 23: The building at 603 Colombo Street, shown in a photograph from the CCC file which appears to have been taken around 1992. Mollett Street is on the left

A seismic risk building survey of 603 Colombo Street carried out by the CCC in 1991 identified the cornice, parapet and chimney as hazards. Mortar deterioration was also noted on the corner of the parapet on the street elevations. Immediate action was recommended.

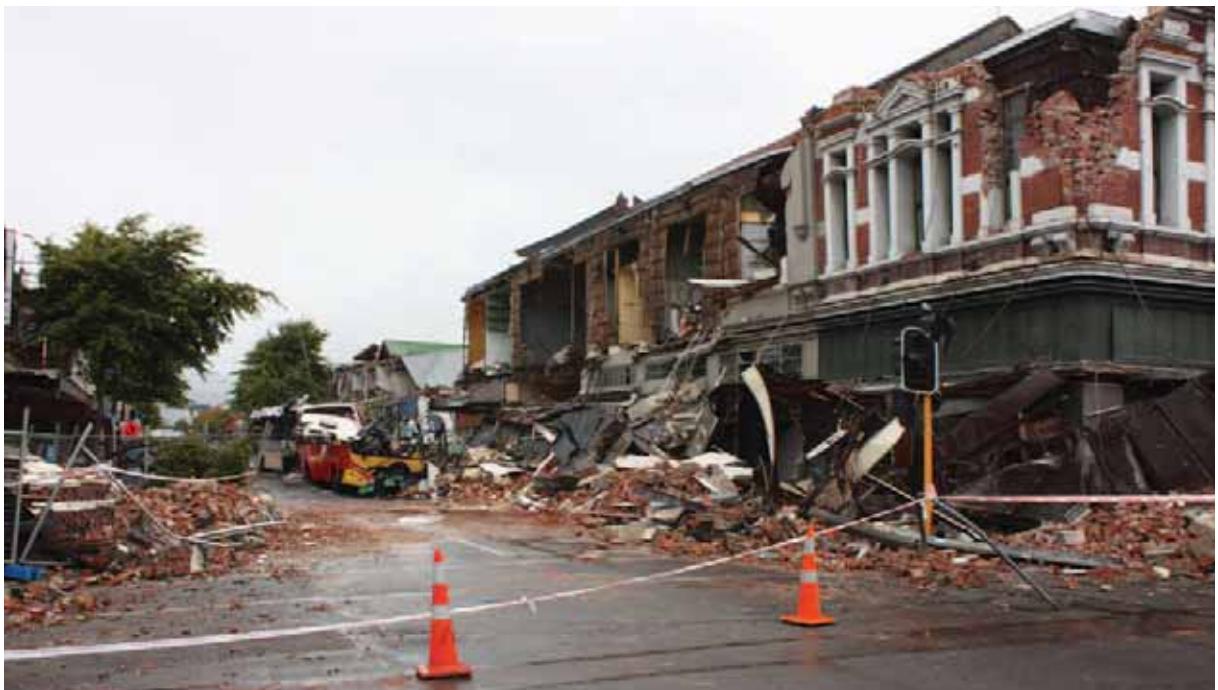
Figure 33: The building at right following the February earthquake

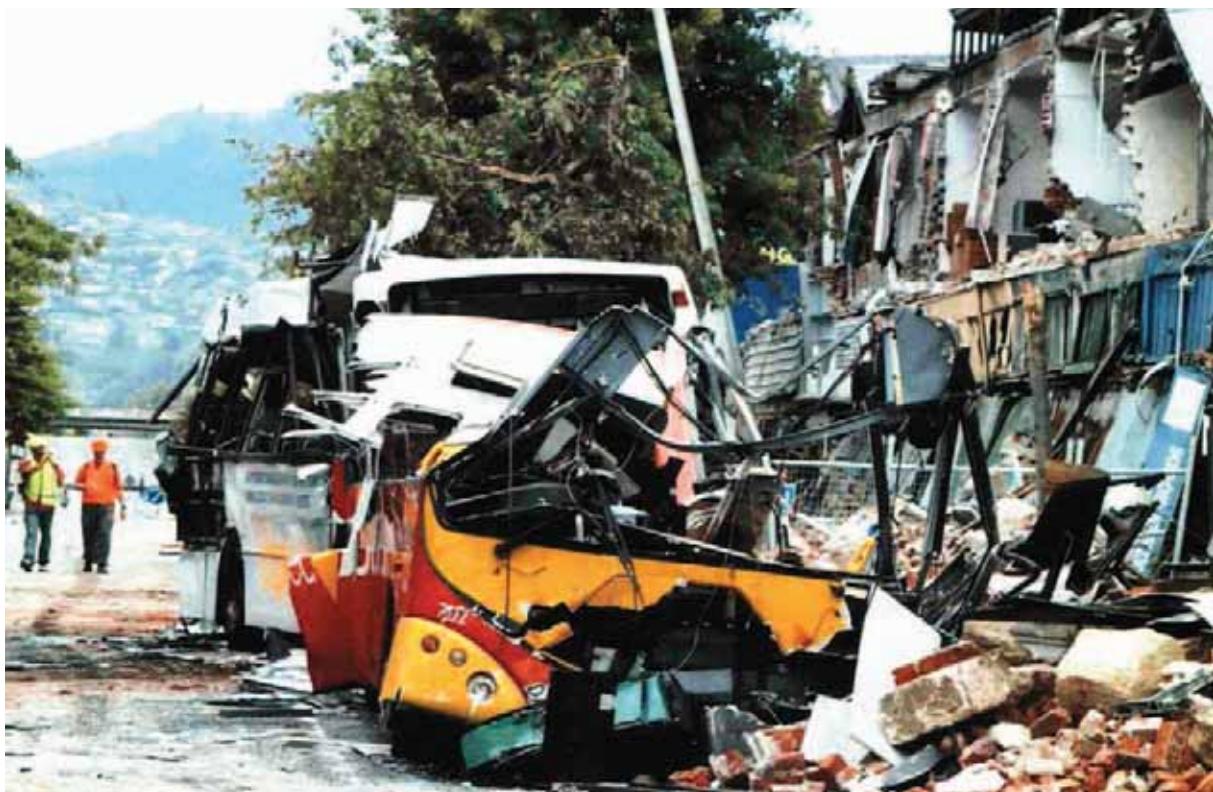
Figure 34: The damaged buses

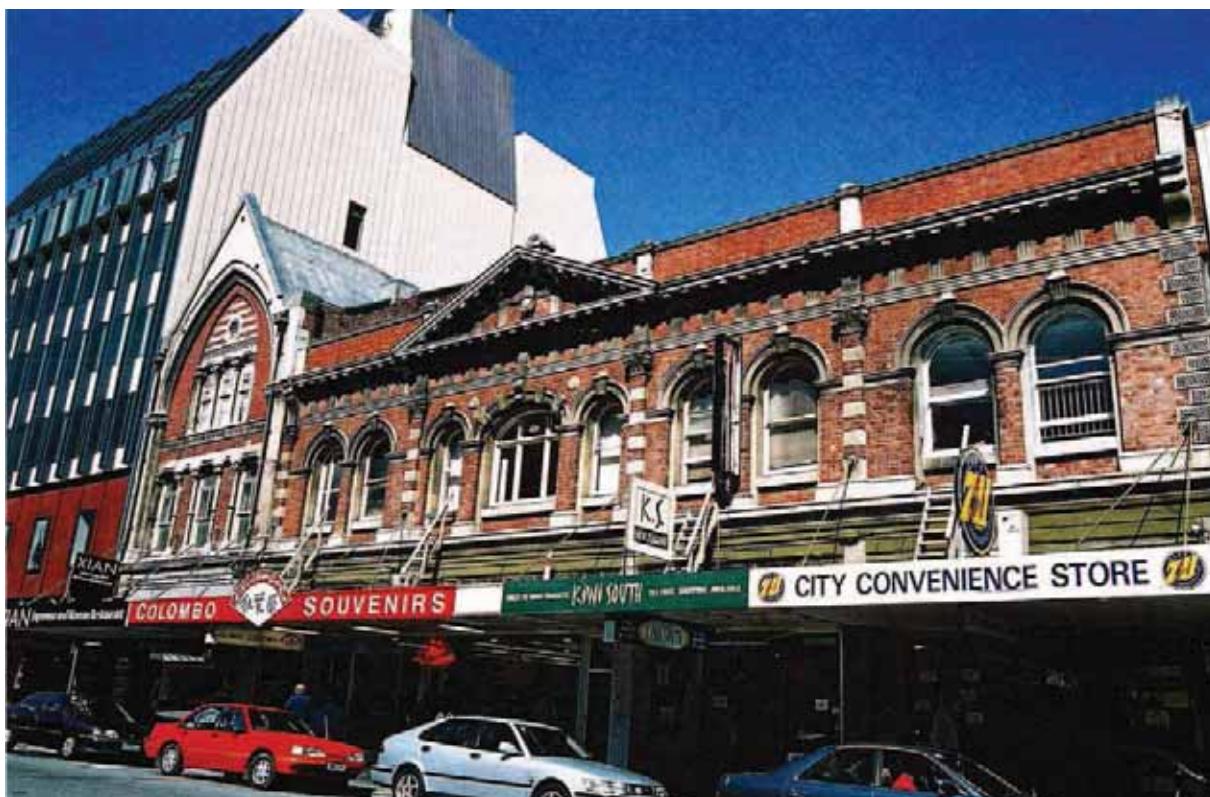
Figure 40: The buildings at 751–759 Colombo Street before the September earthquake. The taller URM building at left bearing the sign “Xian” is 751 Colombo Street. Colombo Souvenirs was a tenant at 753 Colombo Street

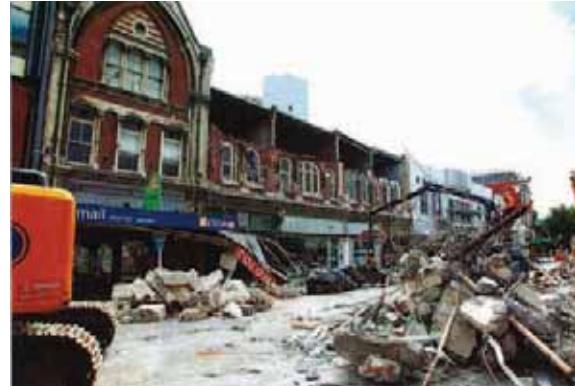
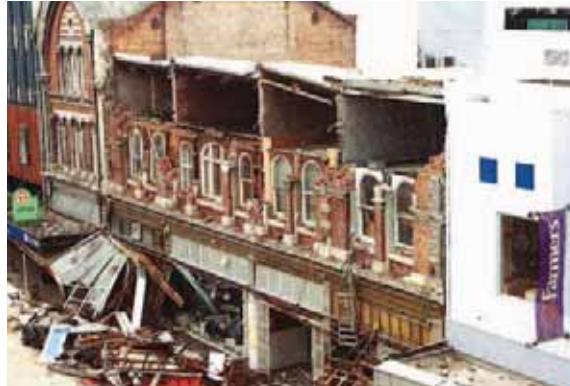
In the February earthquake the building suffered severe structural damage, including collapse of the upper storey façade onto the street. Mr Peter Smith said in his report to the Royal Commission that the front façades rotated outwards at the point of connection above the windows and collapsed onto the footpath on Colombo Street.

Figure 41: Two views of the building after the February earthquake

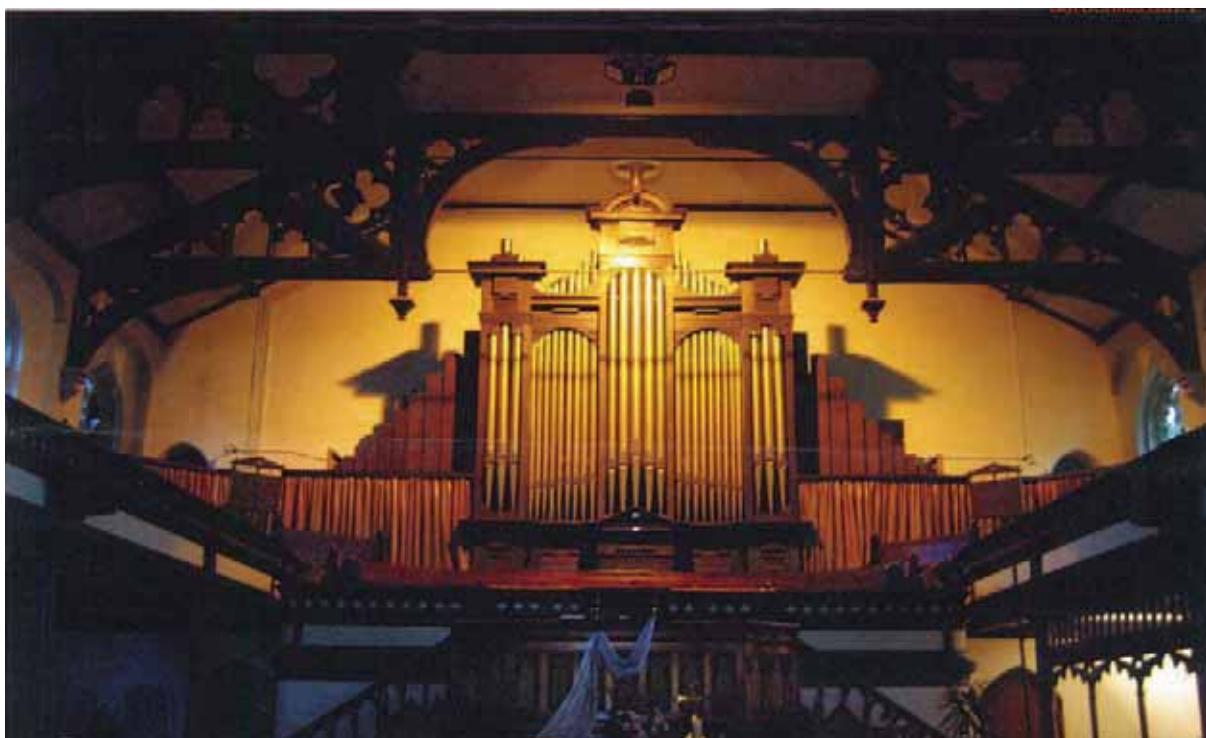
Figure 43: The organ in the Durham Street Methodist Church

The pipe organ had been inspected by the South Island Organ Company Ltd on 22 September 2010 and found to have sustained little damage. The decision was made to remove the organ from the church. Mr Wright explained that he understood this was necessary for remedial work to be carried out on the western wall of the church and he was advised that it could be done safely.

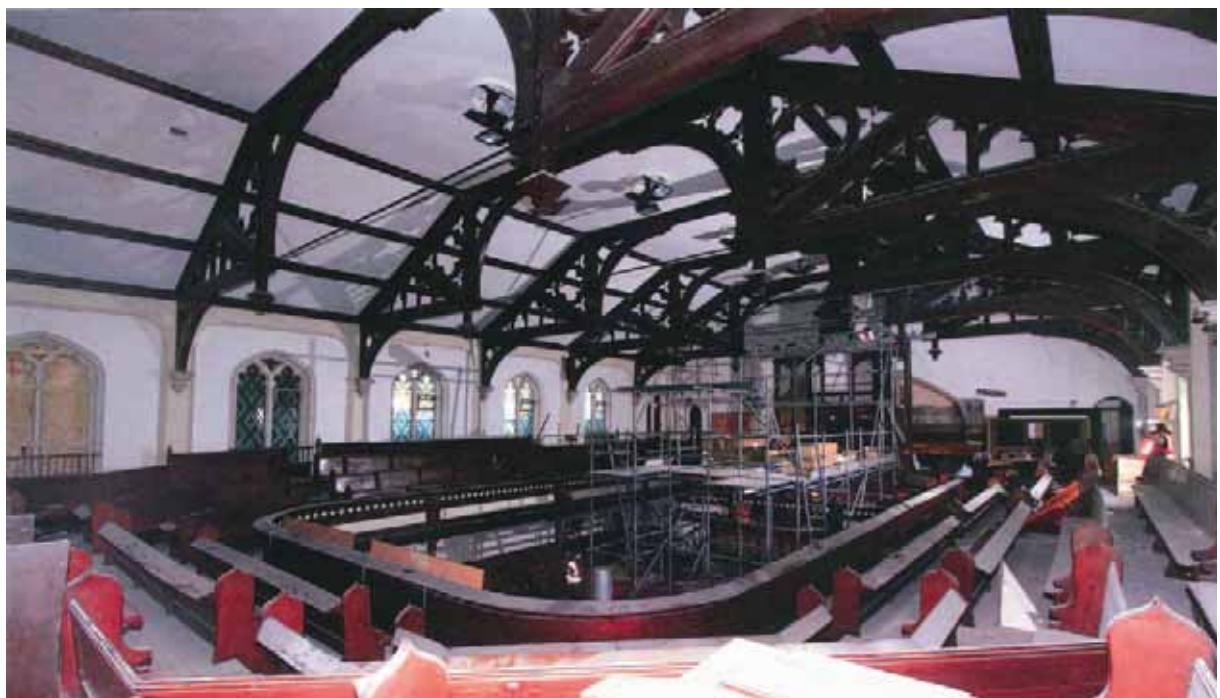
Figure 44: The interior of the church, showing scaffolding erected as part of the removal process

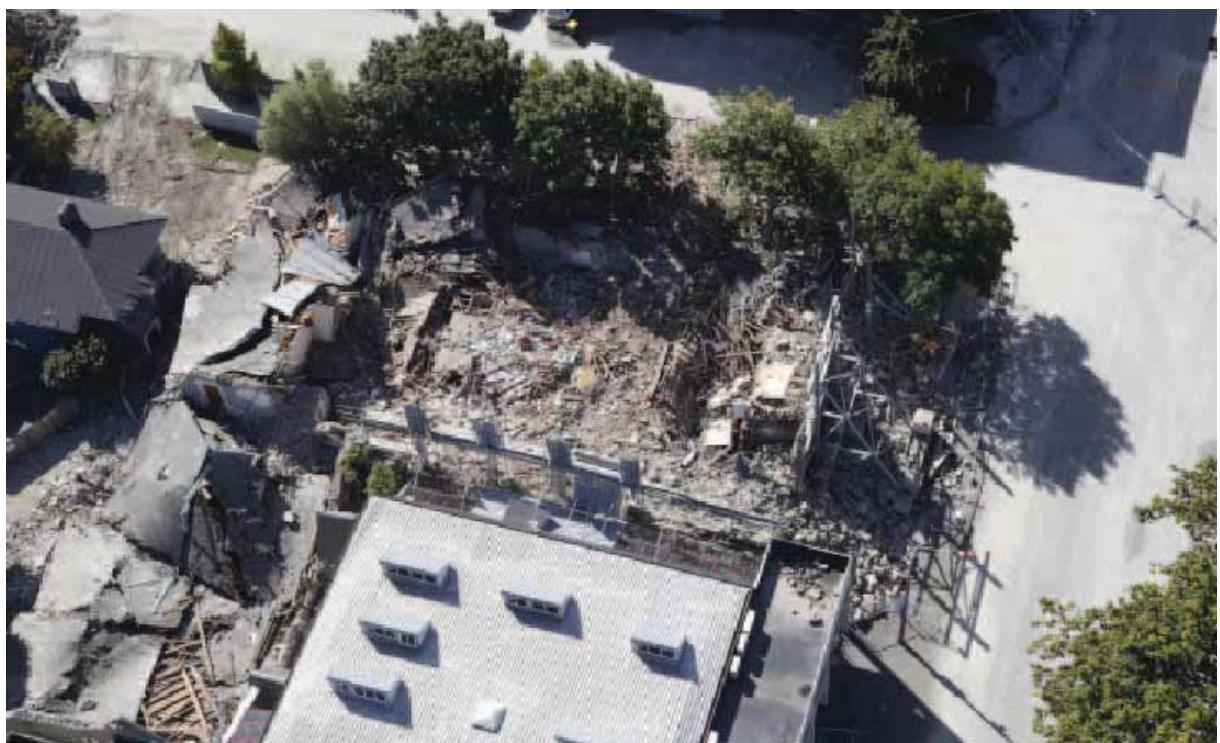
The company began removing the organ on 14 February 2011. The work was expected to take two weeks but was almost complete on 22 February. When the earthquake struck the church suffered a catastrophic collapse.

Figure 45: An aerial view of the Durham Street Methodist Church site after the February earthquake

Mr Peter Smith, who conducted an independent assessment of the failure of the building for the Royal Commission, said in evidence that the building effectively disintegrated in the high level of shaking, particularly the vertical acceleration that occurred during the February earthquake.

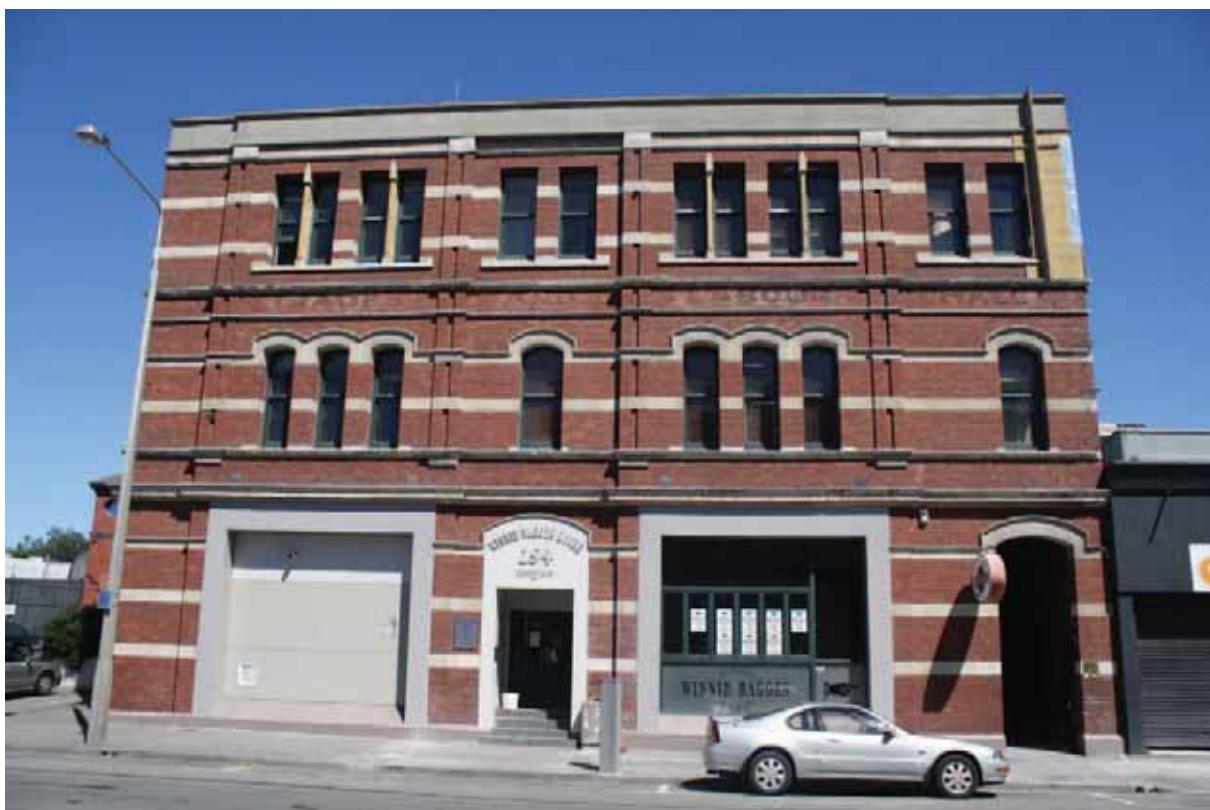
Figure 47: The front (northern) side of 194 Gloucester Street before the February earthquake

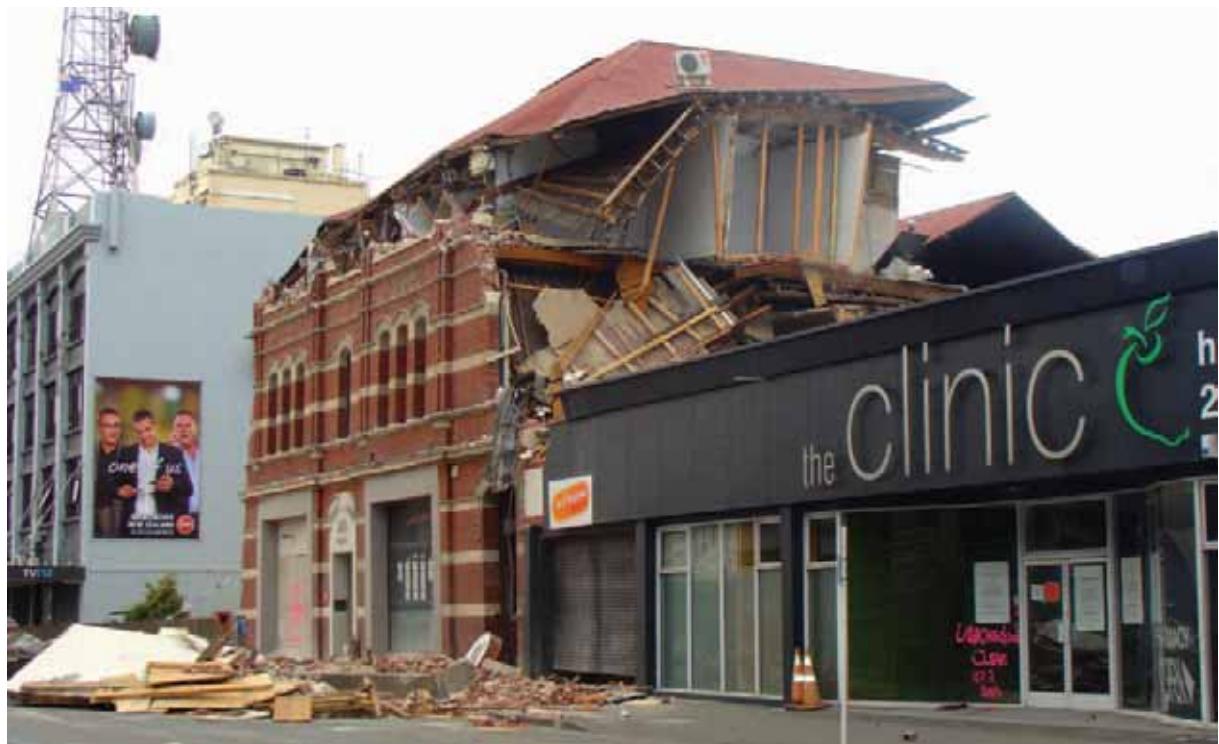
Mr Smith gave evidence that in the February earthquake the building suffered a substantial collapse of the eastern and western walls, and of the northern wall above second floor level.

Figure 48: The building after the February earthquake

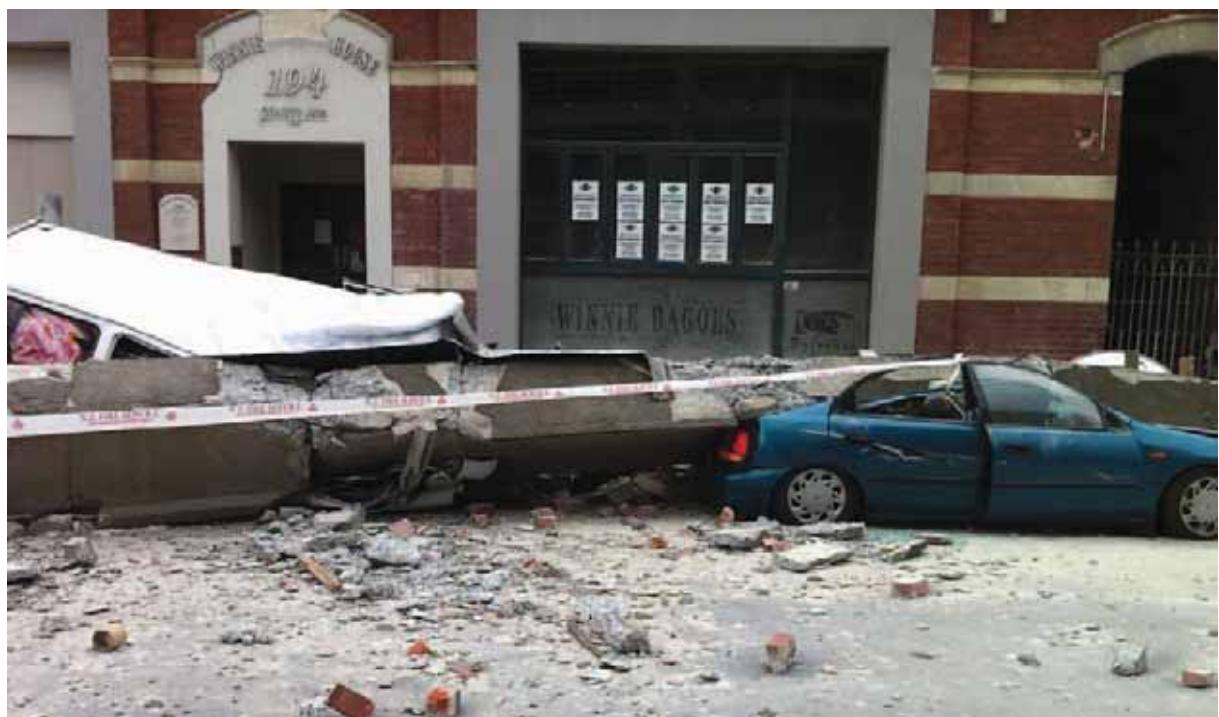
Figure 49: The front of the building after the February earthquake, showing the damaged van to the left

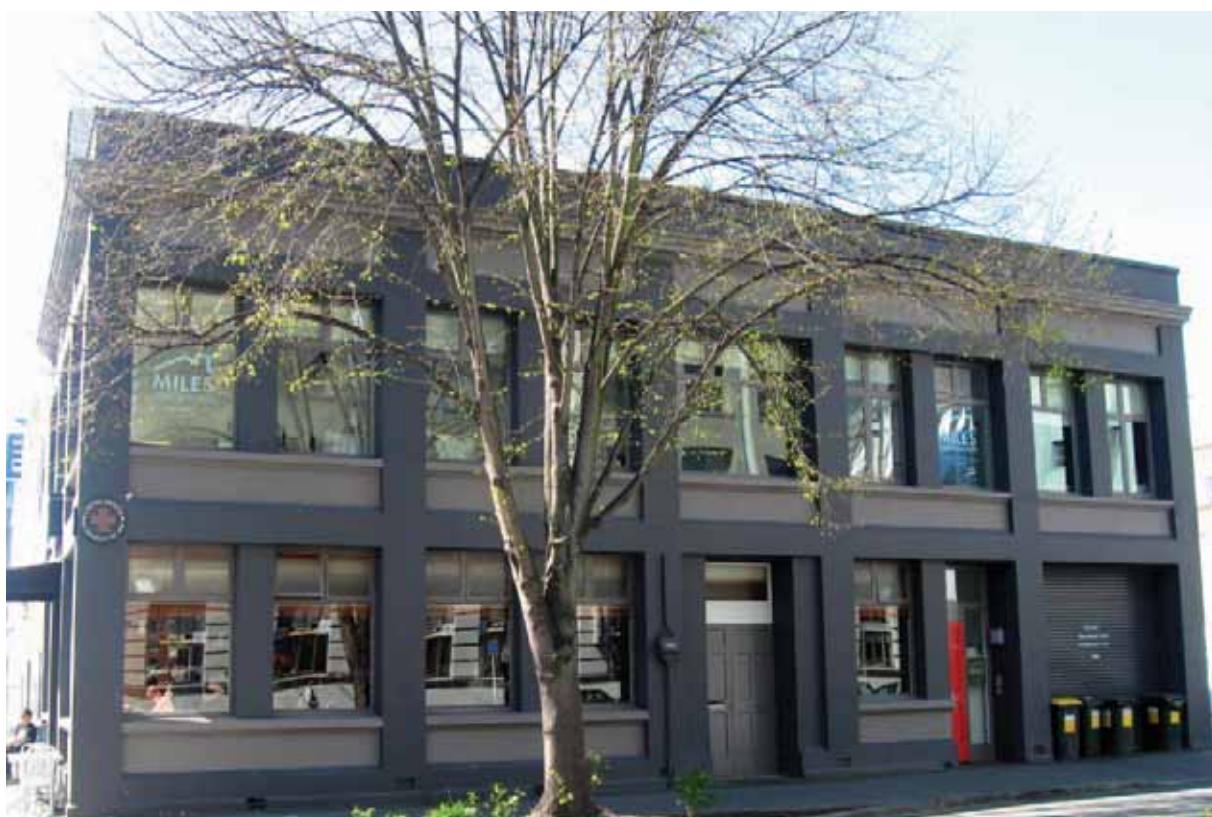
Figure 50: The western side of 194 Hereford Street (viewed from Liverpool Street) before 22 February 2011

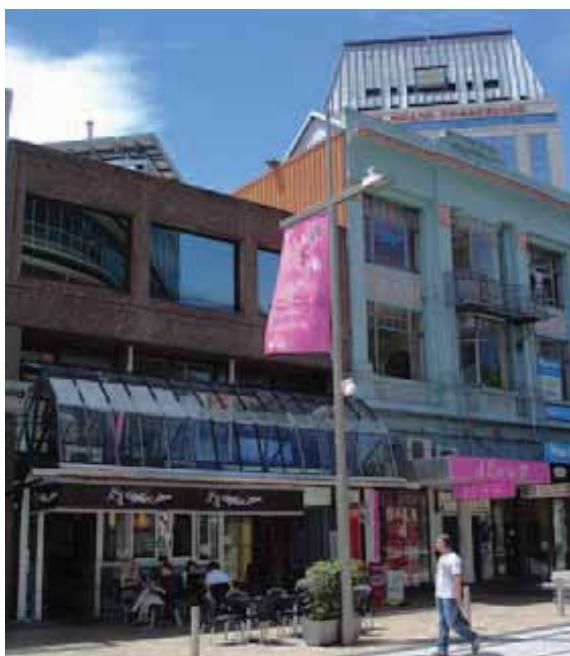
Figure 53: 246 High Street before the February earthquake, viewed from the north-west. The iron-clad mustard-coloured party wall can be seen at top centre

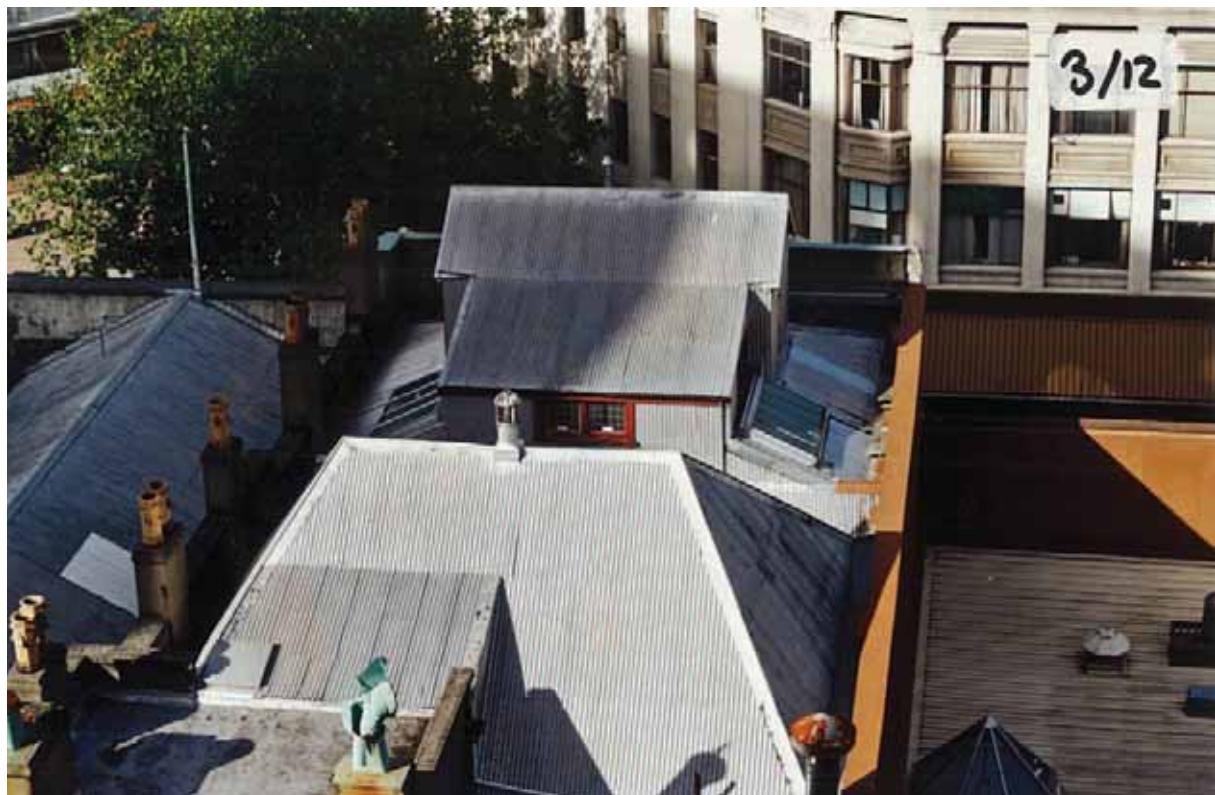
Figure 54: The roof of 246 High Street. The top of the mustard-coloured party wall can be seen on the right

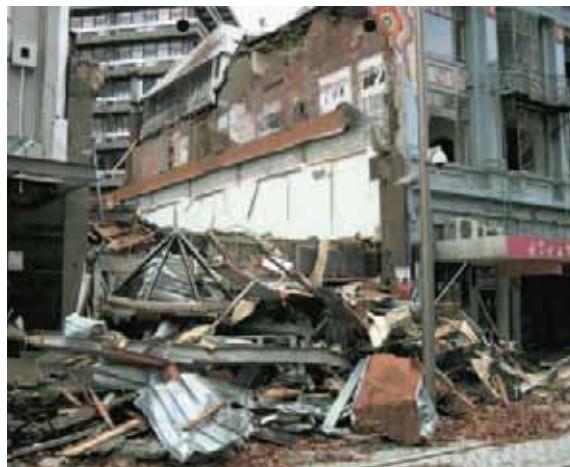
Figure 56: 246 High Street after the February earthquake

At the hearing, Mr Peter Smith, who prepared an independent report for the Royal Commission, raised a significant issue in relation to the northern wall of the building. By referring to a 1978 foundation plan for the Link Centre and a photograph, he was able to explain that the northern brick wall of 246 appeared to have been a party wall shared with the building that formerly occupied the Link Centre site before the Link Centre development. When that former building was demolished and the northern wall of 246 left exposed, the southern block wall of the Link Centre was built 25mm from the party wall. The portion of the third storey of the party wall that was exposed (the Link Centre being only two storeys) must subsequently have been covered in metal cladding to provide weatherproofing.

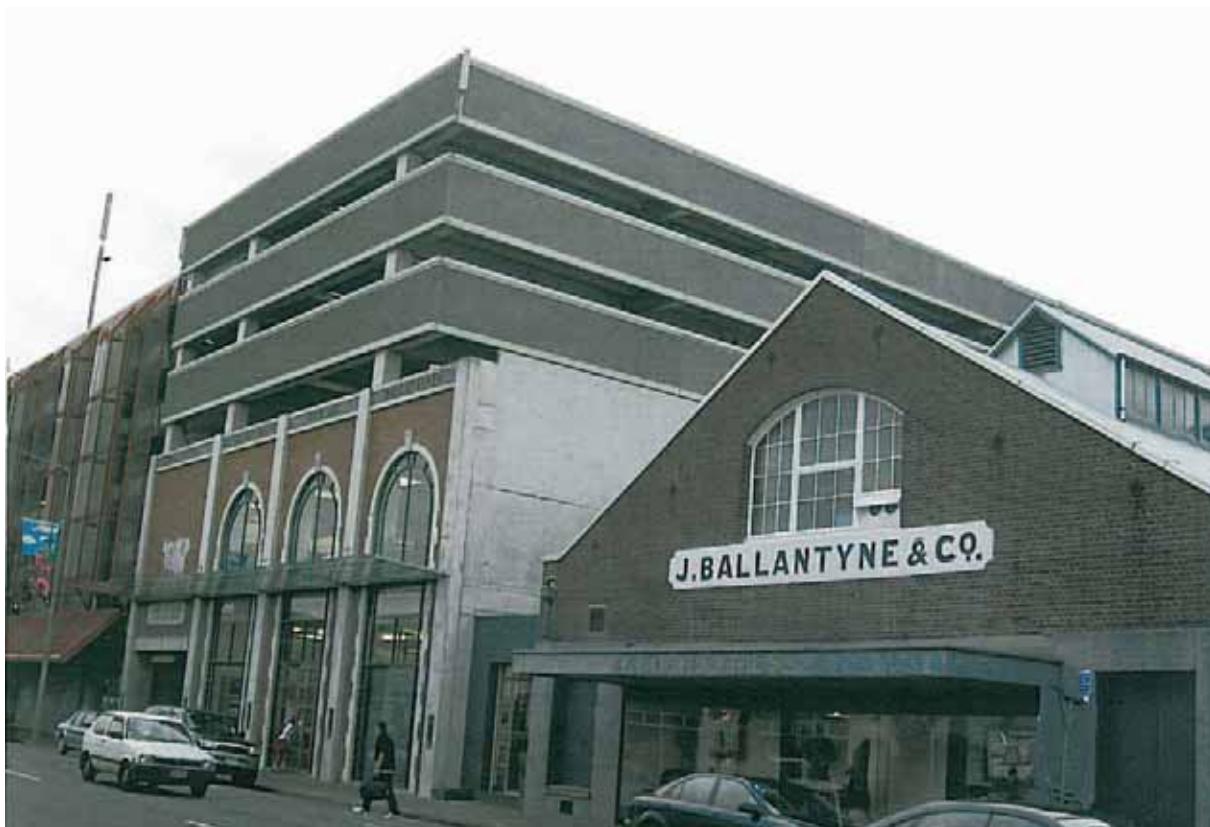
Figure 57: The southern frontage of the building at 43 Lichfield Street is shown at left in this photograph. The three rows of precast concrete façade panels can be seen above the frontage and along the eastern side of the building

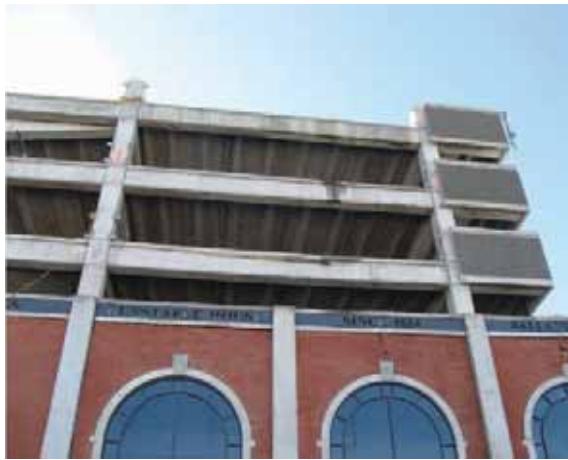
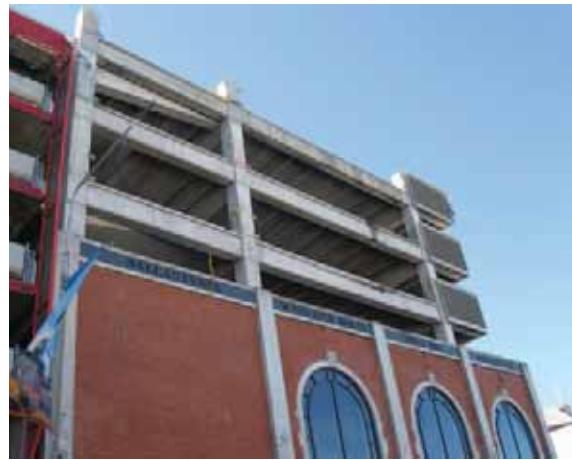
The building suffered widespread and significant damage in the February earthquake, indicating that it had been pushed close to its capacity for seismic loading. The damage included failure of transfer beams, column connection and column beam hinging, as well as shear displacement of beams and beam elongation. In addition, some of the spandrel panels on the southern side fell from the building.

Figure 58: The building after the February earthquake

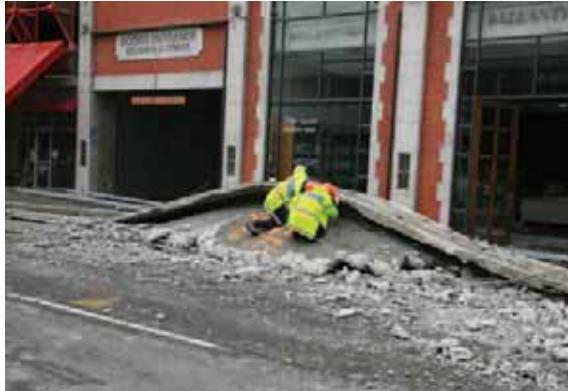
In evidence, Mr Dick Cusiel candidly acknowledged that the absence of the L-shaped cast-in ties on the spandrel panels on the southern side “contributed with the significant force of the earthquake to the spandrel falling away from the structure”. He described the absence of the ties as an omission. He said that the weld plates and angle cleats “were primarily there for the purpose of construction, to put the panels in place while the floor topping was poured. They were unlikely to have been sufficient to keep the panels in place in the event of a major earthquake”.

In a report to the Royal Commission, Mr Peter Smith said that the spandrel panel fixings for the southern side of the building did not comply with the Building Code that was current at the time. In evidence, Mr Dick Cusiel agreed with this. Mr Smith also said that, as the connections were significantly under strength and the earthquake shaking was in excess of the building code design requirements, failure of the spandrel panels was almost inevitable. Mr Cusiel also agreed with this.

Figure 59: A spandrel panel on Ms Arnold's car (left), and the site after removal of the spandrel panel

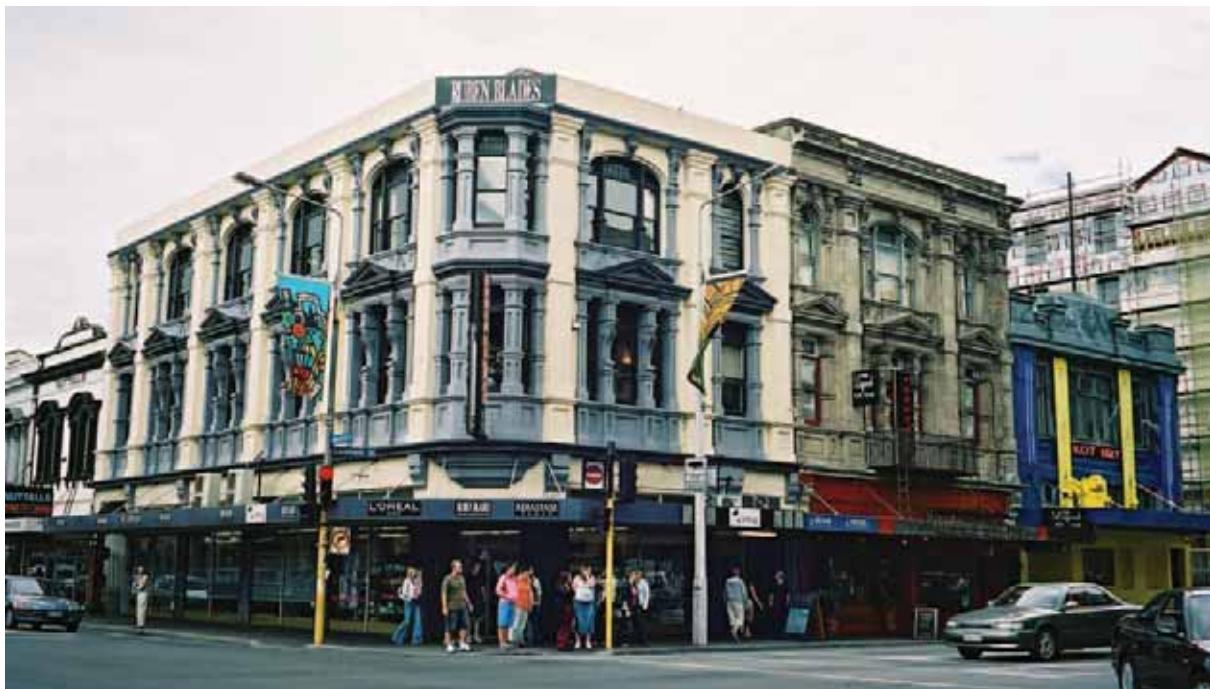
Figure 60: 116 Lichfield Street before the September earthquake

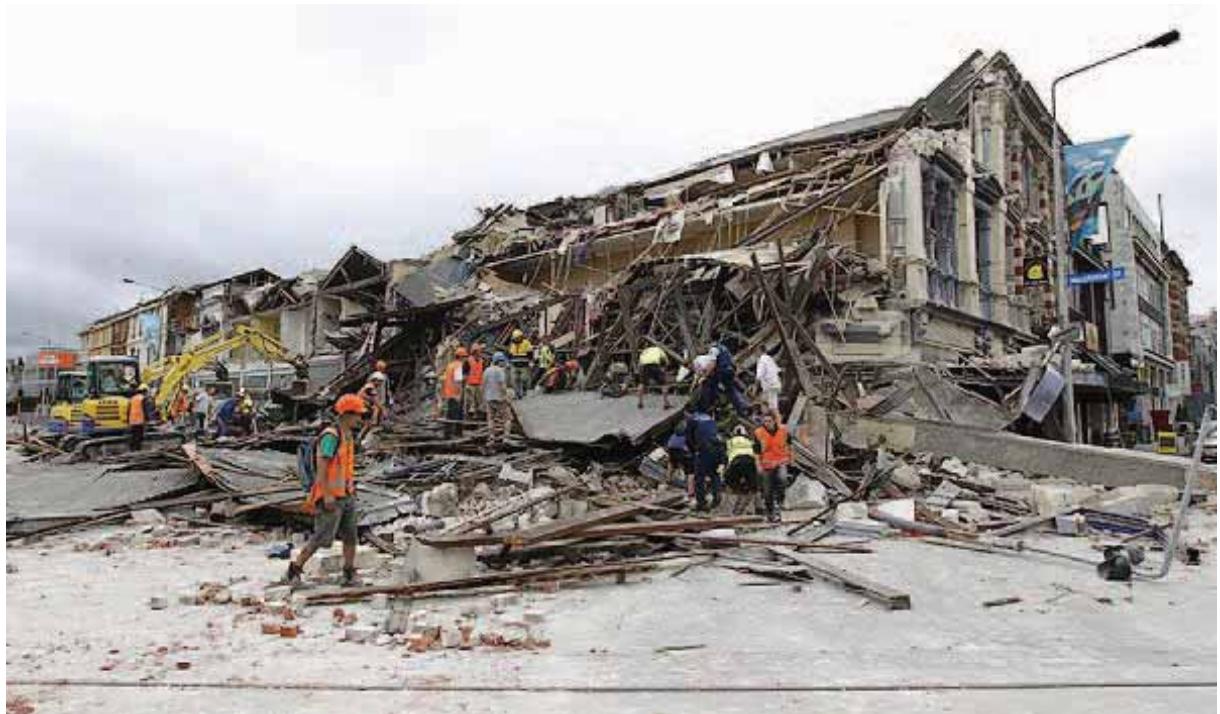
Figure 61: 116 Lichfield Street after the February earthquake

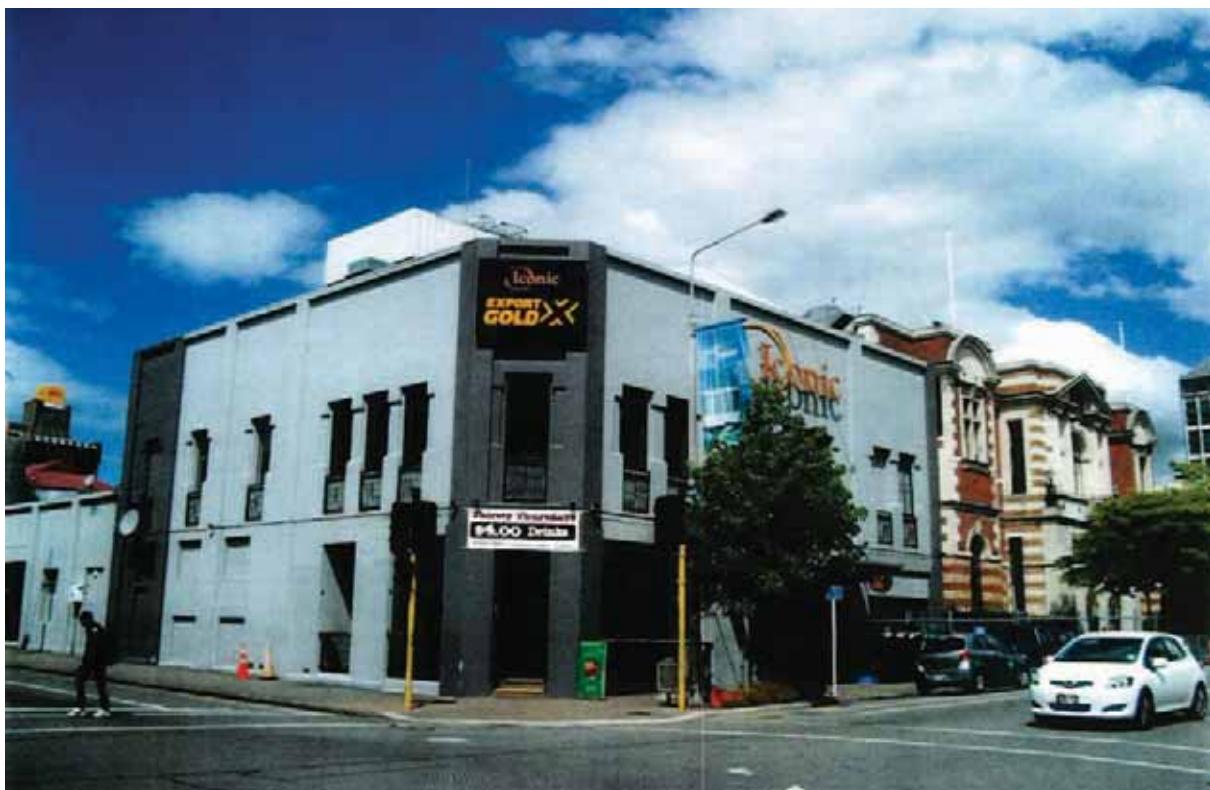
Figure 63: The building at the corner of 200–204 Manchester Street before the February earthquake

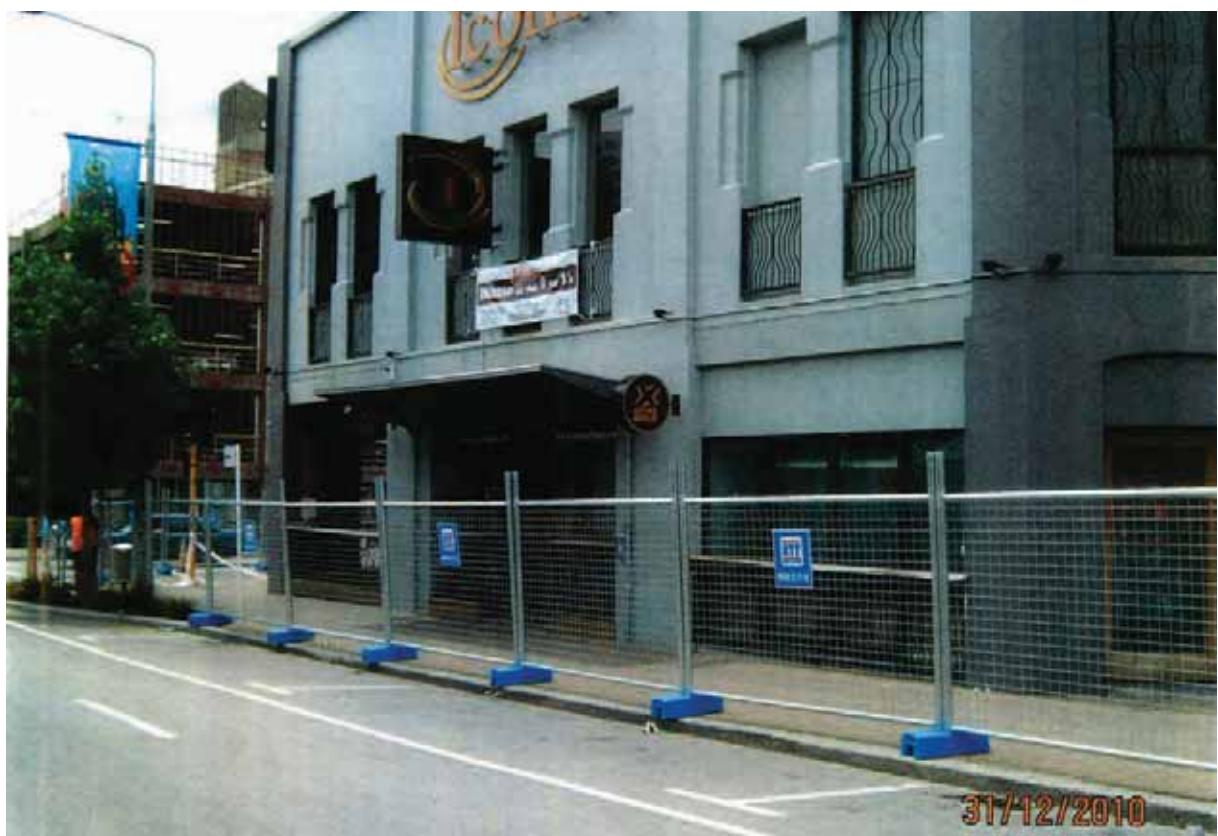
Figure 64: The western side of 200–204 Manchester Street after the Boxing Day earthquake
