# Canterbury Earthquakes Royal Commission

FINAL REPORT

VOLUME 4  
EARTHQUAKE-PRONE BUILDINGS

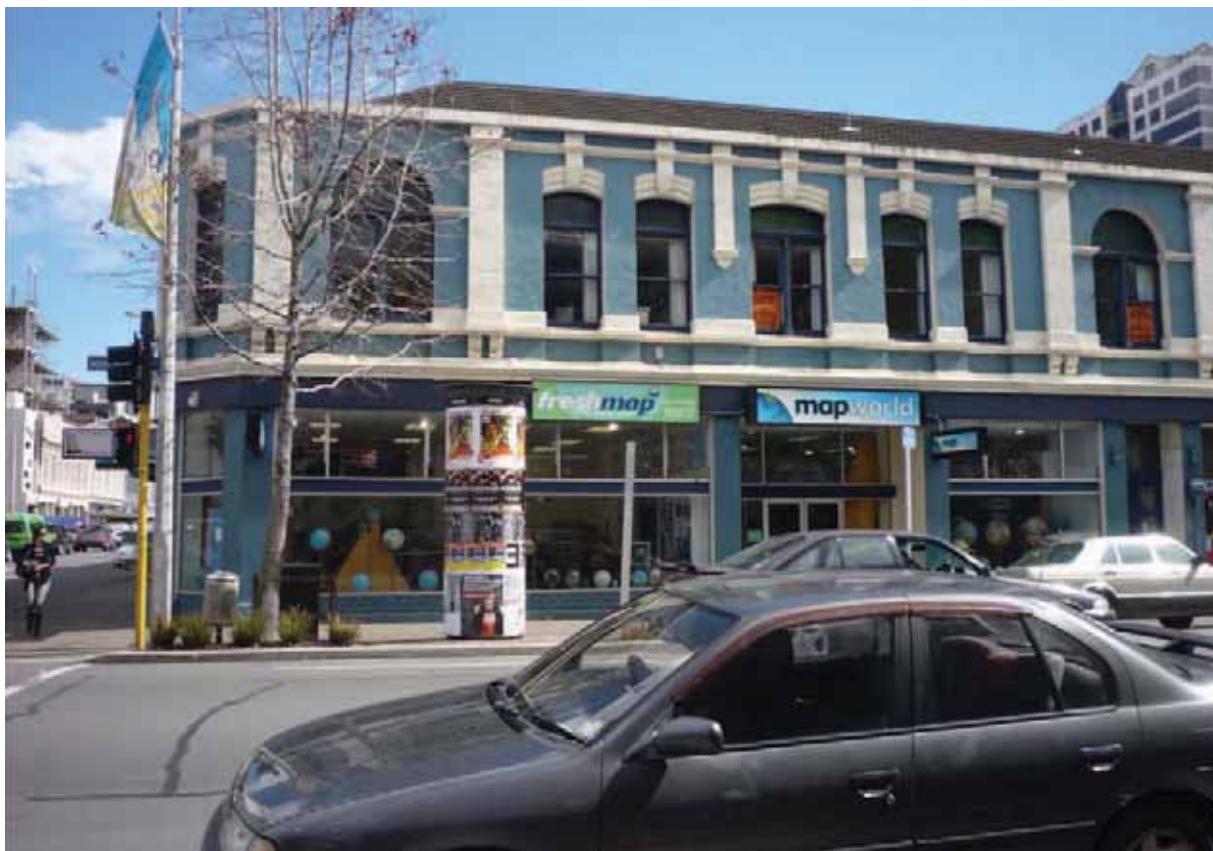
The building at 265–271 Manchester Street was a two storey unreinforced masonry (URM) structure on the corner of Manchester and Gloucester Streets. The address of the Gloucester Street frontage was 173 Gloucester Street.

Figure 67: The south-eastern section of 265–271 Manchester Street

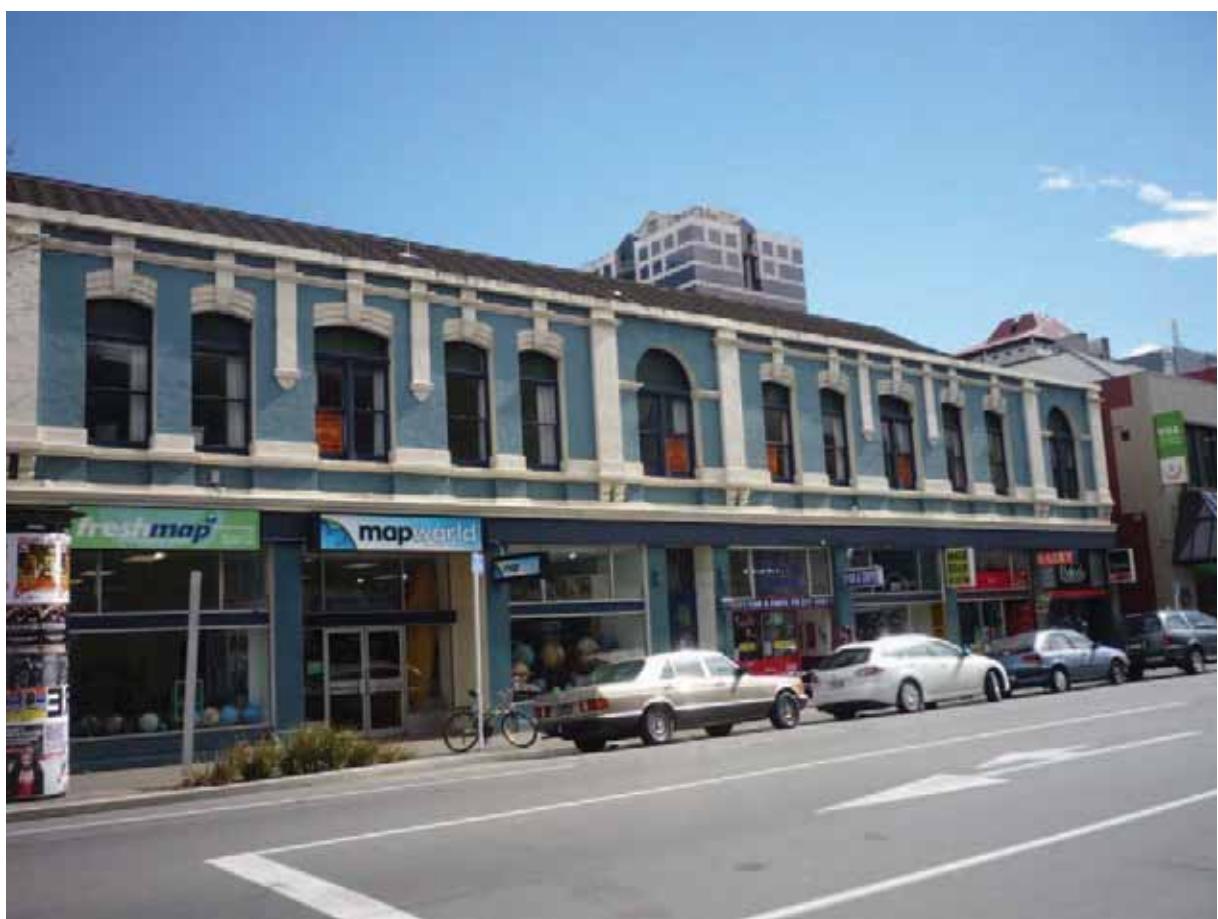
When the 22 February 2011 earthquake struck, Mr Christopher Smith was in his vehicle parked outside 269 Manchester Street, approximately in the position occupied by the car second from the right in Figure 68. The vehicle was severely damaged by rubble falling from the building. Police inquiries established that Mr Smith was rescued by the New Zealand Fire Service and taken across the road to the Orion building at 218 Manchester Street. Despite medical treatment and CPR, Mr Smith died as a result of his injuries.

Figure 68: The Manchester Street frontage of the building

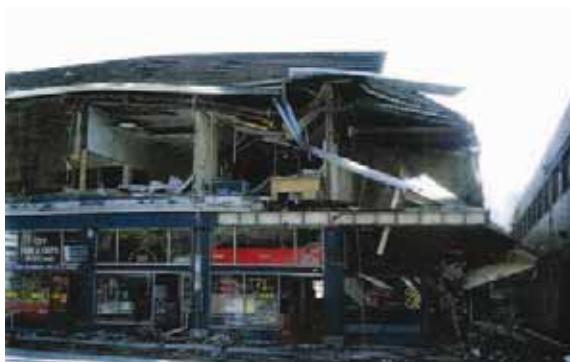
Figure 69: The building after the February earthquake

In the February earthquake the wall on the upper floor of the Manchester Street frontage almost entirely collapsed outwards into the street, including a large section of concrete bond beam on the top of that façade. The wall to the south façade on Gloucester Street suffered less damage, although there was more damage at its western end.

Mr Peter Smith expressed the view that, from his observations of the photographs taken after the February earthquake, it appeared that the façades had been very poorly secured and the concrete bond beam was effectively only restrained by gravity. It was also off centre, which would have increased the risk of its falling from its position on top of the brick façade.

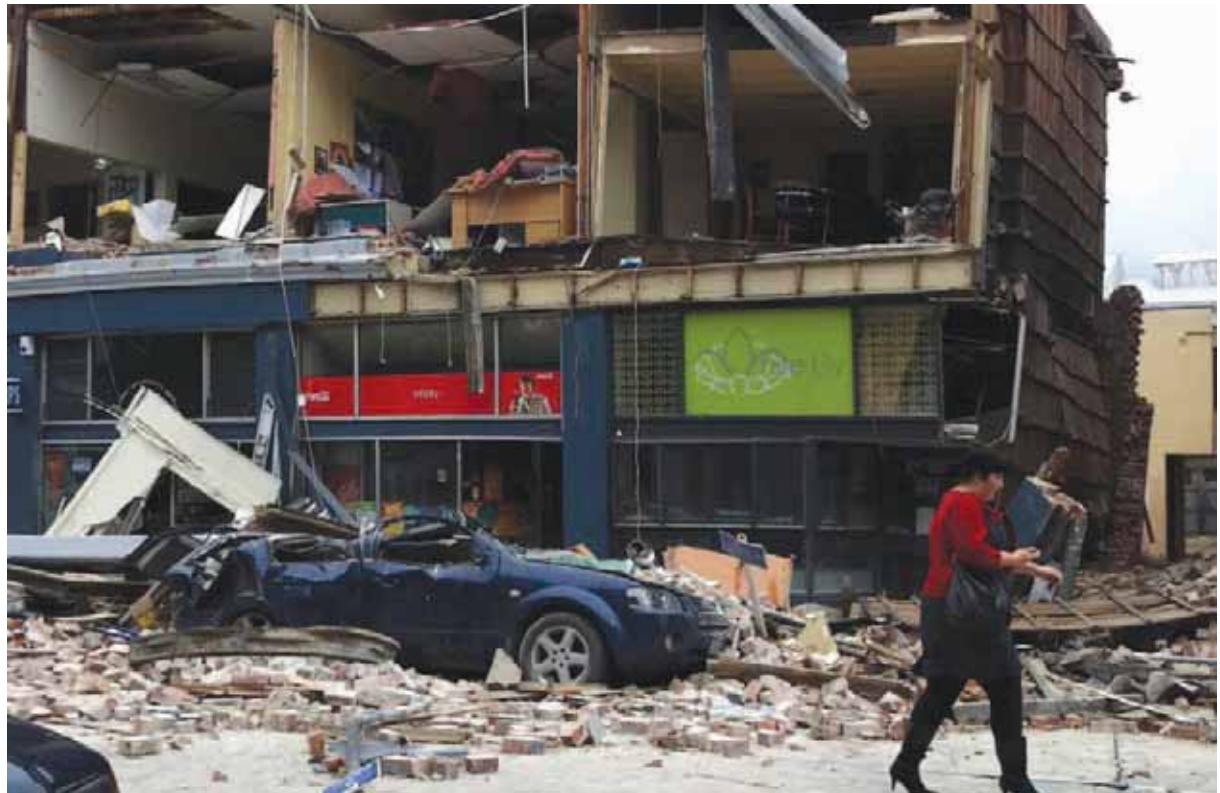
Figure 70: The area outside 269 Manchester Street after the earthquake

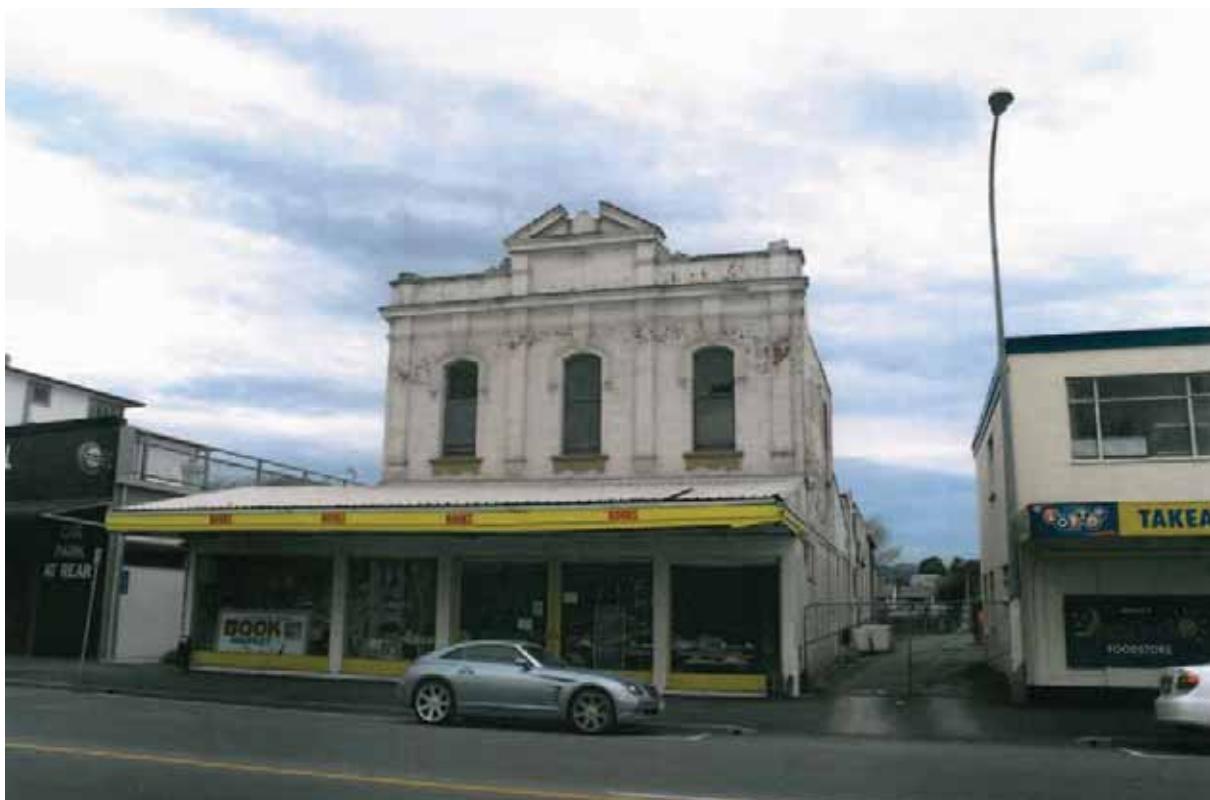
Seismic risk and hazardous appendage surveys in 1991 and 1993 respectively had noted cracking to the parapet, the former recommending remedial action within two years. No action was taken by the owner or the CCC at that time or subsequently.

Figure 71: The building at 7 Riccarton Road before the September earthquake

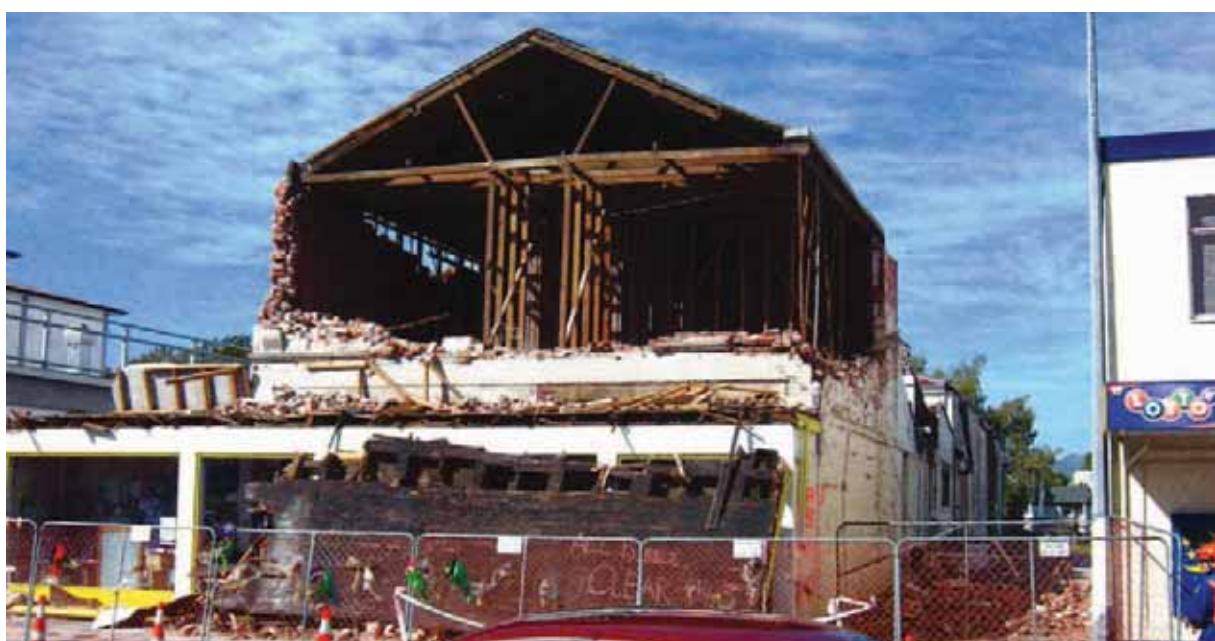
Mr Peter Smith, who carried out an independent assessment for the Royal Commission of the performance of the building in the February earthquake, said that the failure mechanism was an outward rotation of the entire Riccarton Road façade about its first-floor wall support, primarily caused by inadequate restraint at roof level.

Figure 73: The building after collapse (following removal of rubble)

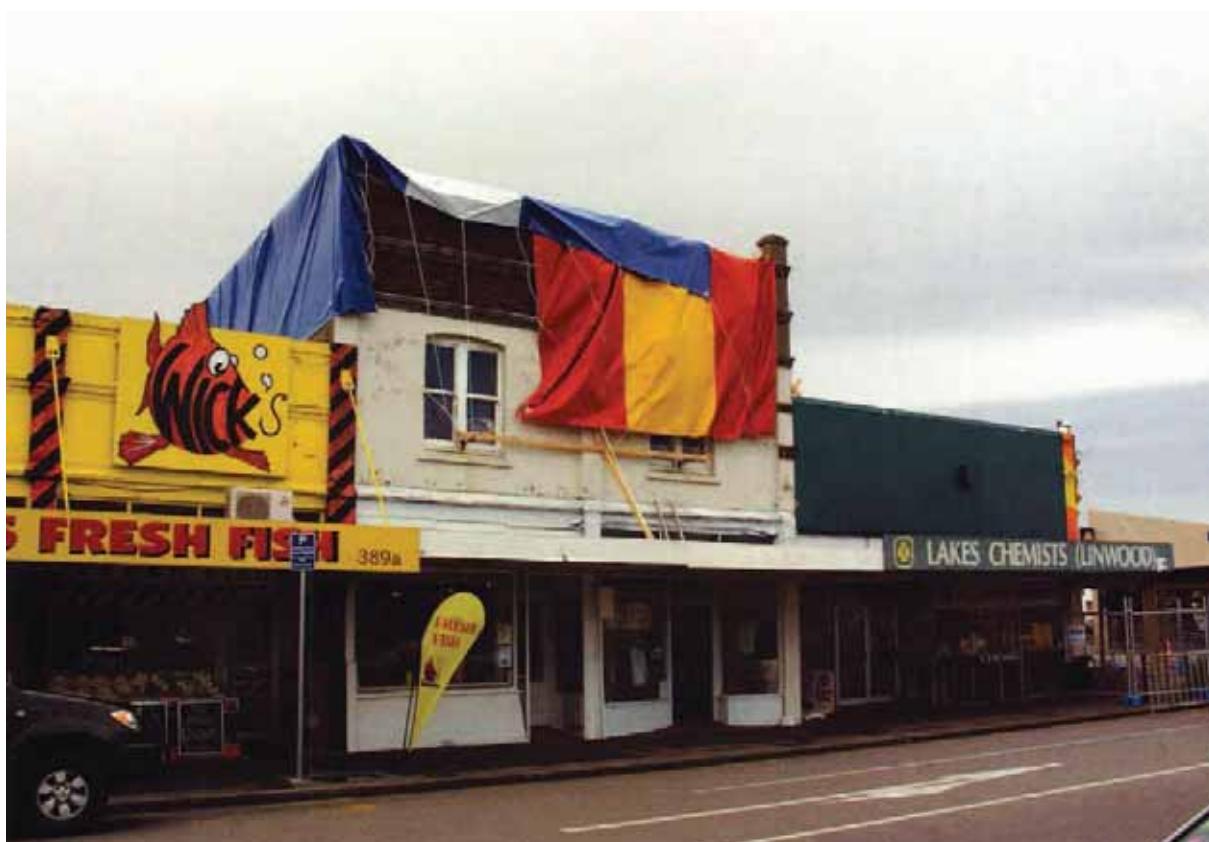
Figure 74: The building at 391 and 391A Worcester Street, with tarpaulins on its roof after the September earthquake

As the building was outside the CBD, there was no CCC rapid assessment after the September earthquake. However, the building was damaged when the parapet on the Worcester Street frontage collapsed back onto the roof, damaging the roof framing. Make-safe works were carried out and tarpaulins placed over the roof and the western wall to make the building weathertight. An assessment of the western wall at that time by the contractor, Contract Construction, concluded that it did not appear damaged, but the eastern wall was damaged and was propped with timber bracing against the roof of the adjoining building.

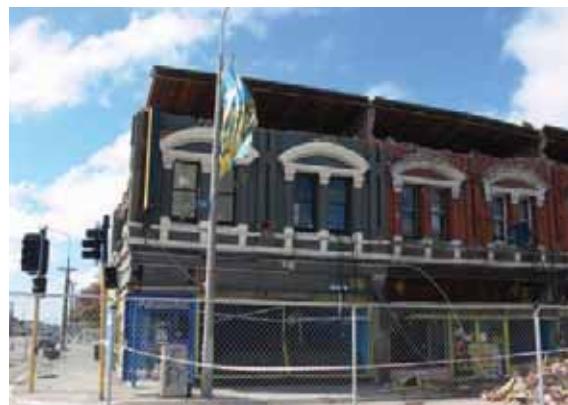
A parapet is the vertical wall element that protrudes above the roofline. These, along with chimneys and ornaments, have little lateral load capacity and present the greatest hazard to life due to their location at height. Numerous unrestrained parapets, as well as some that had been strengthened, collapsed during the Canterbury earthquakes. If unrestrained, a parapet will act as a vertical cantilever that rocks at its base. Parapets were seen to fail around their roof line both inwards onto the buildings as well as outwards onto streets and public spaces. Before and after photographs of the building at 386–406 Colombo Street in Figures 85 and 86 illustrate that parapets were some of the most vulnerable, and generally the first, building elements to collapse.

Figure 86: 386–406 Colombo St after the February 2011 earthquake (source: Ingham and Griffith)

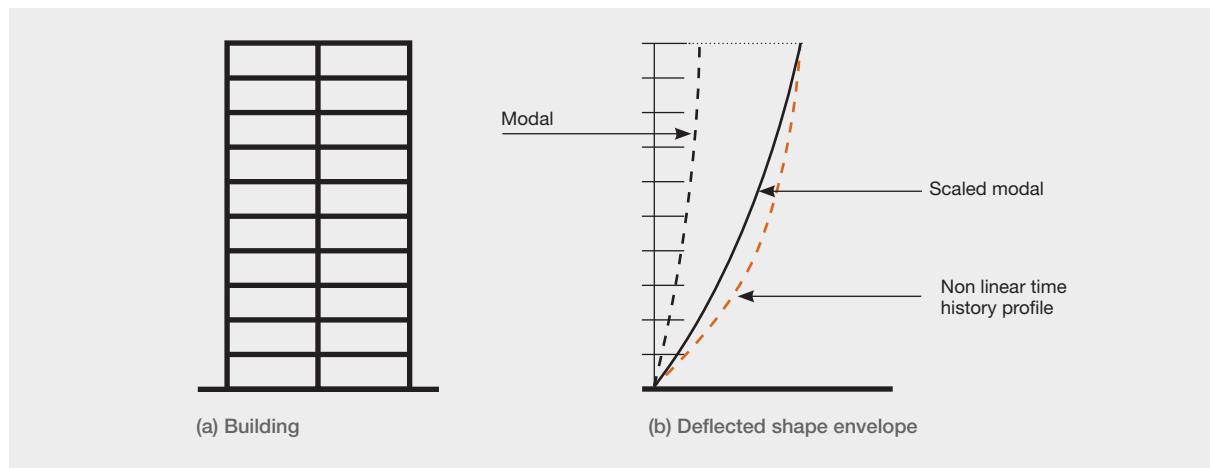
**Figure 88: Drift modification factor**

Peak inter-storey drifts predicted by inelastic time history analyses are found to be appreciably higher than the corresponding values predicted from equivalent static and modal response spectrum methods. Figure 88 illustrates the difference that has been observed. To allow for this discrepancy a drift modification factor was introduced into NZS 1170.5:2004<sup>4</sup>. When assessing the performance of an existing building against current design criteria it is important to allow for the drift modification factor.

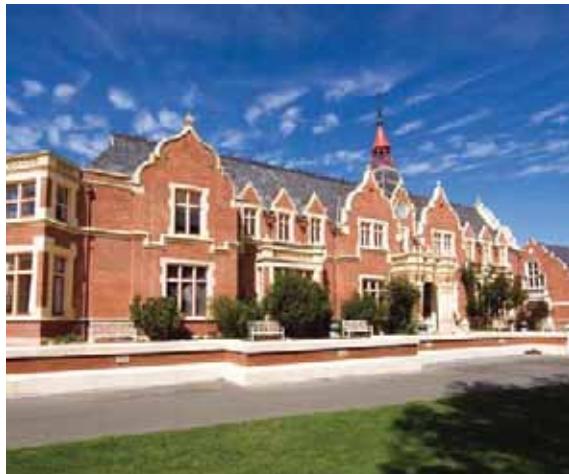
## Ivey Hall, Lincoln University

The Ivey Hall building at Lincoln University was originally constructed in 1880 as a residence for students and the Director of the School of Agriculture. Extensions were made in 1881, 1918 and in 1923. The building was a two storey unreinforced concrete and brick building structure of approximately 38m x 38m in floor plan area. The building includes many ornate features including gable walls with parapets and a tower and clock above the main entrance.

The structural retrofit of this building involved the complete removal and replacement of the original internal structure and was carried out in 1986. This makes the work more of a façade retention and rebuild than a retrofit. A new slab on ground was installed at the lowest level, with spray concrete installed to the inside of all external walls from this new slab up to the parapet level. A series of shear walls were installed towards the northern end of the building from the ground floor to the ceiling level of the upper storey. An entirely new level 1 floor structure was installed using a rib and infill system supported on reinforced concrete beams and columns. The new high level ceiling system includes a combination of a ply diaphragm and steel angle cross bracing. The pitched roof has a series of tubular steel trusses.

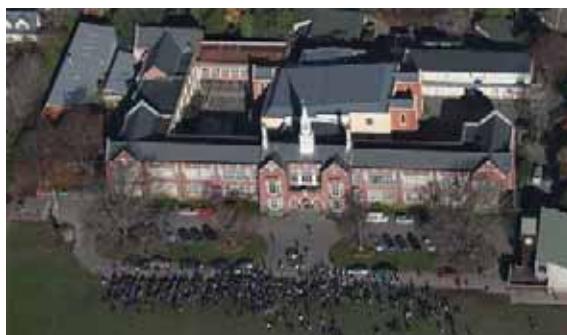
### Christchurch Boys' High School, Main Block

The Main Block at Christchurch Boys' High School was built at the Te Kura Street, Riccarton site in 1926. The Main Block includes a two storey brick masonry building approximately 100m long and 12m deep. The building includes an ornate concrete clock tower above the main entrance.

The structural retrofit, designed in 1987, included the installation of shotcrete (spray concrete) to the inside face of all of the existing brick walls in order to increase the strength of these walls. Both the shotcrete to the external walls and the new internal walls were installed from the footings up to the roof structure. Dowel bars were used to tie the brickwork to the new concrete structure. Internal concrete walls were also added in both the longitudinal and transverse directions to resist lateral loads in both directions. The existing level 1 concrete floor system was retained and tied into the retrofit works. Other items strengthened included the clock tower, using an internal shotcrete lining and the brick parapets, which were restrained with structural steel members fixed to the back of the parapet and attached to the roof structure.

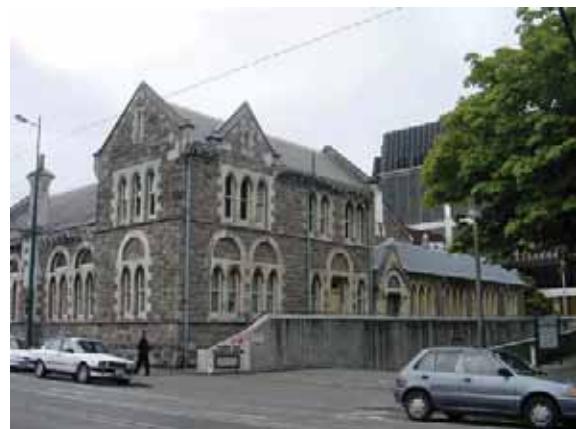
### Family Court, Christchurch

The Family Court building, located at 85 Armagh Street in Central Christchurch, was first constructed as the Magistrates Court in 1881, with a series of additions added in 1908. The building is listed with the Historic Places Trust as a Category I Historic Building. The building is a stone clad brick structure with a single story section in the south west and north east corners and two storey sections in the south east and north corners. The floors in the strengthened building are typically reinforced concrete slabs and the roof structures are constructed from timber framing. The building includes high gable end walls on the western façade, large ornate chimneys and parapets in several locations.

The structural retrofit carried out in 1997 involved the removal of one layer of the internal brick wall and the installation of a 150mm thick reinforced shotcrete lining, dowelled on a regular pattern to the existing masonry walls. The original ground floor timber frame floor was removed to allow the shotcrete to continue to the footings. The timber-framed ground floor system was replaced with a concrete rib and timber infill floor system. Steel members were introduced into the roof structure in the single storey section in the south west corner. For the two storey sections, the original timber floor systems were set into the new concrete lining. Individual dowel bars were used to restrain the parapet capping stones.

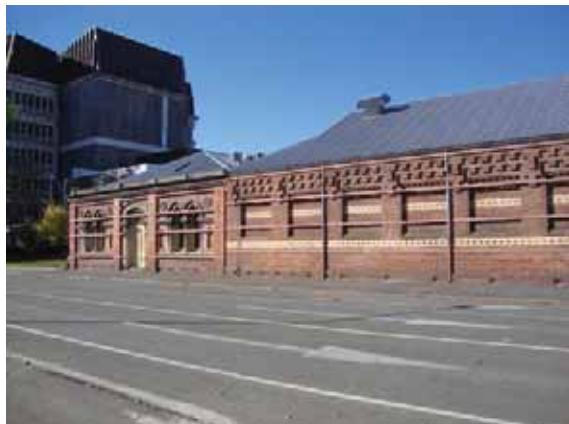
## Environment Court, Christchurch

The Christchurch Environment Court did not perform well and suffered moderate to severe damage as a result of the February 2011 earthquake.

The Environment Court building at 282–286 Durham Street, Christchurch, was constructed for the Canterbury Society of Arts in 1890 as a gallery space. A second adjacent building of similar design was added in 1894. The buildings were constructed of unreinforced brick masonry with steel roof trusses. Both buildings had few external windows in order to provide internal wall space to display the art. The buildings were essentially a high single storey building, though there was a two level section towards the rear of the building. The buildings were acquired by the Ministry of Justice in 1972, when the space was renovated into two court rooms with judge's chambers and jury rooms. At this time, a reinforced concrete block extension was added to the rear adjacent to Armagh Street.

The building was strengthened in 1972. The strengthening included removing ornate decorations and a series of steel elements were added. These steel elements included vertical channel sections under the existing steel roof trusses, and horizontal channel sections internally at approximately quarter points up the height of the walls. Externally, steel bands were added and fixed back to the internal channels. Plate cross bracing was added to the roof and also to a number of wall sections.
