Inquiry 12-001: Hot-air balloon collision with power lines
and in-flight fire, near Carterton,
7 January 2012

Final Report

Aviation inquiry 12-001
Hot-air balloon collision with power lines and
in-flight fire, near Carterton,
7 January 2012

Approved for publication: October 2013

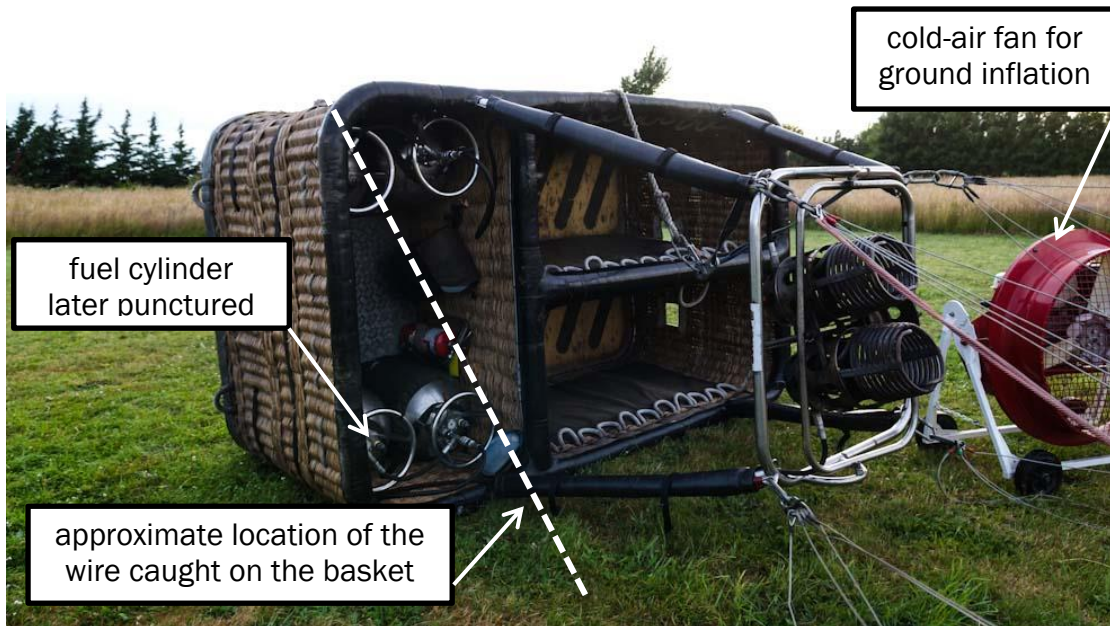
Figure 4
Basket attached to ZK-XXF

- 3.7.4. The basket measured 2.6 m long, 1.52 m wide and 1.125 m high (see Figure 4). The pilot's compartment was at one end and contained the fuel cylinders, fuel hoses, fittings, instruments, a 1 kg powder fire extinguisher and other equipment. The equipment carried in ZK-XXF met the requirements specified in the balloon flight manual. Other equipment included an emergency lighter should the pilot lights for the burners extinguish, and a drop-line that could be dropped to persons on the ground to pull the balloon to a safe area should it become becalmed near obstacles. The pilot had also installed a small aluminium platform to provide easy access to the burner controls.

- 3.7.6. Padding was fitted to the top of the basket, allowing occupants to lean on it for a better view and to help entry to and exit from the basket using steps located at each end. Padding also covered the 4 support rods attaching the basket to the burner frame. The burners were mounted within the frame and were connected to the fuel cylinders by flexible hoses that ran down 2 of the support rods to the 4 fuel cylinders located on 2 sides of the pilot's compartment. Connectors and 2 cross-feed valves allowed the burners to be supplied from any one or a combination of cylinders. Fuel flow from the cylinders could be shut off using a single-action tap located on the top of each cylinder. Any fuel remaining in the lines after the tap had been turned off was vented through the burners. (See Figure 4.)

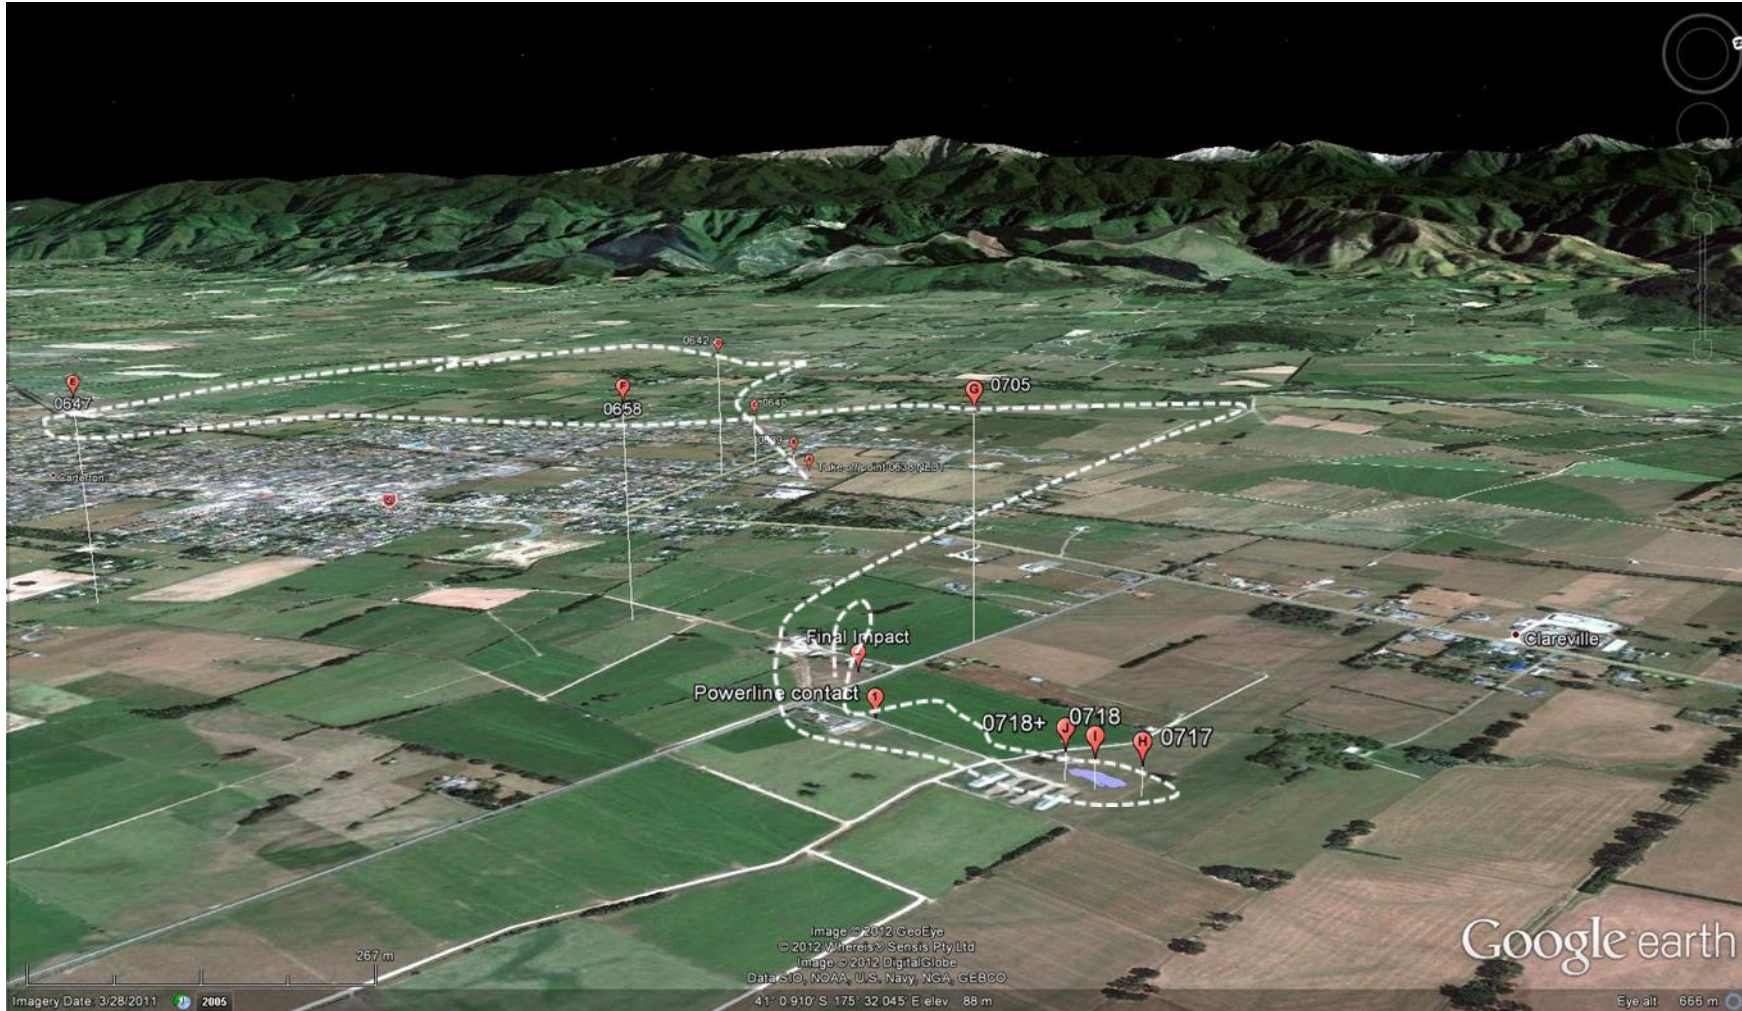
Figure 5
 Approximate flight path of ZK-XXF
 (Image courtesy of Google Earth)

- 3.8.2. The GPS track followed the flight path shown in Figure 5. After lift-off the balloon averaged a groundspeed of about 10 km per hour as it climbed steadily to an altitude of about 470 m. At 0709, as the balloon approached State Highway 2, the balloon descended to about 244 m. During the next 2 minutes, as the balloon passed near the intersection of State Highway 2 and Somerset Road, it climbed to about 594 m. The last recorded data was at 0711:07 near the intersection of State Highway 2 and Somerset Road. Shortly after that the balloon was seen to start descending in a south-easterly direction close to Somerset Road and towards the accident area (see Figures 5 and 6). The remainder of the flight path was calculated from witness accounts and photographic evidence.
