Inquiry AO-2014-006: Robinson R44 II, ZK-HBQ, mast-bump and
in-flight break-up, Kahurangi National Park, 7 October 2014

Final Report

Aviation Inquiry AO-2014-006
Robinson R44 II, ZK-HBQ, mast-bump and
in-flight break-up, Kahurangi National Park,
7 October 2014

Approved for publication: February 2017

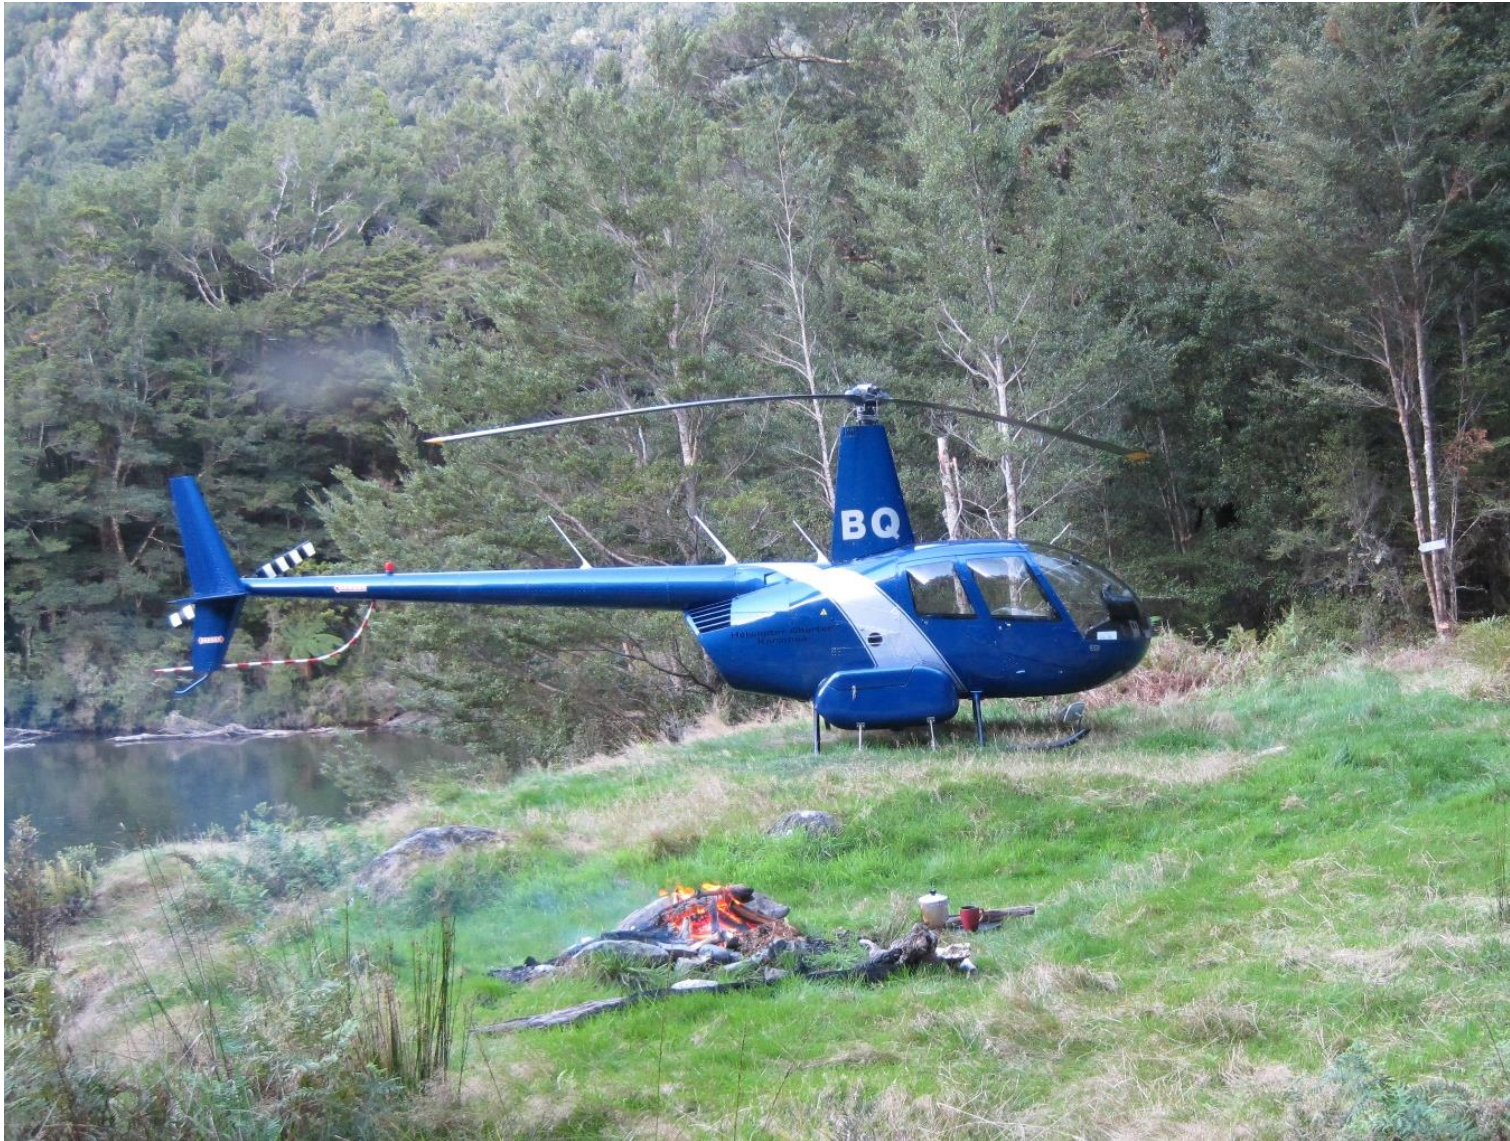
ZK-HBQ R44 II (source: Helicopter Charter Karamea)

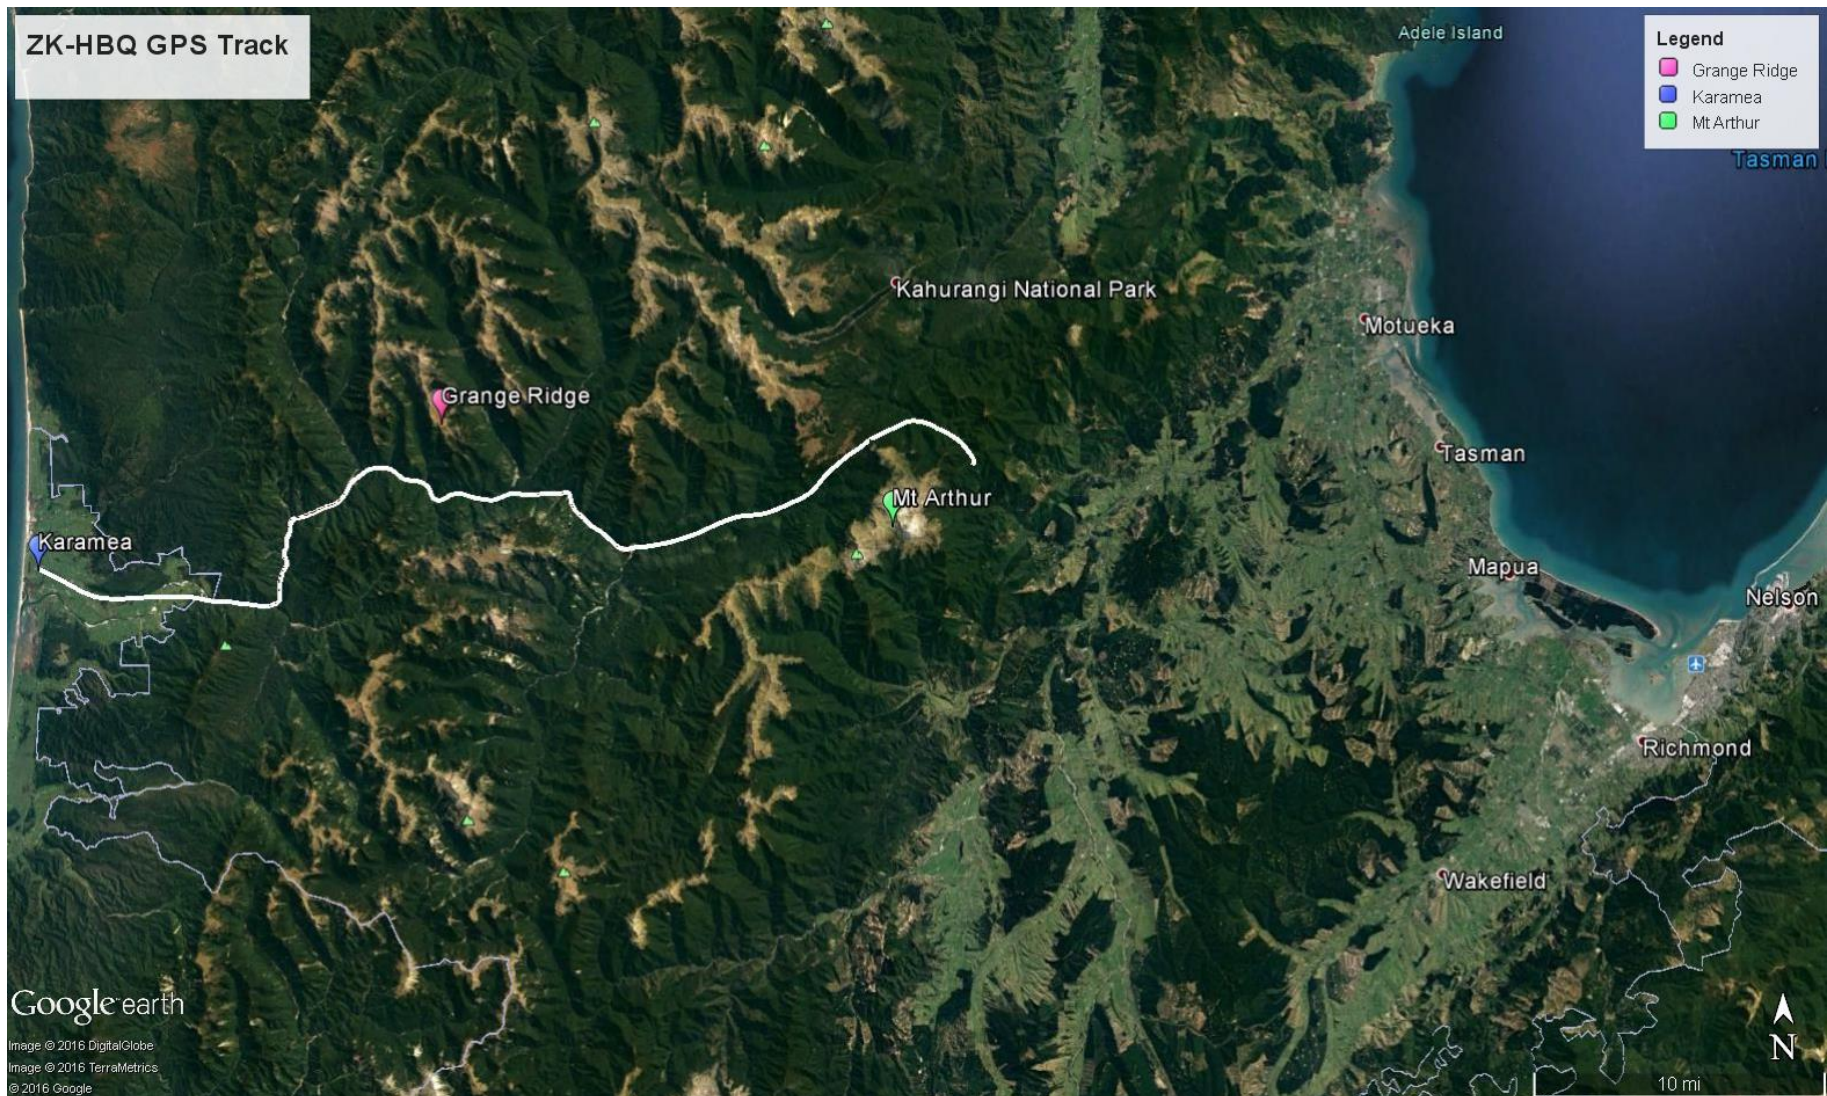
Accident flight GPS track (source: Google Earth™)

- 3.1.4. Based on GPS⁵ and flight tracking data⁶ (see Appendix 1), the pilot departed Karamea aerodrome at about 0740 and flew up the Karamea River at about 500 feet above ground level (AGL). He then followed the Leslie River up to the Tablelands area to the west of Mt Arthur, before flying up the Flora Stream towards the Flora Saddle at about 500 feet AGL. That was a different route from that recommended to him by the owner. The pilot crossed over the Tasman Ranges to the northeast of Mt Arthur and approximately 500 metres to the southwest of the Flora Saddle at a height of about 350 feet AGL.

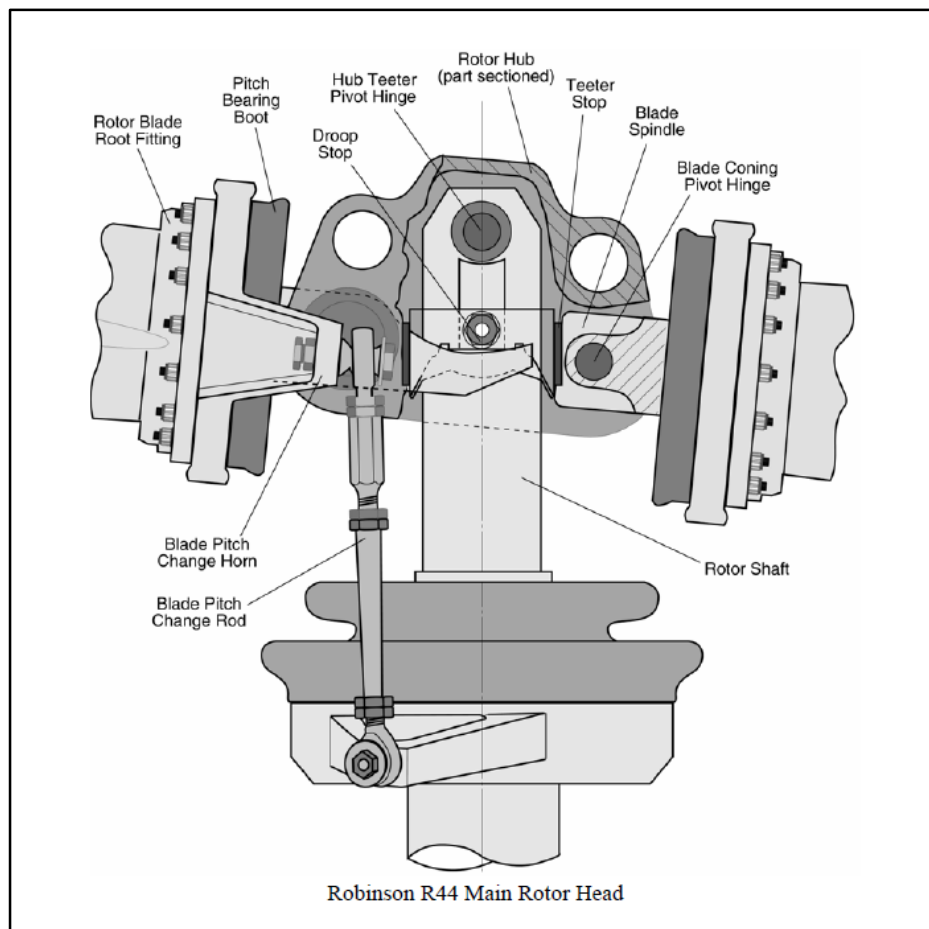
Figure 1
Robinson helicopter rotor head (source: AAIB)

- 3.3.4. All three Robinson types have two-bladed, semi-rigid teetering¹⁴ main rotors. The blades have independent coning¹⁵ hinges, a feature unique to Robinson (see Figure 1). Pilots flying helicopters with two-blade, teetering main rotor systems must avoid low-G¹⁶ conditions

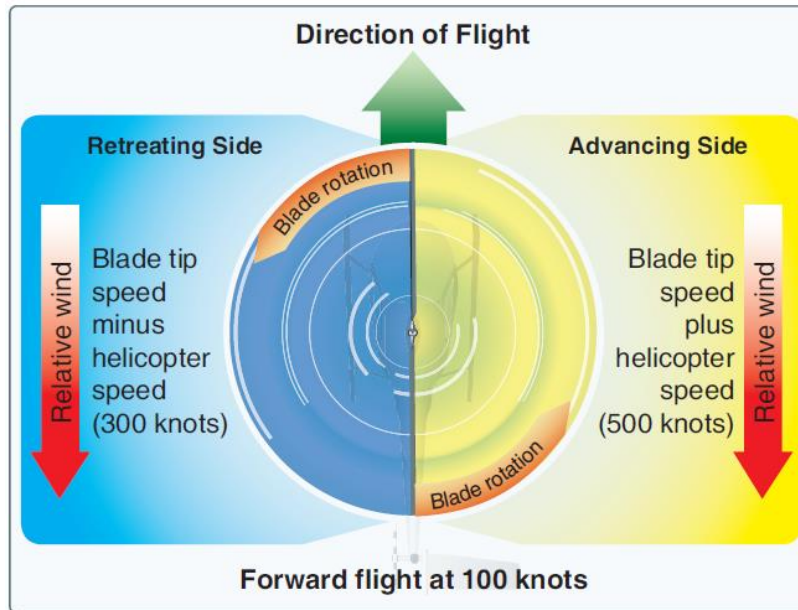
Figure 6
Dissymmetry of lift due to forward airspeed (source: FAA)

- 4.3.2. The speed of a helicopter in forward flight creates a dissymmetry of lift³⁹ across the rotor disc due to the higher speed through the air⁴⁰ of the forward travelling blade compared with the rearward travelling blade (see Figure 6). The unequal lift produced by the rotor disc is normally compensated for by reducing the effective angle of attack of the forward-travelling blade by teetering (flapping) the rotor blade up with each revolution, and the opposite rearward-travelling blade down to increase its effective angle of attack (see Appendix 4). If the main rotor RPM reduces below the normal operating range, the speed of the rearward travelling blade through the air can fall below that required to maintain the airflow over the upper surface of the blade. The blade will then experience an aerodynamic stall and lose lift.

- 4.3.3. In this situation the forward travelling blade with its higher speed through the air has not stalled and is still producing lift, so the net effect is that the rearward travelling blade 'wants' to dive and the forward travelling blade 'wants' to climb. Due to gyroscopic precession⁴¹ (see Appendix 4), the result of this type of divergence is that the rotor disc tilts rearwards and the rotor blades strike or sever the tail boom.
- 4.3.4. In both of these cases of rotor divergence the teeter stops are crushed; the main difference is whether the cabin or the tail boom is struck by the blades. In this accident the tail boom of the helicopter was not struck by the main rotor and the forward travelling blade moved downward and entered the cabin.

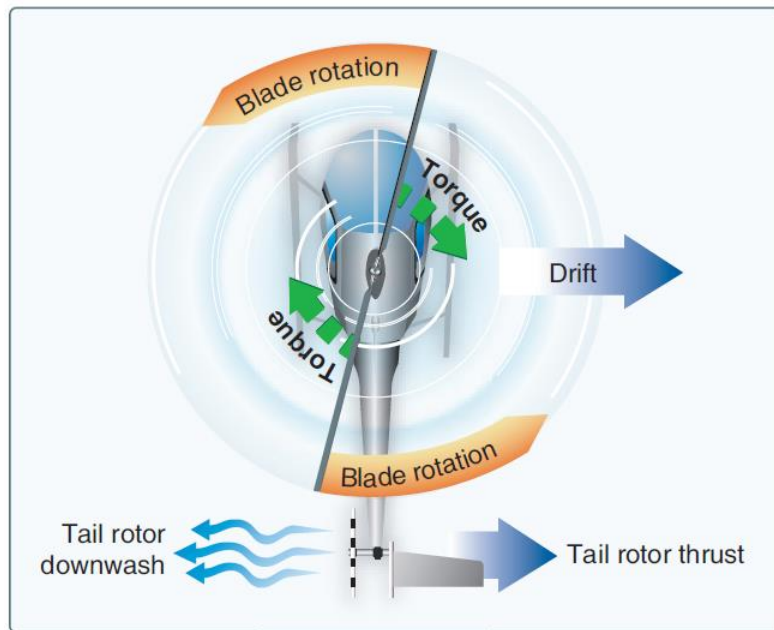
Figure 7
Tail rotor drift (source: FAA)

- 4.6.2. A helicopter with a single main rotor is fitted with a tail rotor to counteract the torque reaction from the engine driving the main rotor, otherwise the helicopter would spin uncontrollably in the opposite direction to the main rotor. The tail rotor's thrust stops the helicopter spinning clockwise, but it creates a sideways thrust as a result and would make the helicopter drift in the same direction as the thrust. In the case of Robinson helicopters this is to the right (see Figure 7).

- 4.6.3. The horizontal tail rotor thrust acts in a line that is above the helicopter's centre of gravity, which if not compensated for would make the helicopter roll to the right. The sideways drift and roll are counteracted in flight by tilting the main rotor to the left slightly to produce a sideways component in the lift produced by the main rotor, which offsets the right drift and right roll from the tail rotor.

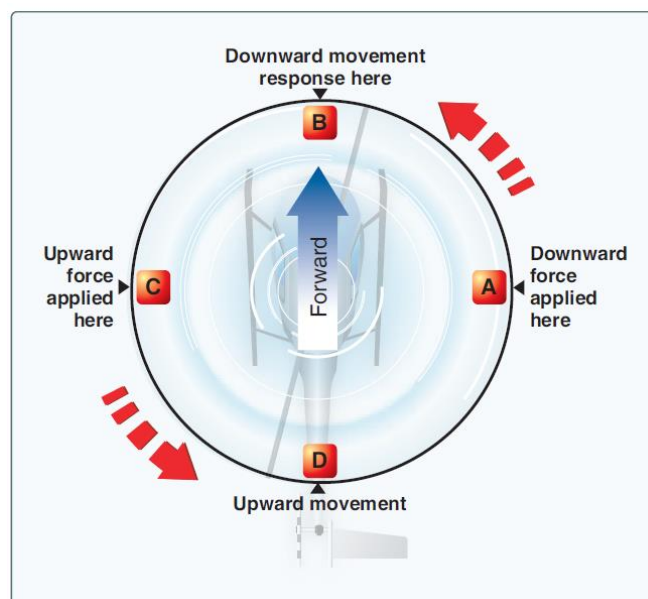
Figure 10

Gyroscopic precession (source: FAA)

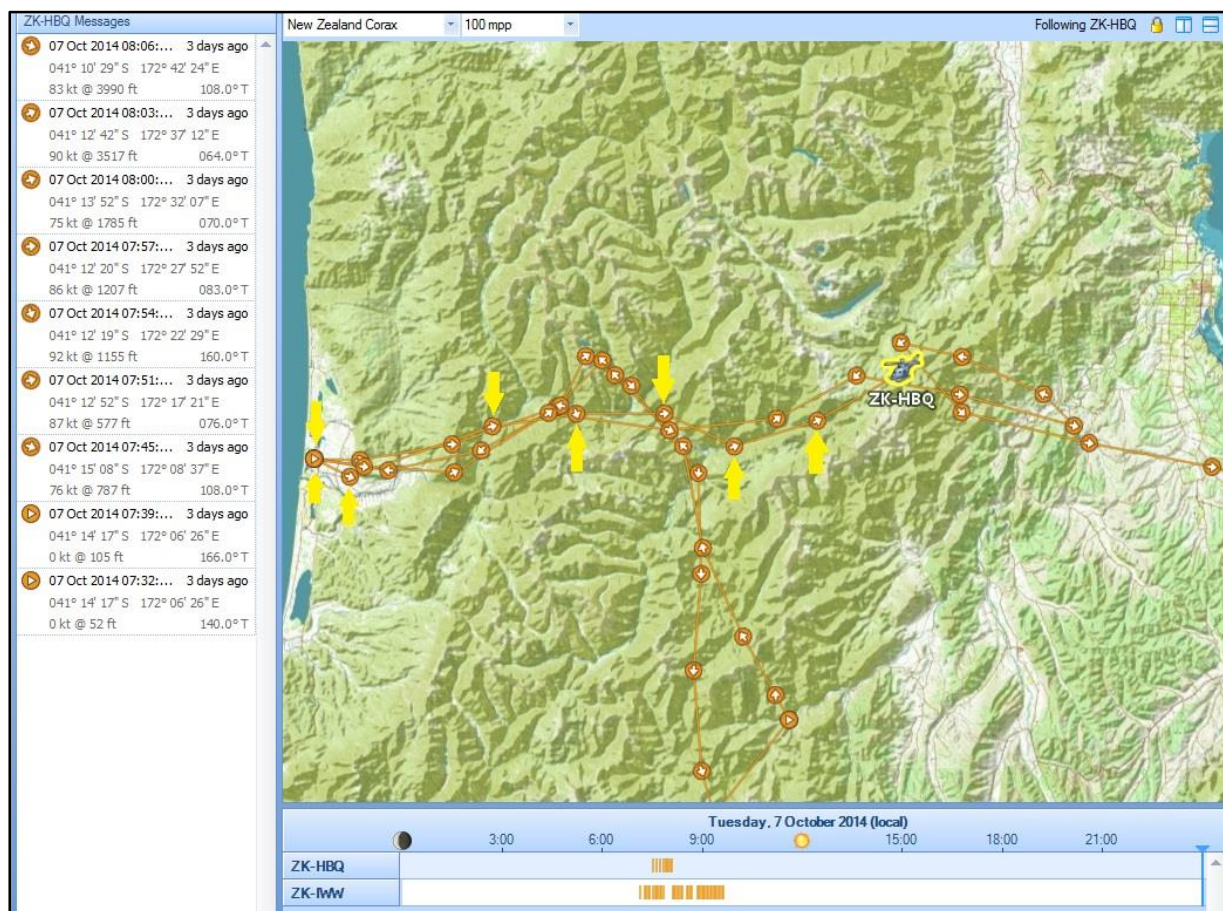
↓ ZK-HBQ TracPlus™ position reports (the others are from ZK-IWW, the second helicopter flying on the day).
