Wellington City Council Targeted Assessment Programme

following the
Kaikoura Earthquake of 14 November 2016

Technical Report

7 May 2017

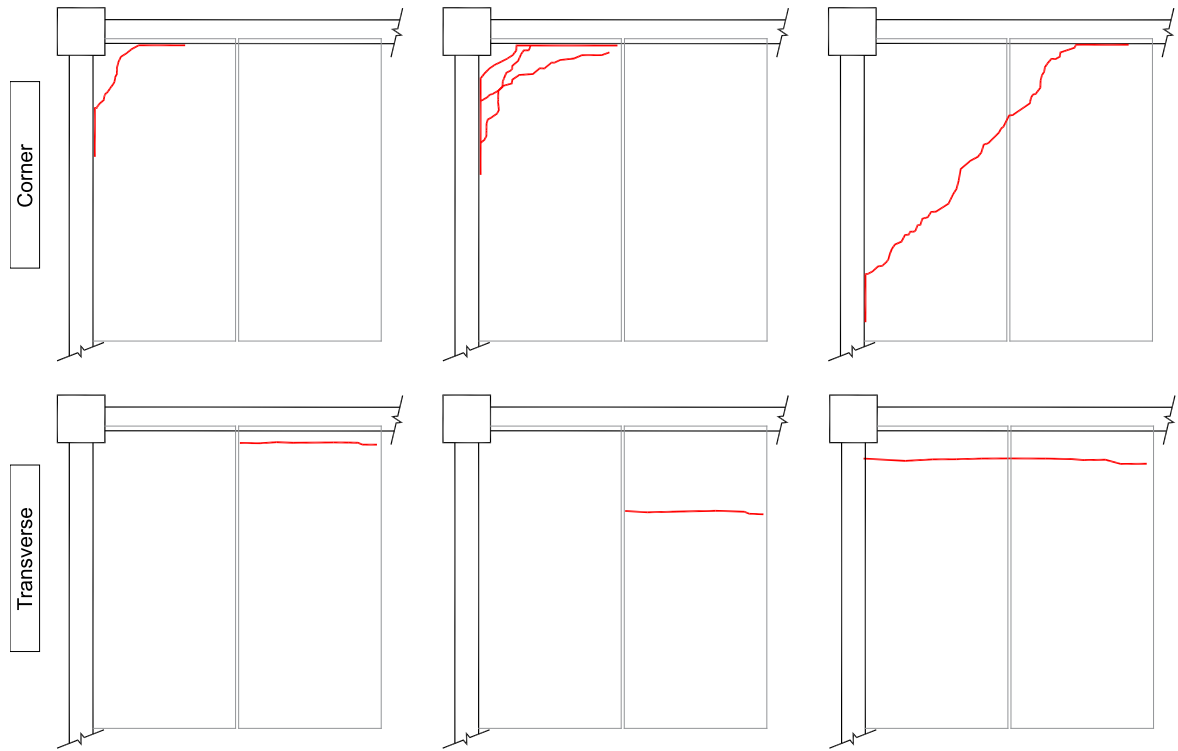
Figure 13: Plan views of typical crack patterns observed in floor units (from below or from above)

The most commonly observed damage pattern was cracking of floor units in the floor plate corners. Figure 13 indicates this corner cracking typically takes one of three forms:

- 1) localised with only one or two, typically fine, cracks near corner column (examples in Figure 14);
- 2) a complex intersection of many, typically wider, cracks, generally limited to the first unit (examples in Figure 15); or
- 3) a single diagonal crack set back from the corner, crossing more than one unit, and intersecting the frames roughly halfway along the bay lengths.

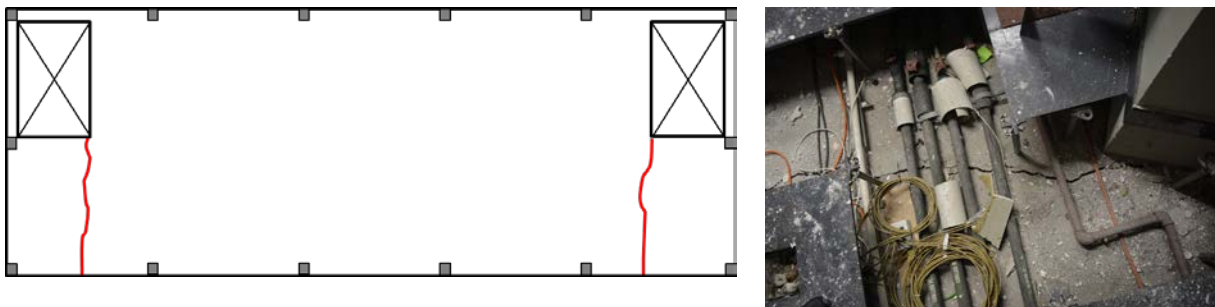
Figure 16: Generic illustration (plan view) of rectangular perimeter moment frame building with diaphragm failure at openings for stairwells

In at least one significantly damaged building, the layout of the structural system led to failure of the diaphragm with wide cracks extending through the topping and hollowcore units (10-15mm wide in some locations with topping steel mesh fracture). The principal crack ran longitudinally along the unit and stepped across cells at discrete locations, with damage to internal webs of the unit being likely. As illustrated generically in Figure 16, connection between the diaphragm and the short seismic frames at perimeter was interrupted by the presence of stairwells, leading to high shear demands on a short length of diaphragm. Floor unit demands were further exacerbated by limited beam elongation in the corner of the building and reasonably high building drifts (estimated at 1.0 - 1.5%).

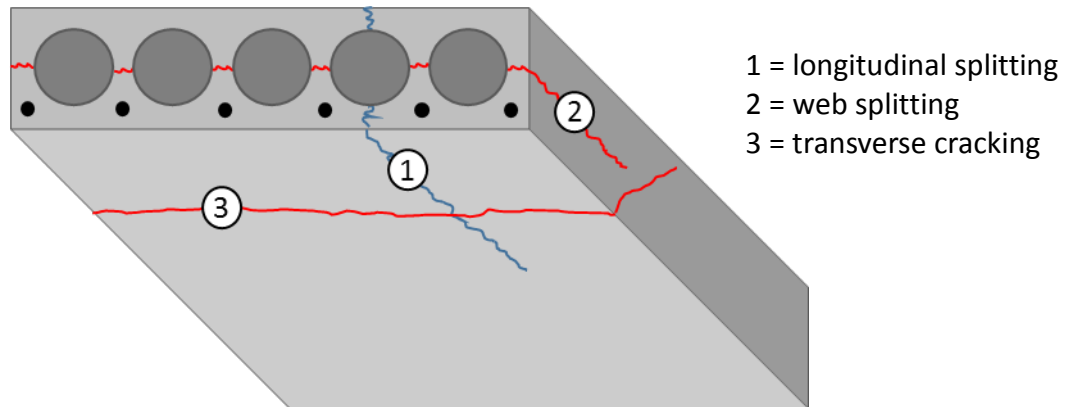
Figure 17: Types of cracks found in hollowcore units

When assessing the critical damage states, it was important to identify whether the cracks in the floor topping concrete had propagated between the joints of precast units or through the unit itself. Different types of cracks found in hollowcore units are shown in Figure 17. Transverse cracking in hollowcore was of particular concern because these units do not include transverse reinforcement, and transverse cracks near the support may impact the bond between concrete and the bottom flange prestressing strand and reduce shear capacity near the support. Transverse cracking in hollowcore units was observed in 14 of the 64 TDE buildings. In three of these buildings the transverse cracks were identified to have propagated diagonally through the web of the hollowcore as illustrated in Figure 17 (CDS A1).

It is noted that a further 11 buildings with transverse cracking were identified where the orientation of the cracking through the hollowcore unit had not been confirmed (and hence have been classified as CDS A1). Further inspection of these units for diagonal web cracking using a borescope camera is recommended.
