Final report RO-2016-101: Signal passed at danger leading to near collision,  
Wellington Railway Station, 28 May 2016

Rail inquiry RO-2016-101  
Signal passed at danger leading to near  
collision

Wellington Railway Station

28 May 2016

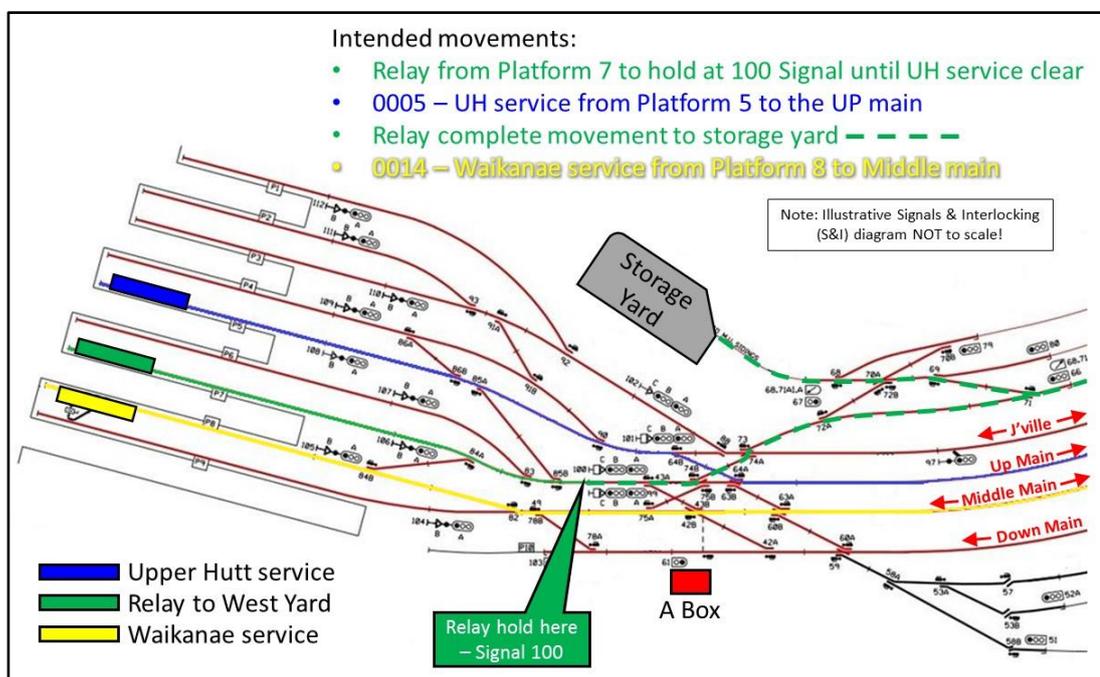
Figure 2  
Diagram of planned train movements

- 3.1.3. This incident involved an empty train that was being moved from Platform 7 into the train storage yard for the night (route depicted in green on Figure 2 below).

- 3.1.4. Around the same time as the relay movement, an Upper Hutt service (depicted in blue on Figure 2 above) was scheduled to leave Platform 5 at 0005 for the Up Main, passing ahead of the relay train. Also a Waikanae service (depicted in yellow on Figure 2 above) was scheduled to depart Platform 8 at 0014 for the Middle Main, by which time the relay should have been completed.
- 3.1.5. The trains were all being controlled by a signalbox controller (the signaller) from the Wellington Signalbox, locally known as 'A Box' (depicted in red on Figure 2 above).

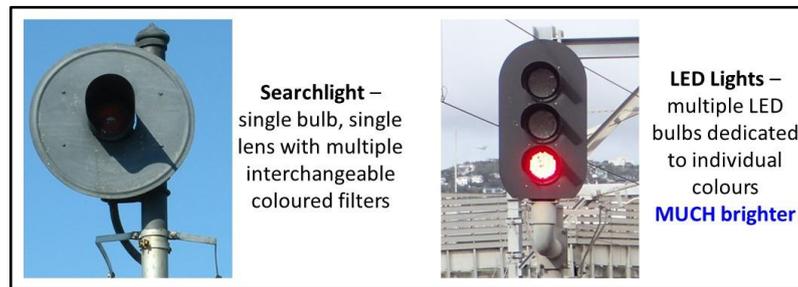
Figure 7  
Old searchlight vs modern LED signals

- the upgrading of individual signals from the older searchlight type to modern LEDs (light-emitting diodes) (see Figure 7)

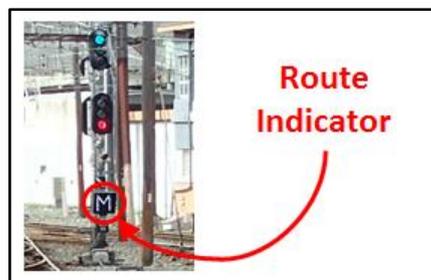
Figure 8  
Route Indicator

- the placement of route indicators (see Figure 8) to Directing Signals in the area to identify the route which has been set, indicated by illuminated characters

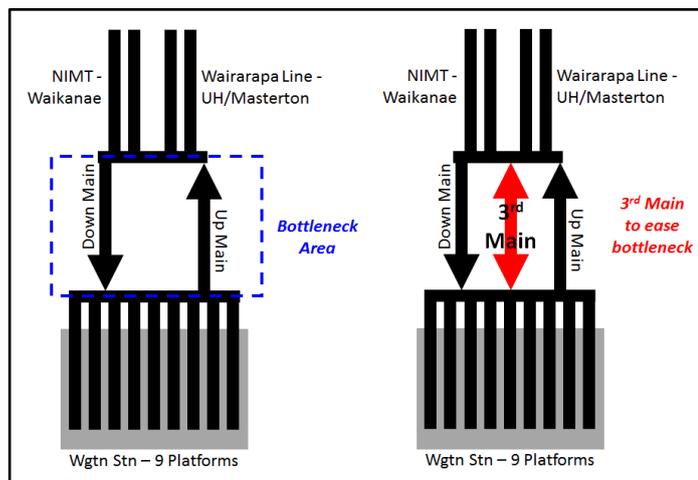
Figure 9  
Addition of third main line – bi-directional in 2010

- the addition of non-reflective white arrows to the uprights of signals 99 and 100 in 2005, to assist drivers to identify which signal is controlling which track
- the introduction of a third bi-directional main line into and out of Wellington in July 2010 (see Figure 9) to improve flexibility into and out of Wellington Station.

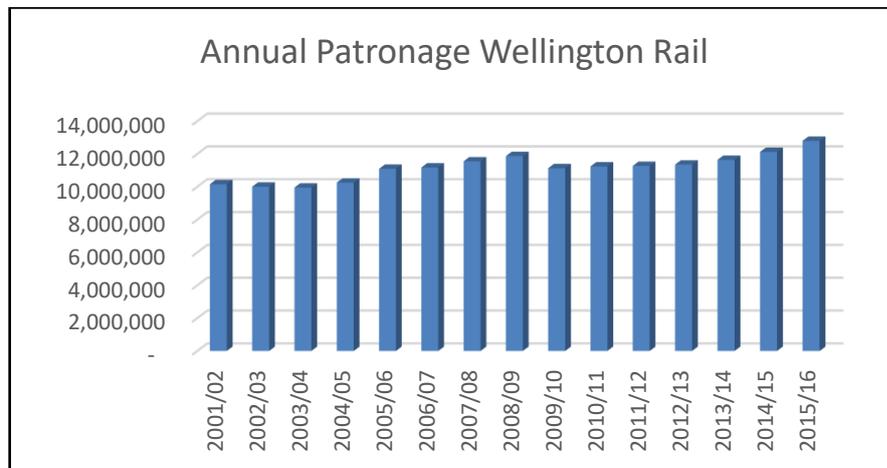
**Figure 11**  
Annual patronage Wellington rail commuter network

- 4.3.7. Between the 2001/02 and 2015/16 financial years there has been a 26% increase in patronage on the Wellington commuter network (see Figure 11). To meet this demand there has to be a corresponding increase in the length of trains or an increased service frequency, which has therefore increased the pressure on this congested area.

- 4.3.8. Using longer trains to accommodate an increase in patronage does not increase the likelihood of collisions, but the potential consequence is elevated. Alternatively, a more frequent service means the likelihood of collisions is increased, but the potential consequence is not.
