FIRE INVESTIGATION REPORT

87-93 Wellesley Street West, Auckland Central, Auckland

F2866954

High Value Loss

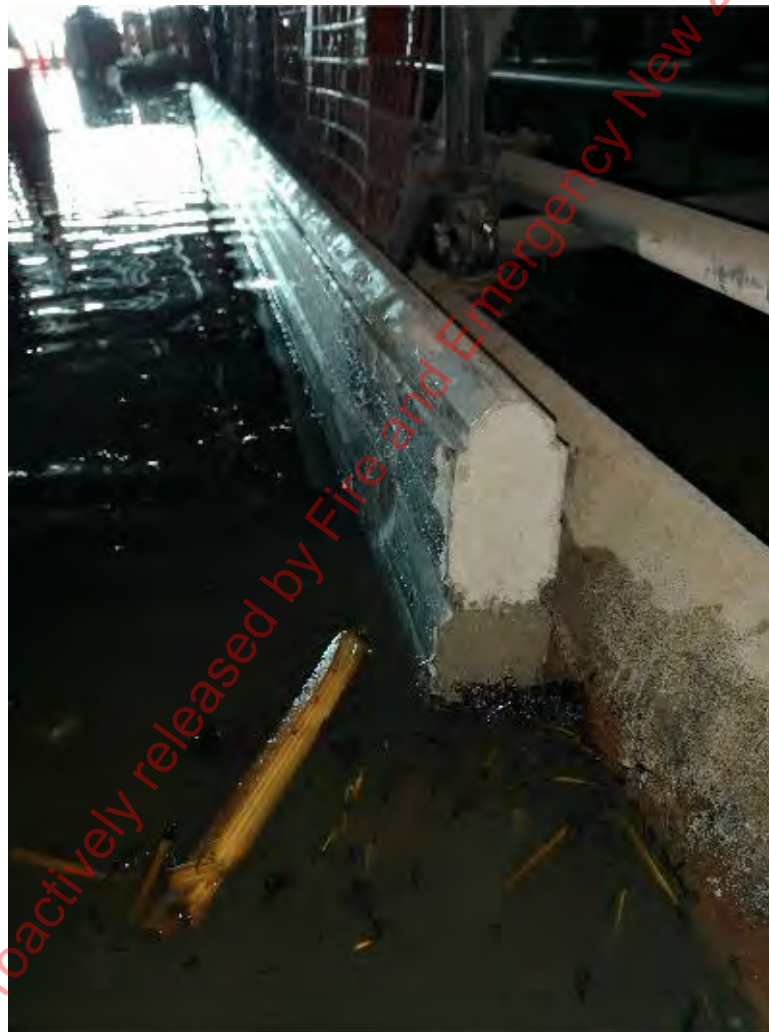
Photo 8: Example of a length of the non-combustible Speed Wall.

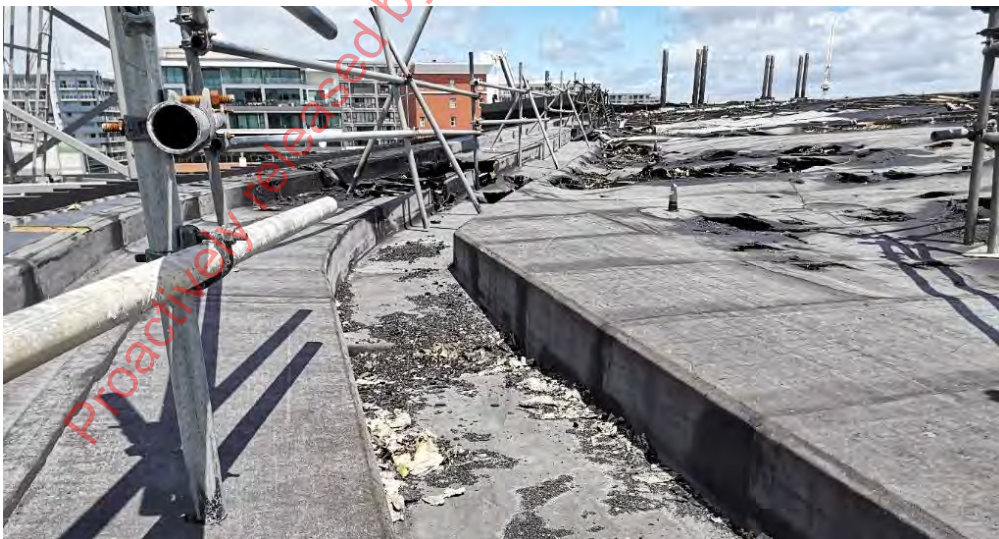
Photo 20: Shows a comparable view of the gutter on the east side of the Level 7 roof after the fire showing the Base Sheet installed. The Cap Sheet had not been applied in this location.

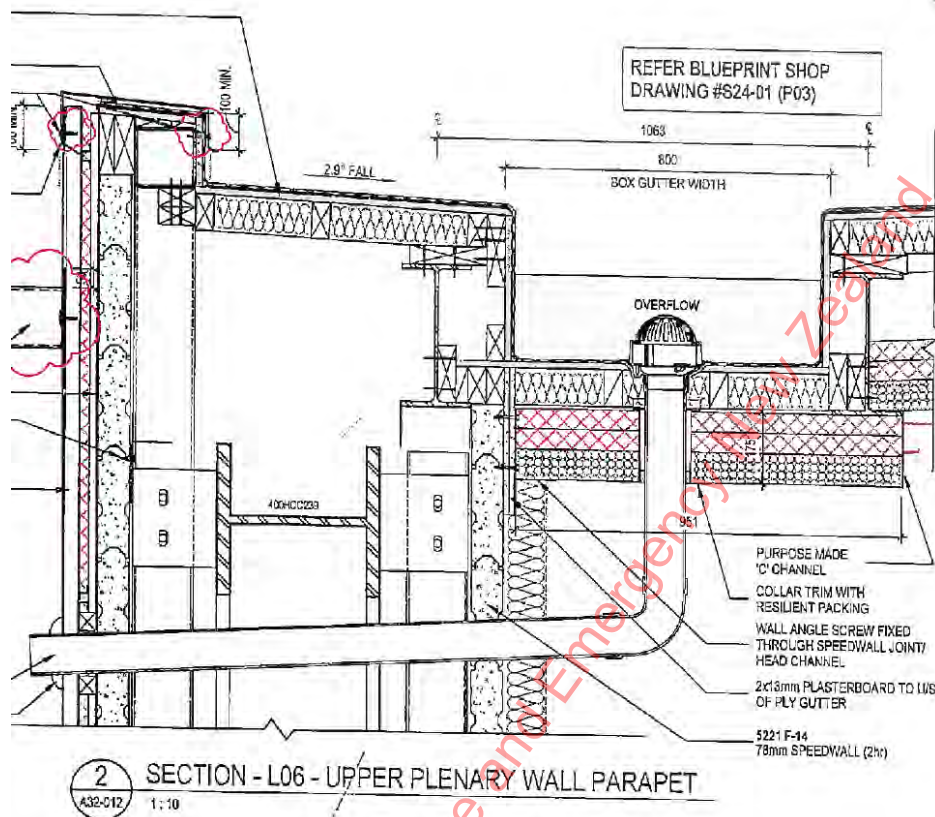
The construction of the gutter consisted of the layers of membrane (Cap Sheet and Base Sheet) torched on and laid over a wire mesh stapled to a 20 mm (17 mm on drawings) plywood substrate. The

plywood was fixed on to timber framing secured to steel joists. Beneath the plywood was laid 100 mm of thermal insulation sitting on 2 layers of Durra Panel® with insulation beneath.

Image 4: Shows sample cross section of guttering.

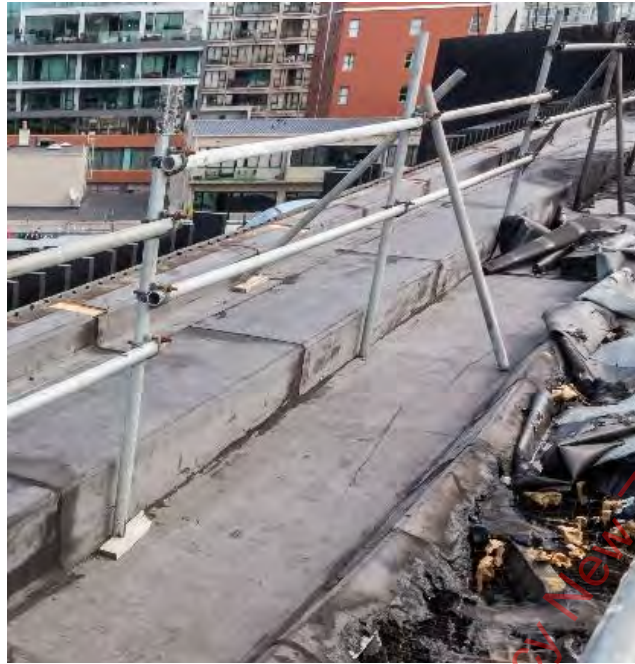
Photo 25: Example of guttering on eastern side of Level 7 with Base Sheet complete.

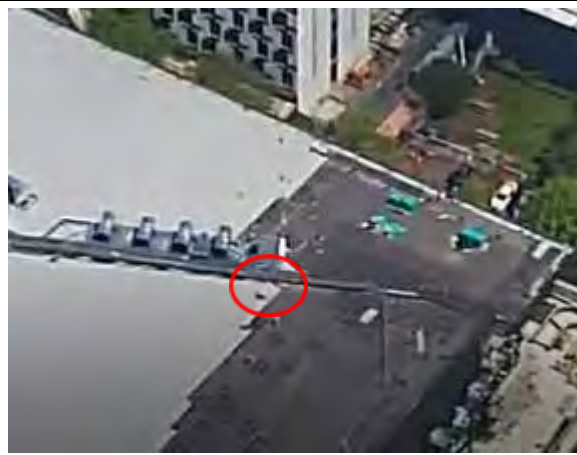
12:17 p.m.	Cap Sheet visible not completely finished to gutter (Photos 19 and 21, 33 and 34).
12:20 p.m.	Cap Sheet laid to gutter. Worker leaves the gutter area for the final time and visits gas cylinder for ~30 s.

Photo 33: Shows Cap Sheet at 12:17 p.m. incomplete to gutter edge.

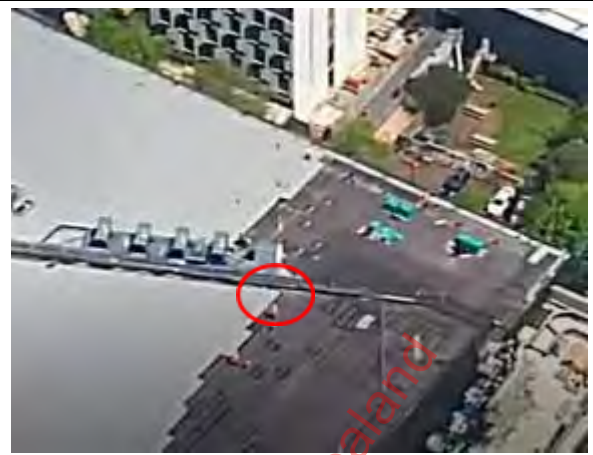
Photo 34: Shows Cap Sheet complete to gutter edge at 12:20 p.m.

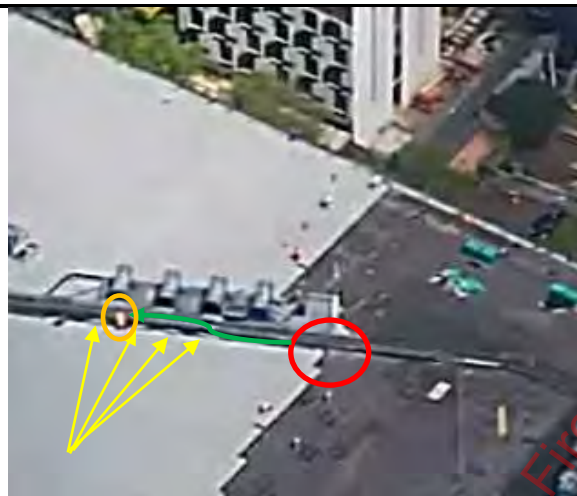
12:06 p.m.	Worker returns to gutter area where a short length (~3 m) is required, for about 25 s; then departs and walks south along the gutter passing several rolls of membrane lying in the gutter (Photos 35 - 36). Stoops and retrieves an object and returns to area of work.

Photo 35: 12:07.10 p.m. Roofer (orange circle) leaves area where a short length is required (red circle) and walks along gutter passing several rolls of membrane (yellow arrows).

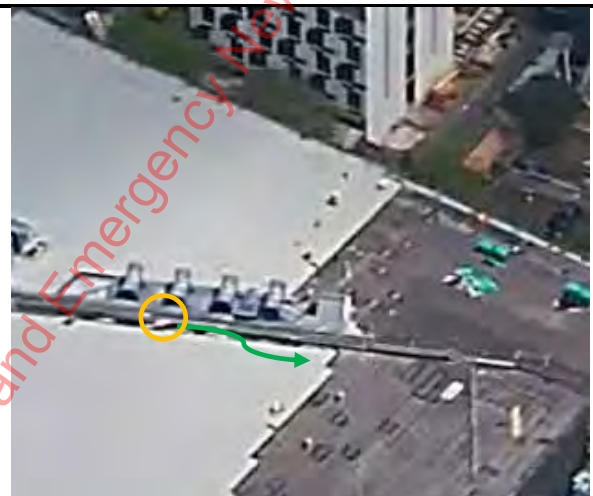
Photo 36: 12:07.14 p.m. Roofer stoops in gutter, presumably to uplift a roll and returns to the area of work.

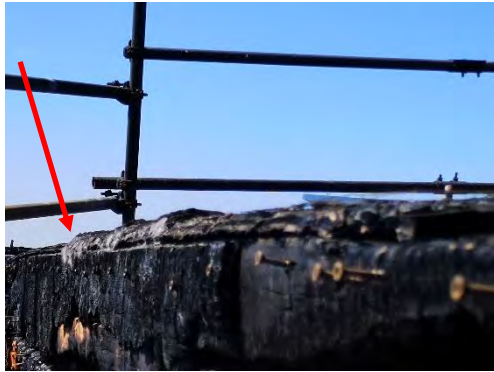
Ignition of fine fuels under the membrane was considered. Examination of an unburned section of roofing on the eastern side of Level 7 showed the edges of the plywood generally butted together tightly however there were instances observed of 2–4 mm gaps between sections of plywood. Small amounts of sawdust were observed trapped in these gaps. It was noted the configuration of plywood construction differed to the area of origin. Near the area of origin on the western side of Level 7 the top horizontal sheets of plywood overlapped the vertical plywood which made up the walls of the gutter, refer Photo 41. On the eastern side of Level 7 the vertical gutter walls reached the top of the horizontal plywood sheets making collection of sawdust more likely, refer Photo 42.

Photo 41: Example of roof on western side of Level 7 near the area of origin with top plywood sheets overlapping vertical plywood.

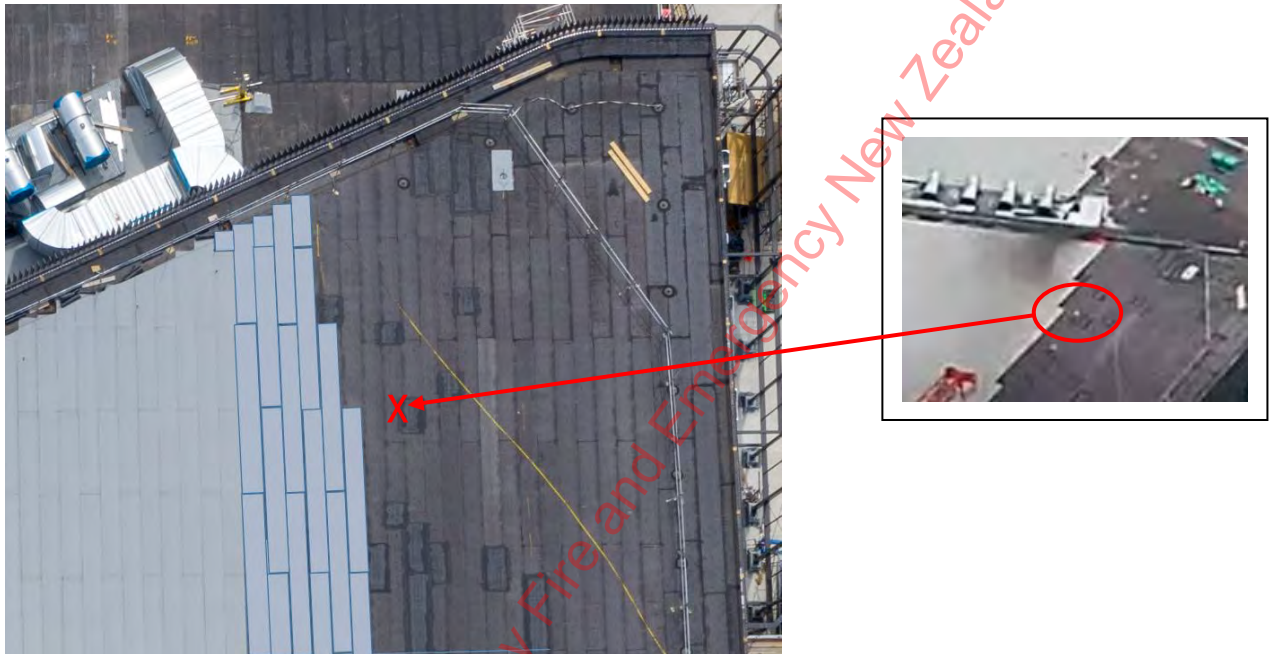
At 12:20 p.m. on 22 October 2019 the worker left the gutter area and travelled to the nearest cylinder. At 12:25 p.m. on 22 October 2019 the worker moved the gas cylinder to a more central location on the roof to enable work in that area. The gas cylinders' final locations prior to the fire were 11.6 m and 16.9 m respectively from the western gutter. Video show both workers laying another full length of Cap Sheet. No further work was done in the gutter area and workers left Level 7 at 12:39 p.m. on 22 October 2019. Once the fire reached the locations of the gas cylinders on Level 7 they fell horizontally landing on the burned debris and wiring netting on the roof. The final location of the gas cylinders prior to the fire was identified by examining key markers on the roof such as membrane patches clearly visible in a range of pre-fire photographs and comparing these to the video that captured the first sighting of the fire.

Photo 44: Showing last location of gas cylinder (marked 'X') nearest point of origin while in the vertical position prior to the fire. Photo supplied by Fletcher Construction and modified by Fire and Emergency.

Inset image shows gas cylinder at time of fire. Video image from ATOC.

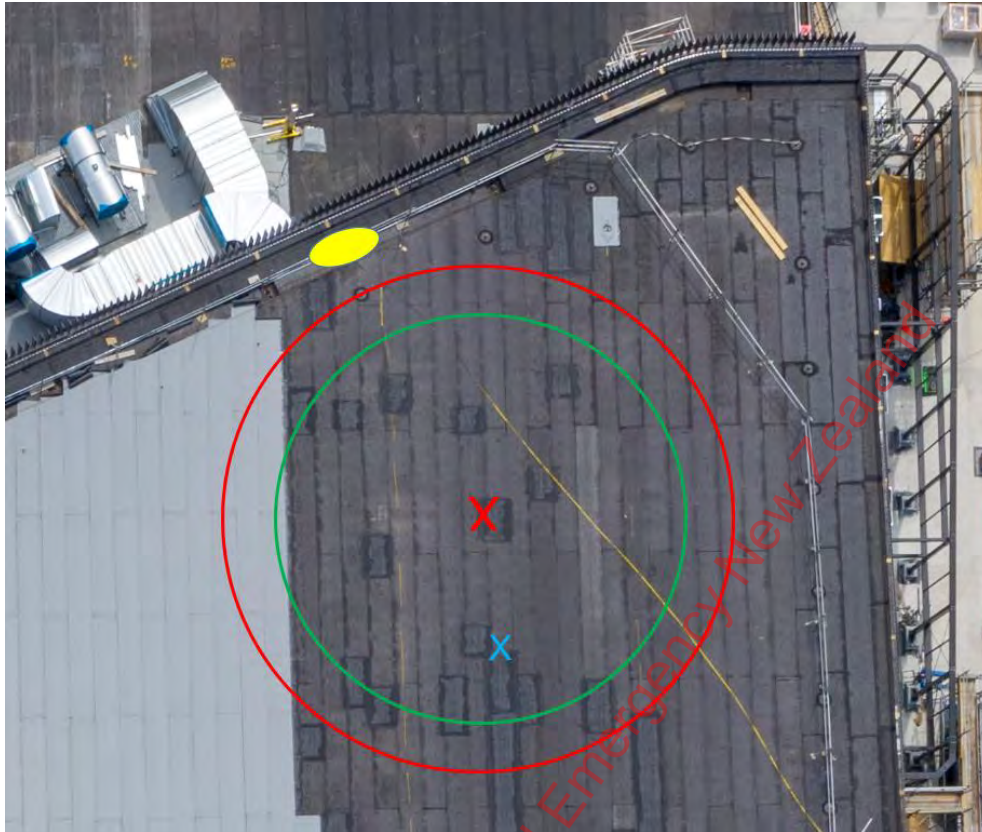
Flex in the hose also reduces the un-tensioned length of the hose 0.3 m - 0.5 m. In an un-tensioned state, a 10 m hose can be expected to reach less than 9 m.

Photo 46: Indicates a 10 m radius (red) and 8 m radius (green) indicating the maximum reach of a gas hose line from the gas cylinder (red 'X') closest to the area where the fire started (yellow ellipse). The adjacent gas cylinder location is marked with blue 'X'

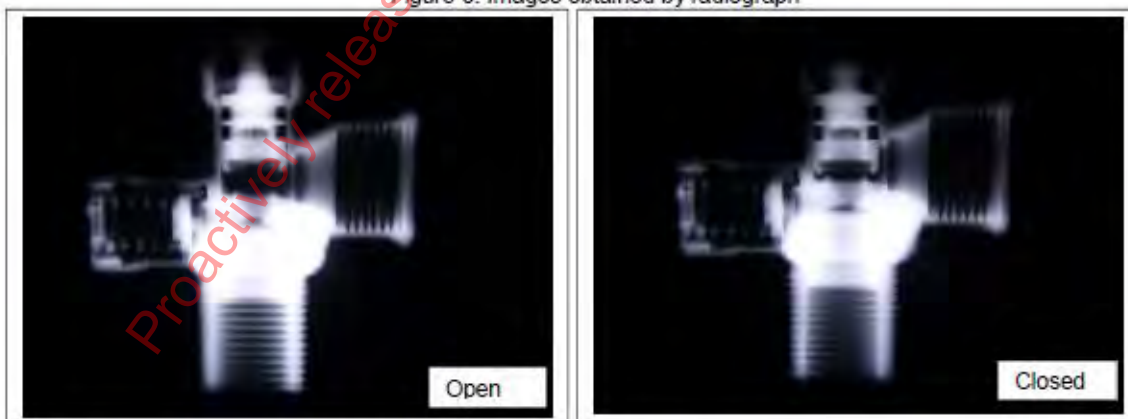
Figure 6: Images of the new valve obtained from the manufacturer in open and closed positions

One of the cylinders (105484) had the manufacturer ID of 'Galpro' stamped into the cylinder. The manufacturer was located and contacted, and new replacement valve purchased for comparison in the open and closed position. (Figure 6 and 7). No manufacturer was able to be located for the other cylinder (105485) for a comparison valve.
