# Pike River Independent Technical Advisory Group

## Conceptual Development Plan for Main Fan Access Roadway Recovery

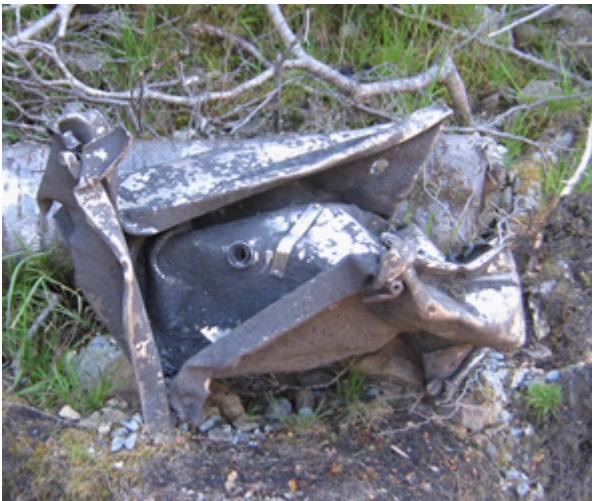
*remains of non-explosion proof cabinet LC601 photographed near the top of the ventilation shaft in 2010*

Important evidence comprising part of the main fan electrical power supply cabinet, LC601, and associated plastic circuit board pieces were recovered on the surface having been blasted through the ventilation shaft at the time of the disaster, photographed and retrieved from the mountainside to the Pike River manager's office. These items have since disappeared. The police were apparently unaware of this evidence until it was brought to their attention by family experts in 2018.

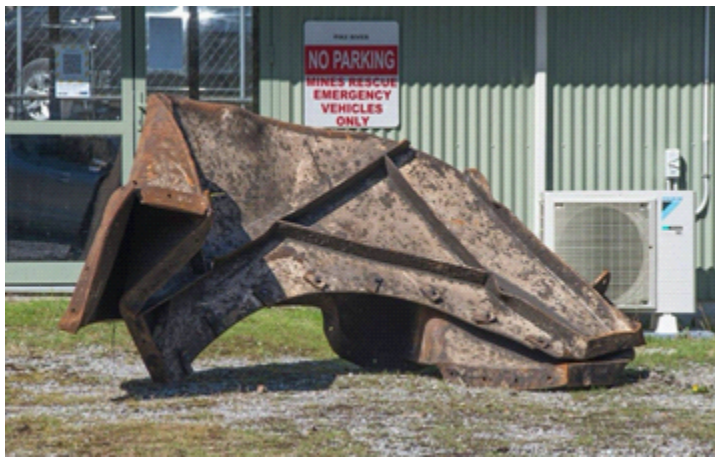
*remains of a section of main fan cowl recovered by PRRA near PBIS*

More recently a section of the main fan cowl (10mm plate construction) estimated to weight 920kgs was recovered close to PBIS by the PRRA recovery team, some 300m from the main fan site.

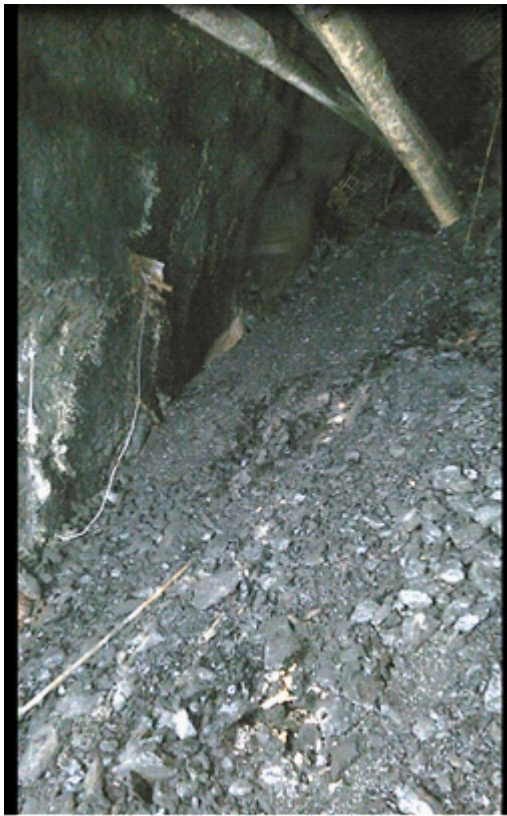
*photos taken by Dinghy Pattinson at the roof fall zone shows only coal*

The fall zone comprised two distinct roof-falls, in which all the visible material was coal. Dinghy reported as being able to see around the first roof-fall associated with PRBH50 and identified the outer edge of the main fan roadway junction roof-fall as being in line with the left hand side inner edge of the widened section (9m wide) of roadway made to accommodate wet coal recovery. From this position it was possible to accurately fix the distance from the edge of the junction roof-fall to the centre line of the main fan access roadway at 15m.

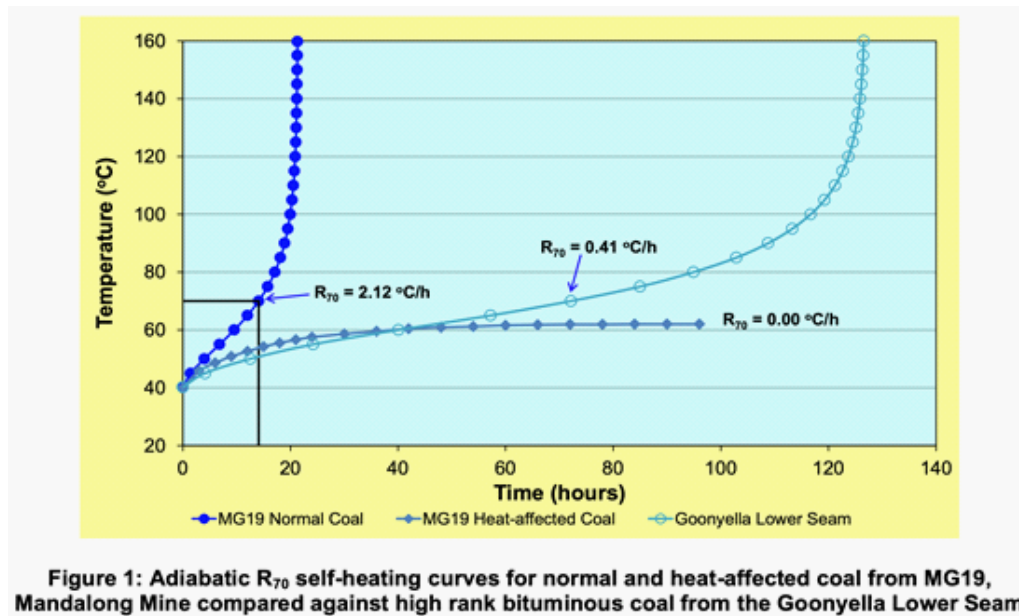
at Mandalong NSW and 2019 at Pike River, on the basis of R70 testing, to indicate there is any increased risk of spontaneous combustion due to pre-burnt, baked, or coked coal. Dr Beamish noted in respect of the sample tested below:

*“It is clear from these results and the results of the R70 self-heating rate testing that the heat-affected coal is not capable of reaching thermal runaway, unless it is exposed to a significant external heat source. Even then, it would take a considerably long time for the coal to reach thermal runaway”.*

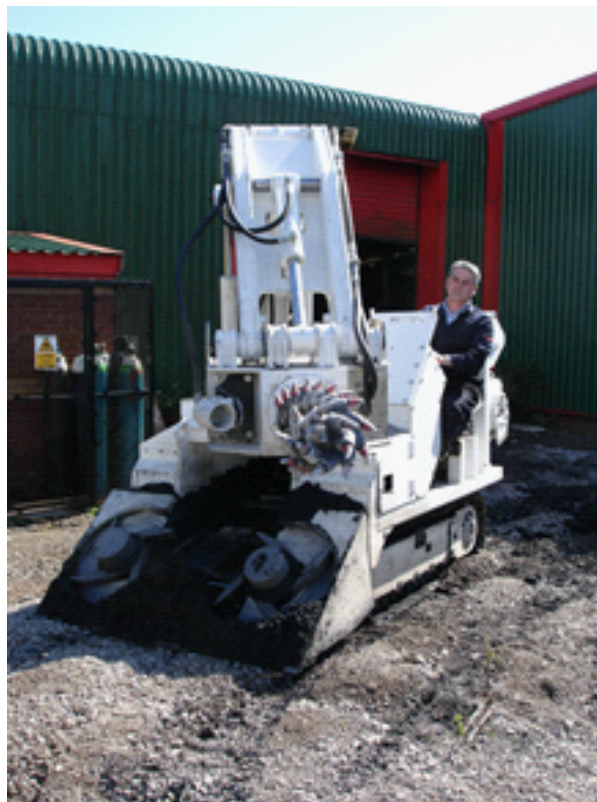
The Celtic Miner - CM4500 pictured below, is a robust, compact mining cutter / excavator used in coal mining and civil engineering tunnelling. It has no electrical components, is fully hydraulic powered by umbilical hose (which can be several hundreds of metres long), CE approved for use in coal mine methane environments and approved for use in New Zealand. A unit imported into New Zealand in 2009 by SENZ is still available, following refurbishment.

Excavate loose material taking as much coal and other debris away as will freely run. Excavation of loose material imbedded in Rocsil foam could be achieved using either the diesel loader and/or a refurbished, locally available CM4500, (ideally, if time permitted, a new hydraulic Celtic Miner could be imported). Using a remote module, the CM has the potential to operate under the fall area if assessed as safe to do so. As in normal mining 'mucking out' operations using routinely in coal and metalliferous mining, the diesel loader could also safely advance its bucket several metres under the fall area whilst the drivers cab remains under fully supported ground. The quick-detachable-system (QDS) means that an 'arch lifting' device can be readily fixed to the machine jib
